All Souls Church
1500 Harvard Street NW (US)
Report number: 2206.03-1
Date: April 21, 2022 10:00

Feasibility Assessment Walk Through

ALL SOULS CHURCH
BUILDING ASSESSMENT
2022

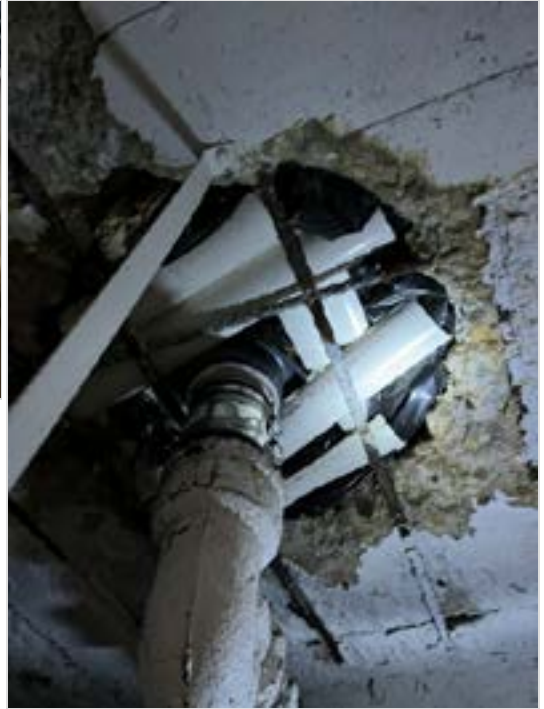
- Reinforced concrete has begun to deteriorate around the the drain pipe exposing the pipe and rebar reinforcement which has compromised the integrity of the concrete. This is located near the perimeter wall adjacent to the weather service room.
- Exposed pipe reveals unconventional support of pipe with PVC pipes and pipe surrounded with what appears to be a heavy duty black garbage bag.
- Cause of deterioration appears to be from water infiltration and/or stress concentration, but further investigation is required to confirm.
- Cause of deterioration should be investigated and cause resolved. Concrete should be repaired as required.
- Refer to images below.

Concrete breaks collected across floor.

Exposed pipe and main location of concrete deterioration.

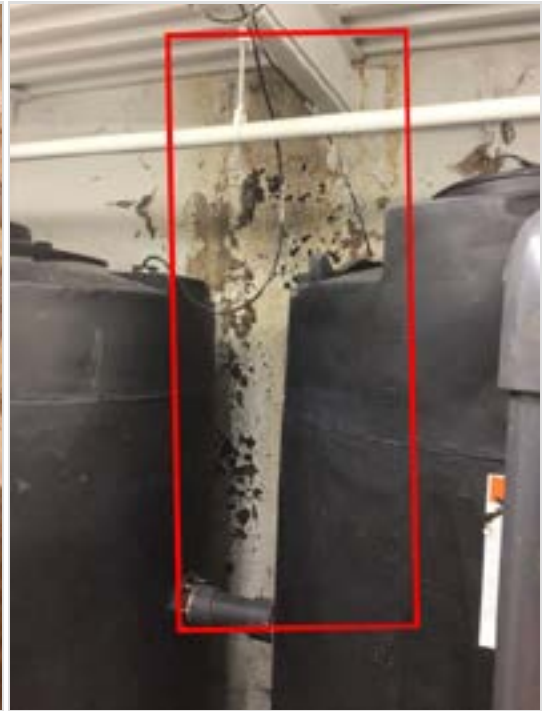
Pump line appears to be leaking from an interior point. Location of leak could not be observed.

Signs of water infiltration at perimeter wall. Leak appears to be from exterior and will require further investigation to locate.

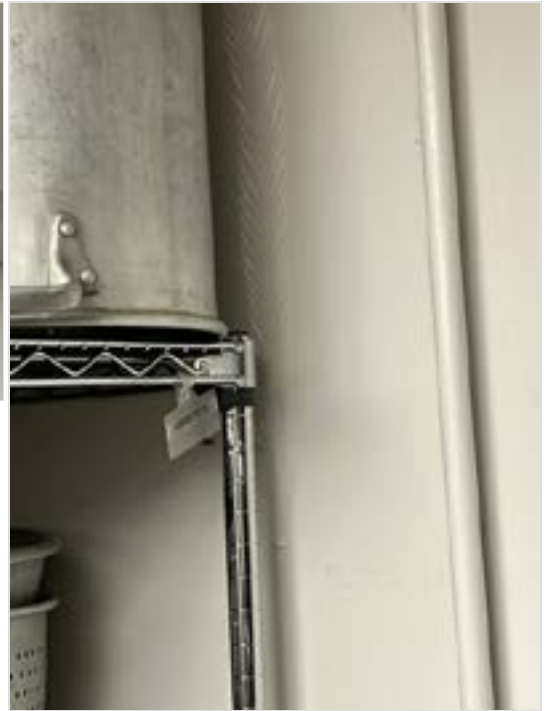
Evidence of water infiltration at multiple locations on the ceilings and walls.

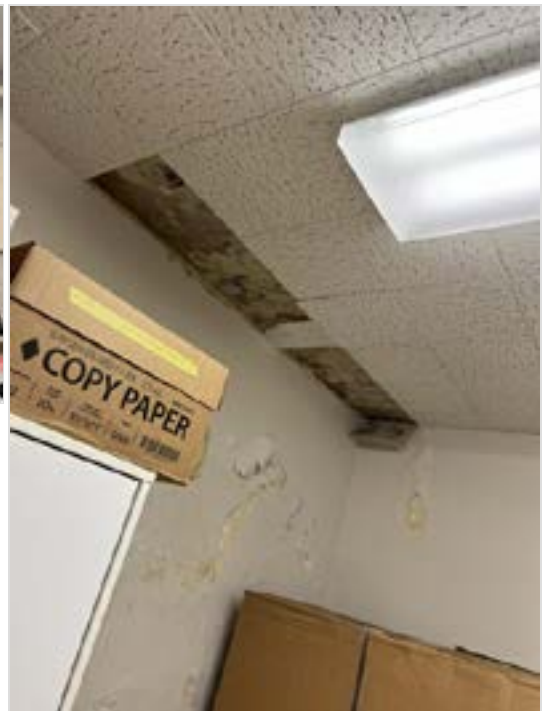
- Evidence of water infiltration at multiple locations. Courtyard is located above this space. Concrete and rebar above may also be affected. Further investigation is required to locate the cause and to understand the full extent of damage. Waterproofing documents should also be reviewed including detailing, warranty coverage and reports for testing completed to confirm performance. Refer to images below.

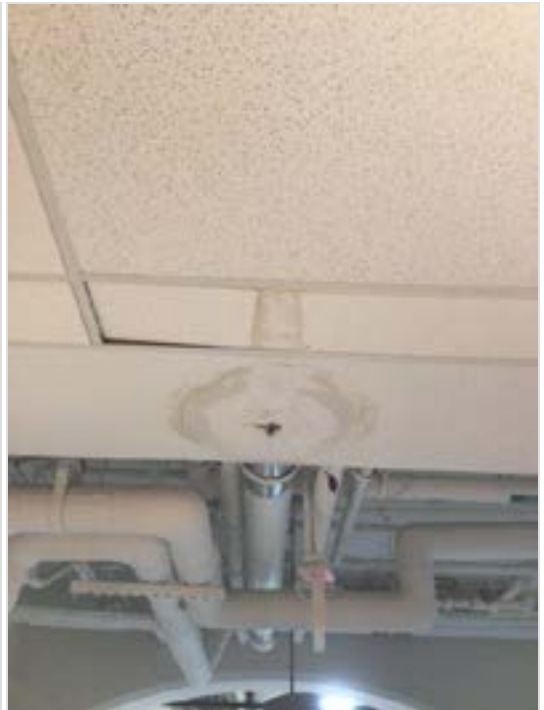
Stair treads in Corridor 115-B are damaged. Repair as required.

Evidence of water infiltration in ceiling at multiple locations. Investigate above ceilings for cause. Repair/replace ceiling as required.

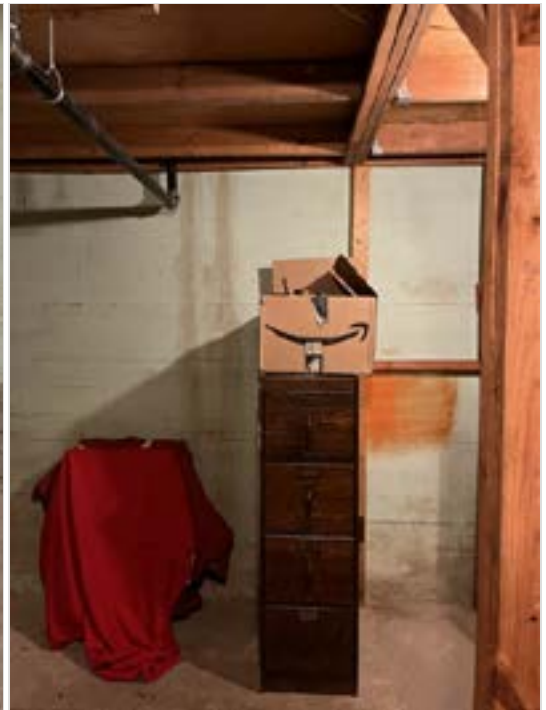
Wear and tear on piping insulation; typical.

Wall showing evidence of water infiltration in multiple locations.

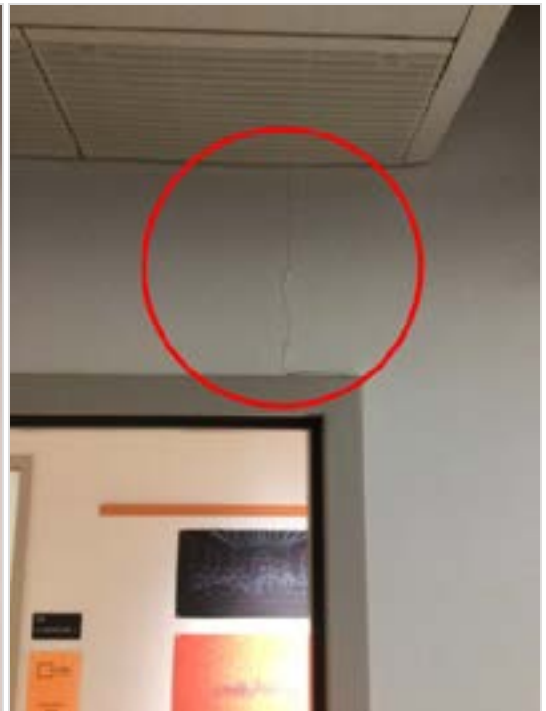
- Both classroom entry doors have cracks in drywall below HVAC penetrations. Walls should be repaired as required. Additional bracing may be required between studs.

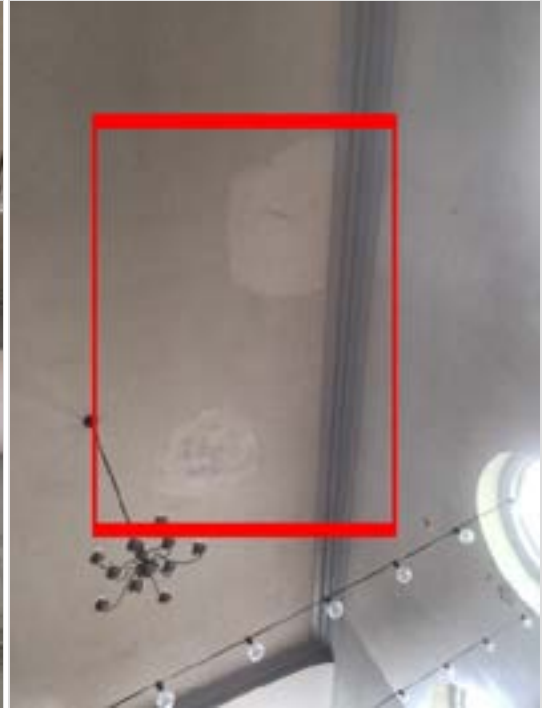
Evidence of water damage.

Areas of water damage appear to be painted over.

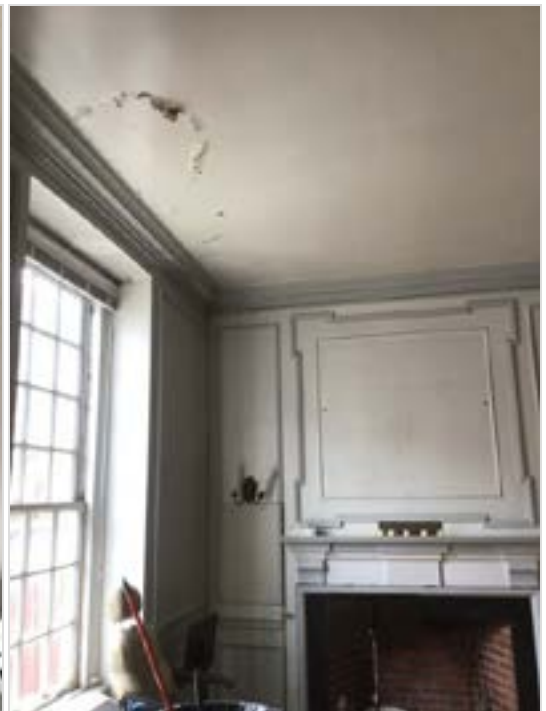
Water damage.

Paint blistering and peeling.

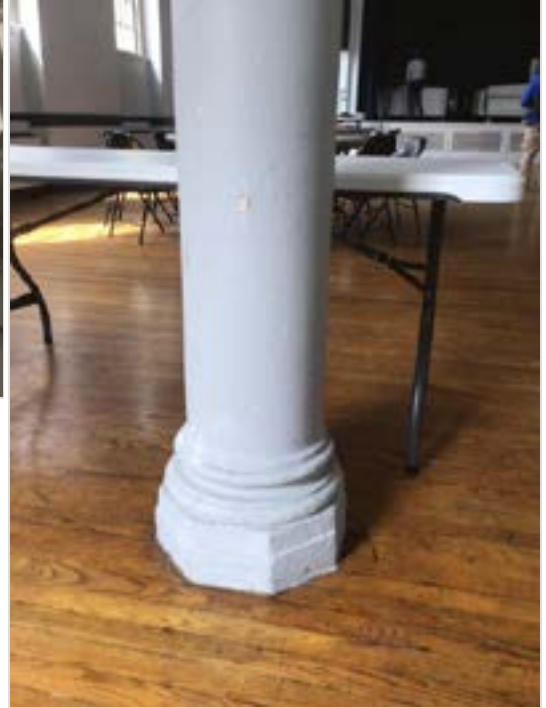
Paint chipping, typical.

Paint wear on columns.

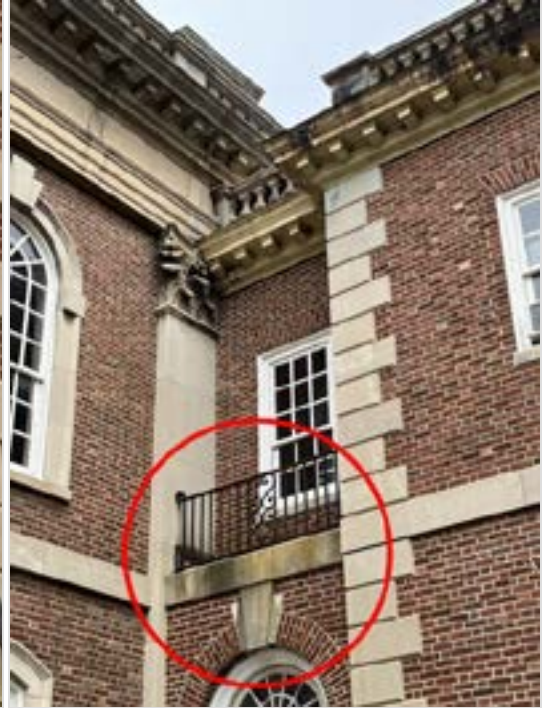
Transom needs to be replaced.

Railing rusting / evidence of water infiltration and damage; investigate and repair.

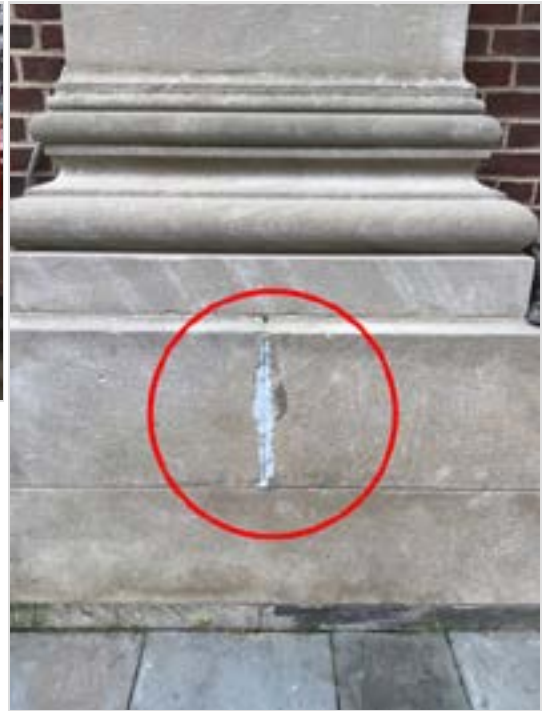
Cornice (pierce hall side)

Cast stone joint needs mortar. Evidence of water infiltration and damage; investigate and repair.

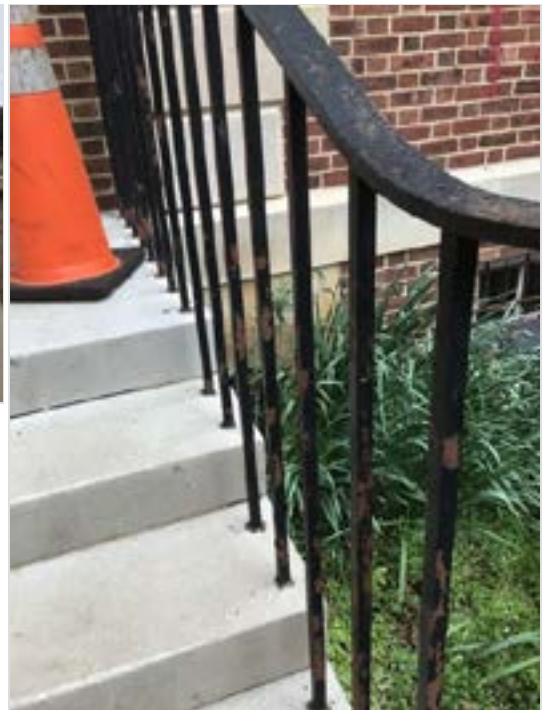
Cornice (sanctuary side)

Railing rusting

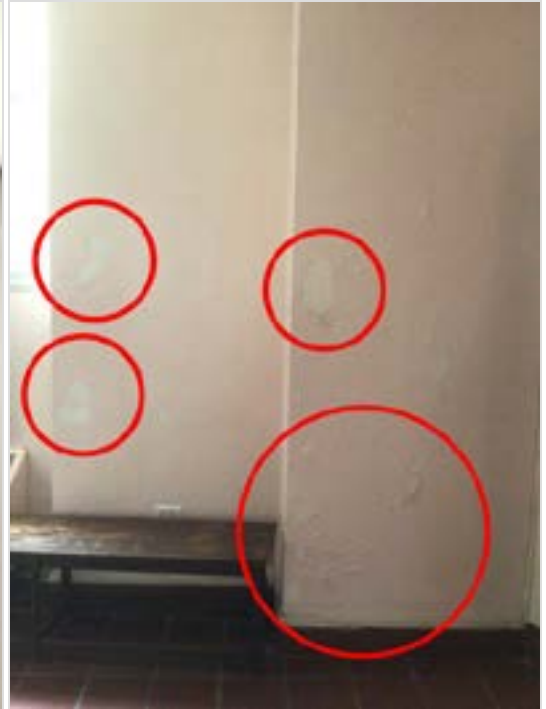
Paint cracking and peeling.

Blistering and peeling of paint.

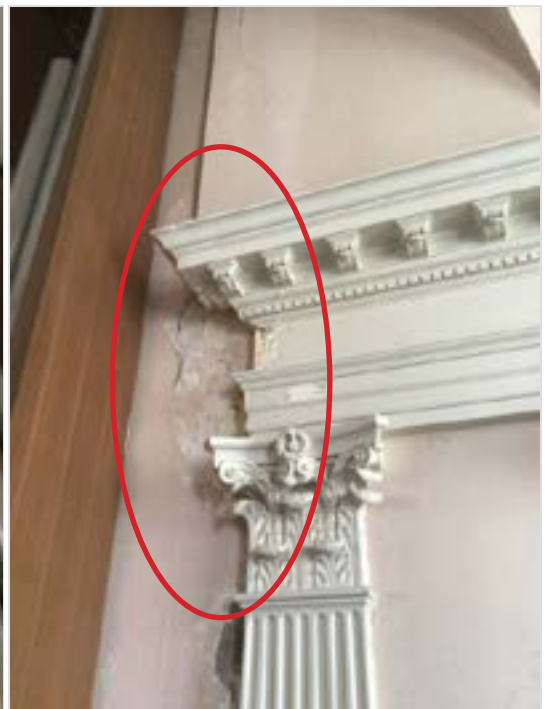
Cracks above decorative wood cornice.

Paint deteriorating by cornice. Cause requires further investigation.

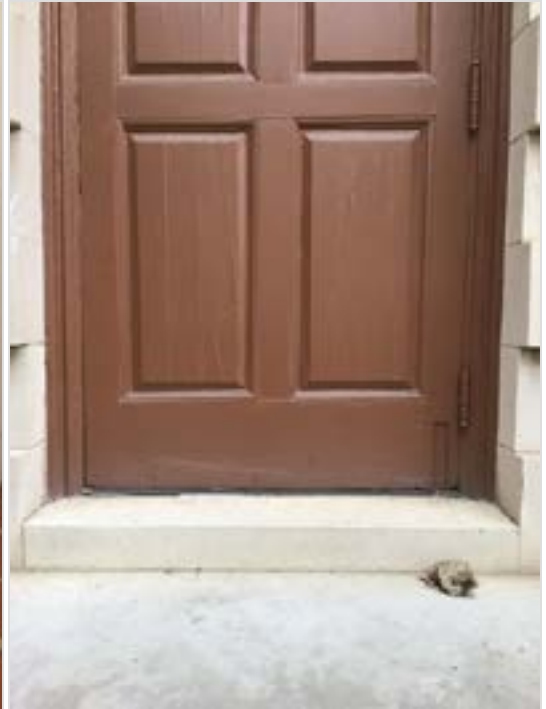
Air gap at bottom of door. Provide proper weather seals.

Bottom of wood door damaged. Repair and provide weather seals. A kick plate can help prevent damage to bottom face of door.

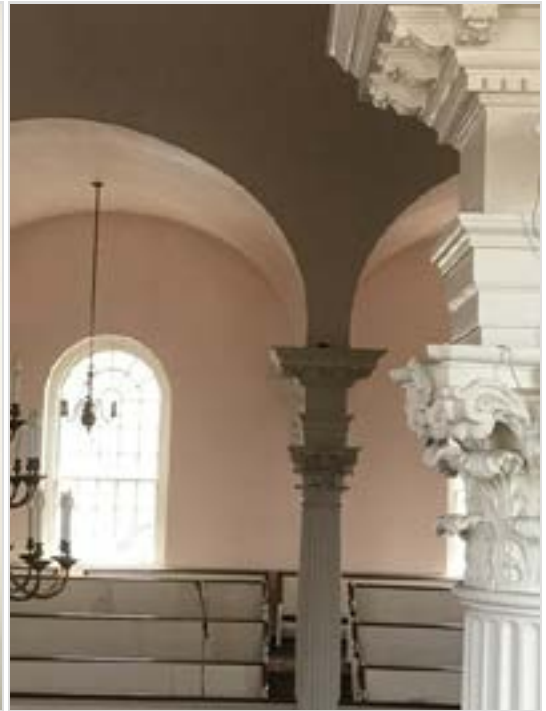
Cracking in ceiling.

Decorative wood column requires cleaning and painting.

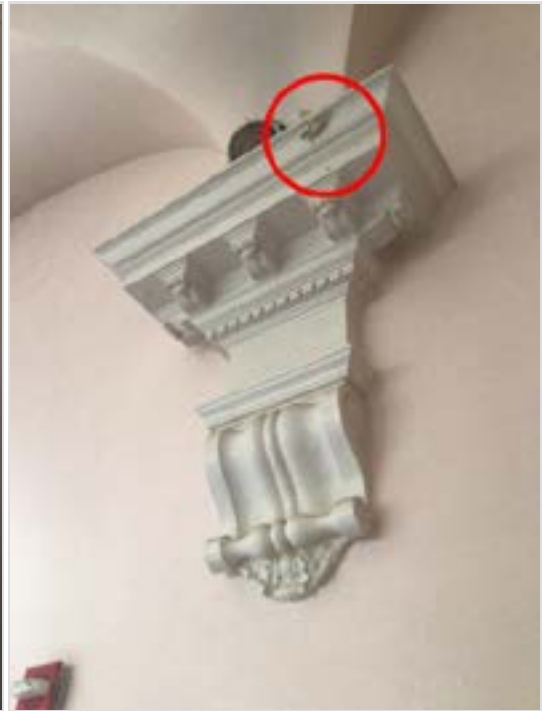
Damaged drywall at fire alarm pull. Repair and paint as required.

Peeling paint and layer of dust at corbel.

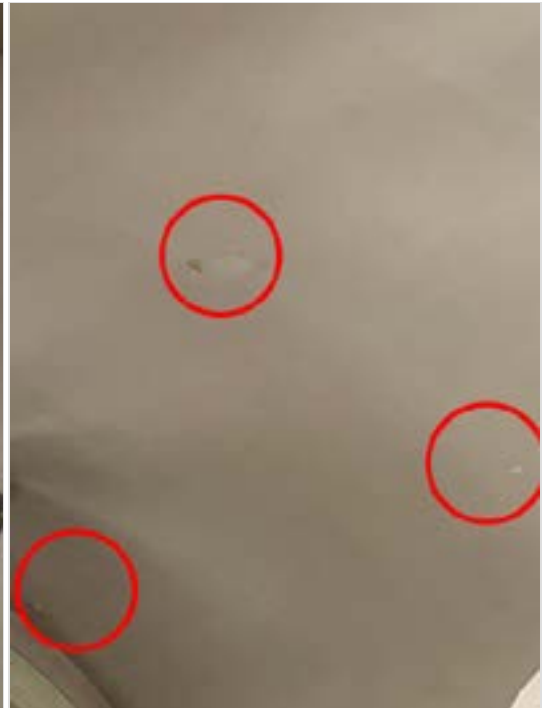
Corbel appears to be deteriorating. Layer of dust visible.

Vaulted ceiling staining and cracking.

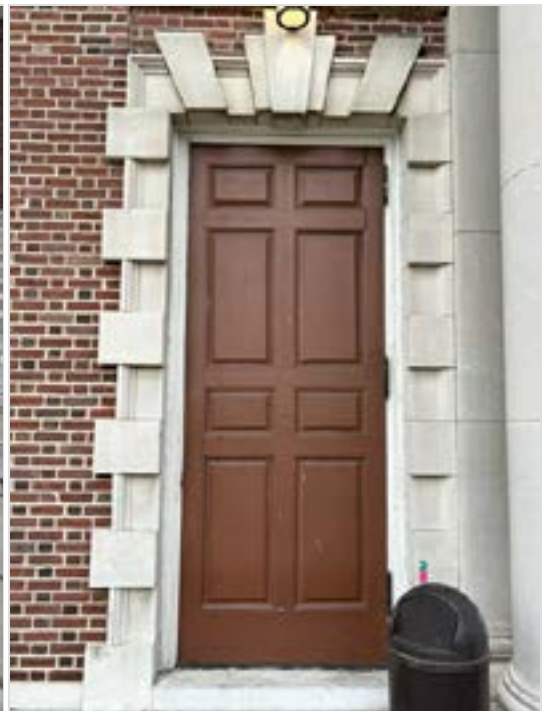
Uneven surface of pavers may not meet accessibility requirement's

Door and door frame showing signs of wear and tear, typ.

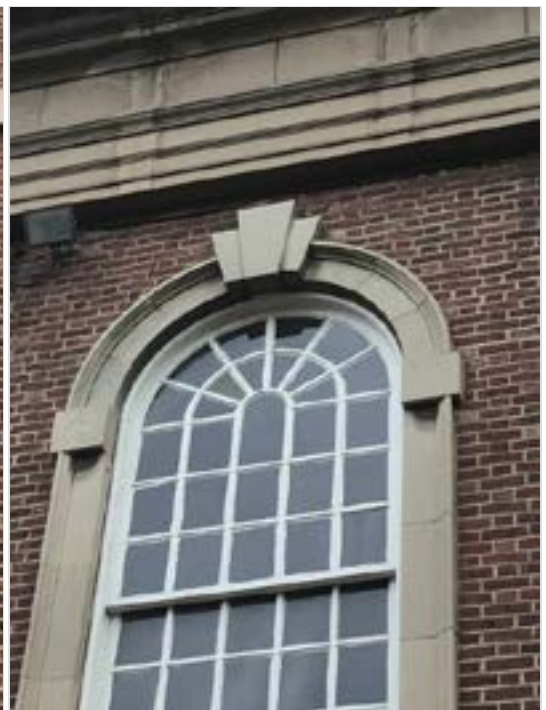
Sanctuary windows: window frame and sill in good condition, cast stone window arch has water damage and needs cleaning.

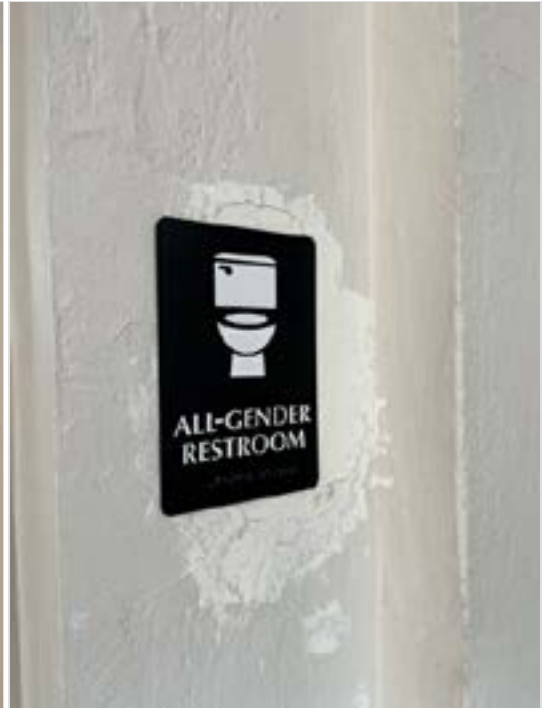
Repair hole in wall for clean smooth finish. Paint as required. Patch paint at restroom sign.

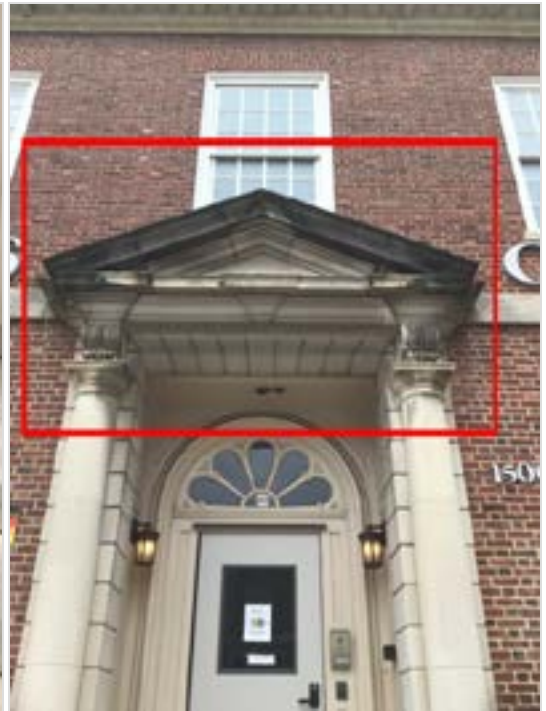
Efflorescence on cast stone steps below pediment.

Door in great condition, pediment has significant water damage.

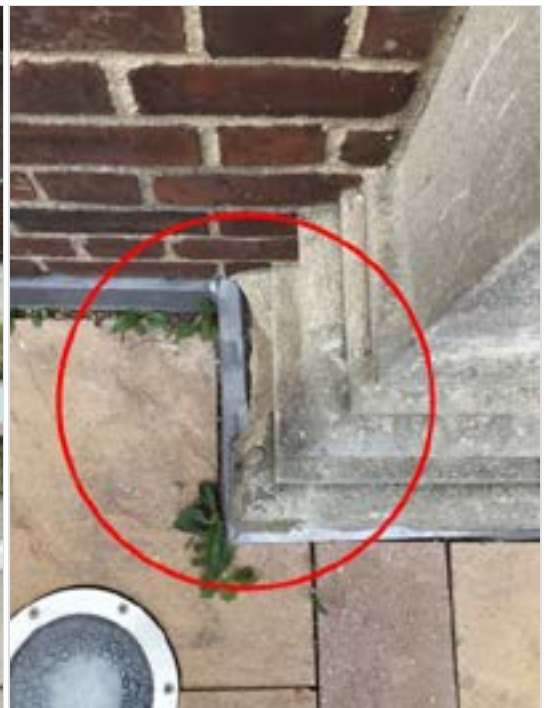
Skylight over room 127 needs repair.

Flashing assemblies need repair at the base of the pilasters.

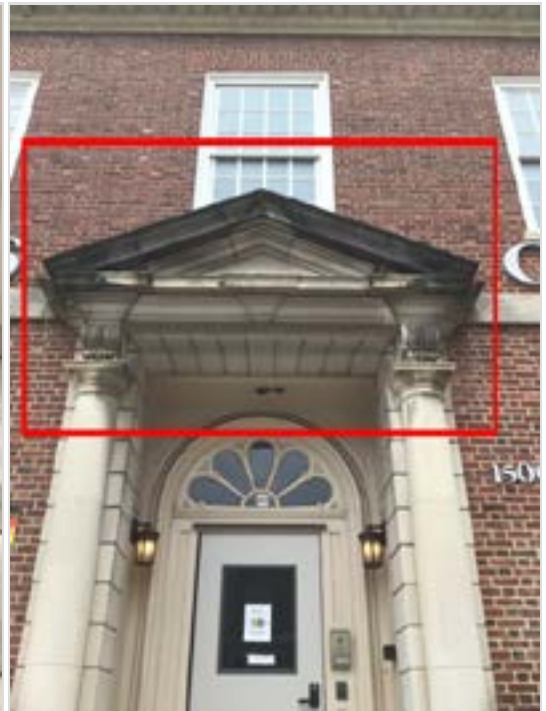
Efflorescence on cast stone steps below pediment.

Door in great condition, pediment has significant water damage.

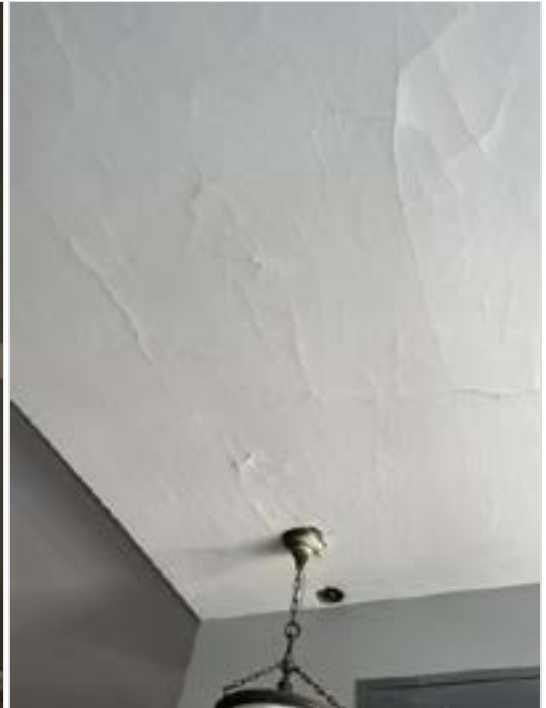
Door does not have weather seals. Seals should be provided. Paint scuffed - paint/clean as required.

Ceiling paint is cracking. Appears to be due to age and base surfacing. Strip old paint layers and repaint.

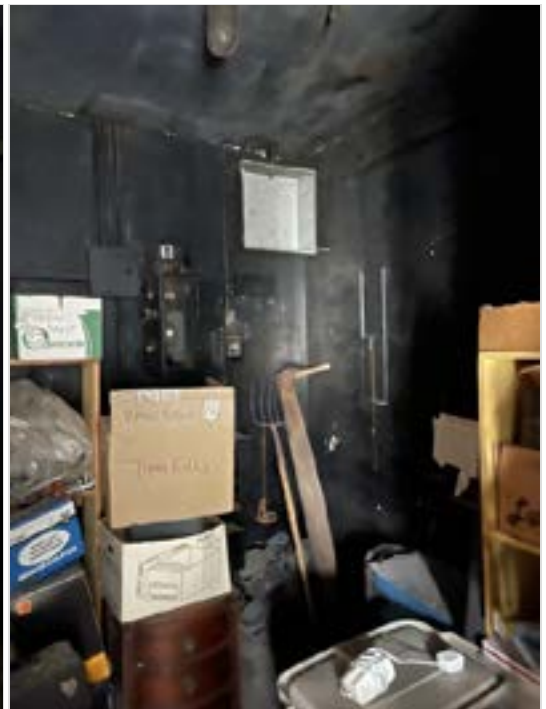
Repaint windows and provide weather seals.

Projector room has some general wear and tear. Walls have some damage/chipping paint.

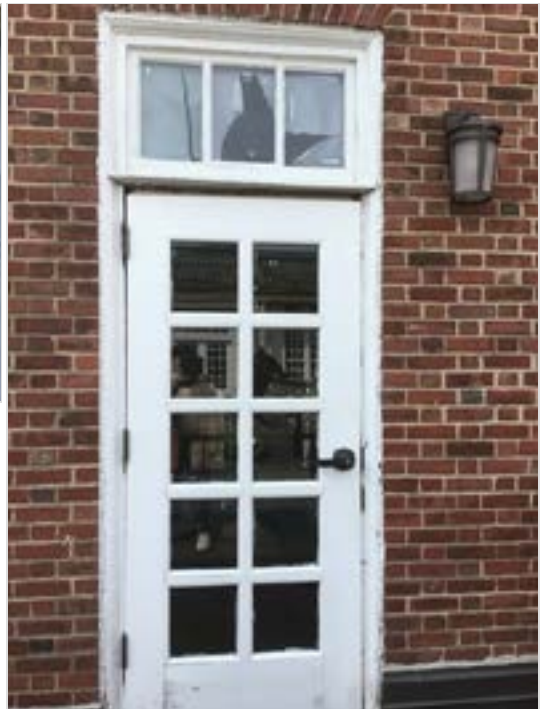
Flexible pavers need replacement

Door frame and weather-stripping needs repair, refinishing, and/or replacement.

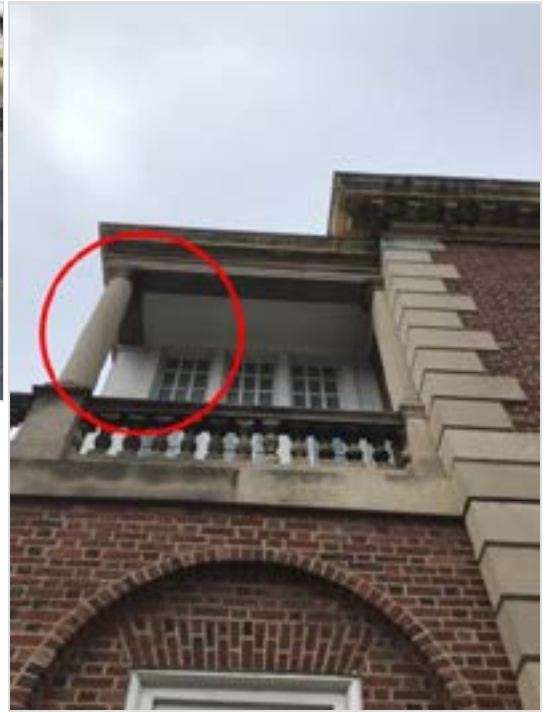
Exposed wood; window frames need repair, refinishing, and/or replacement

Joint between window wall and masonry portico needs repair.

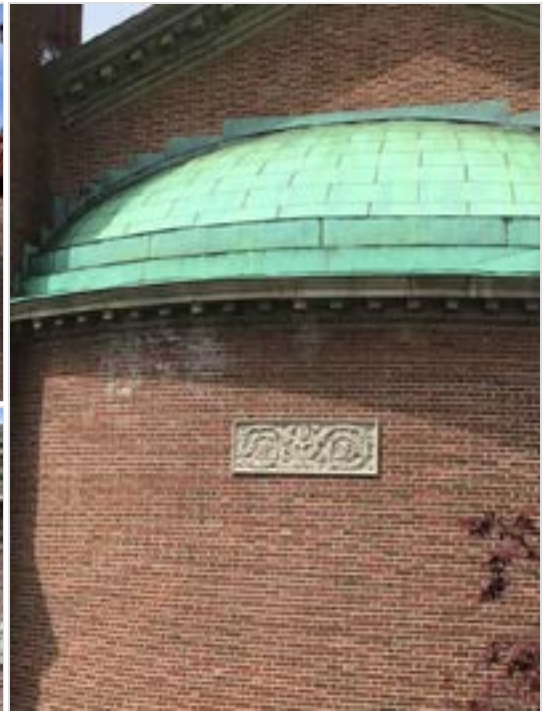
Efflorescence under cornice; gutters above cornice need to be repaired and/or replaced

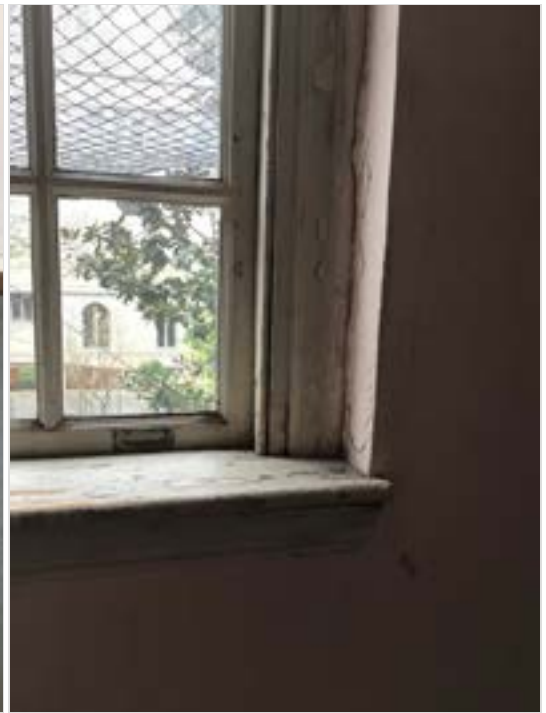
- Window sill and frame need to be refinished/painted.
- Paint is peeling, chipping & blistering in multiple locations of walls and ceilings. This is typically caused by paint being applied to a dirty surface or fluid pockets. There appears to be no signs of water infiltration. Walls should be repaired/painted. Surfaces should be clean of debris, oils, etc. prior to painting to prevent reoccurrence.

Floor is damaged. Repair as needed.

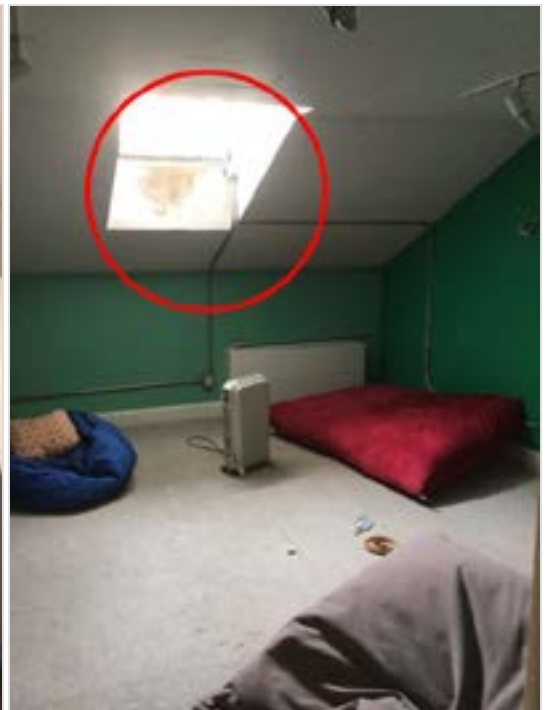
Signs of potential pipe leak due to staining.

Evidence of water infiltration at window. Investigate source, repair as required and paint wall.

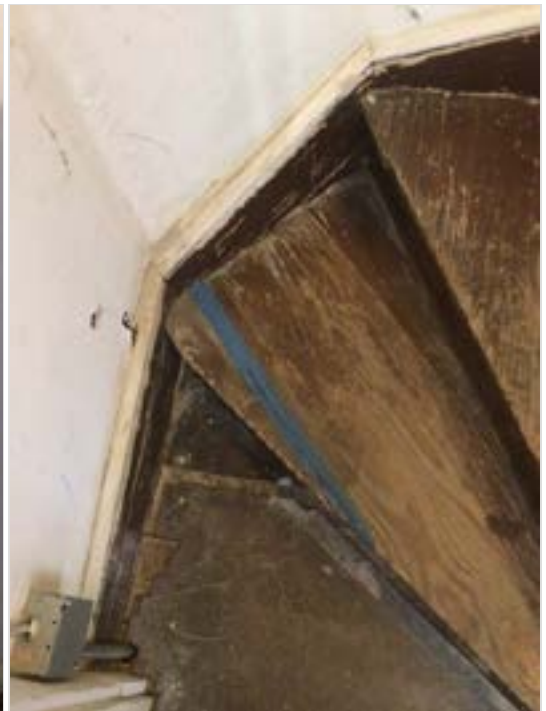
Paint blistering.

Stair nosings splintering and damaged. Stair requires refinishing can be applied to tread nosings to help prevent damage of stairs.

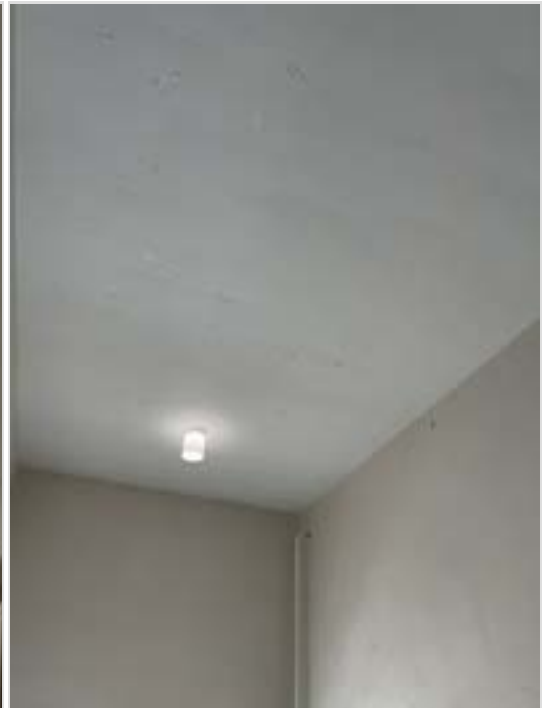
- Paint is peeling, chipping & blistering in multiple locations of walls and ceilings. This is typically caused by paint being applied to a dirty surface or fluid pockets. There appears to be no signs of water infiltration. Walls should be repaired/painted. Surfaces should be clean of debris, oils, etc. prior to painting to prevent reoccurrence.

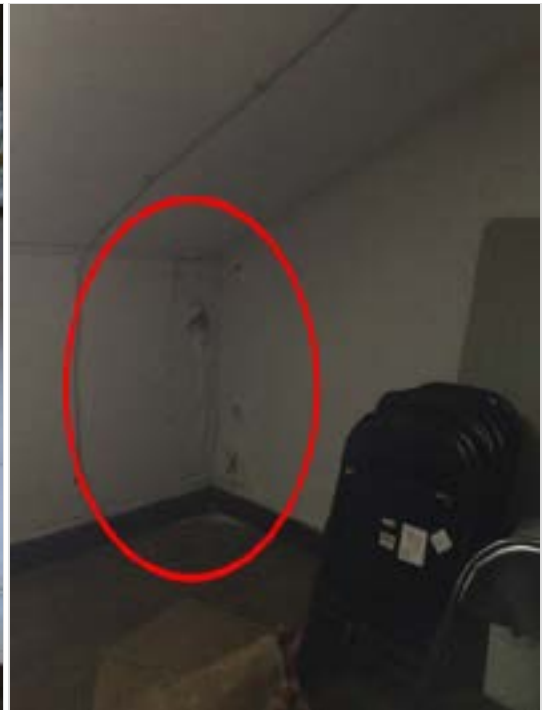
Door to bell tower requires repair and paint.

Paint is peeling, chipping & blistering in multiple locations of walls and ceilings. This is typically caused by paint being applied to a dirty surface or fluid pockets. There appears to be no signs of water infiltration. Walls should be repaired/painted.

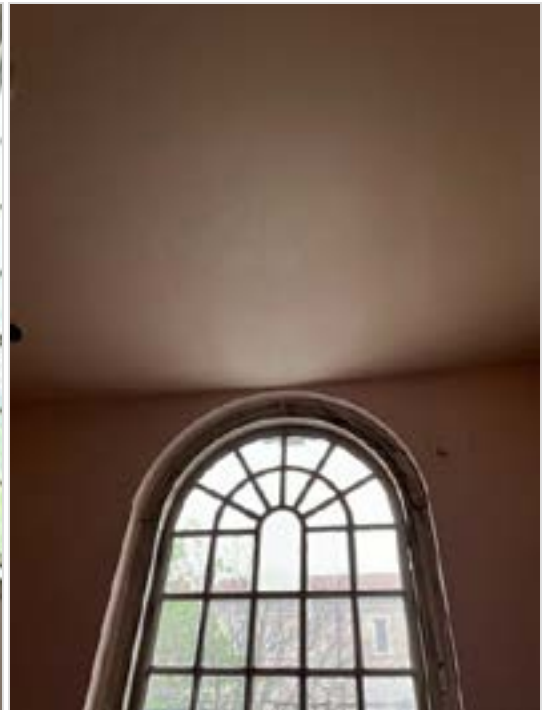
Blistering and peeling paint.

Deteriorating wood frame. Repair and paint.

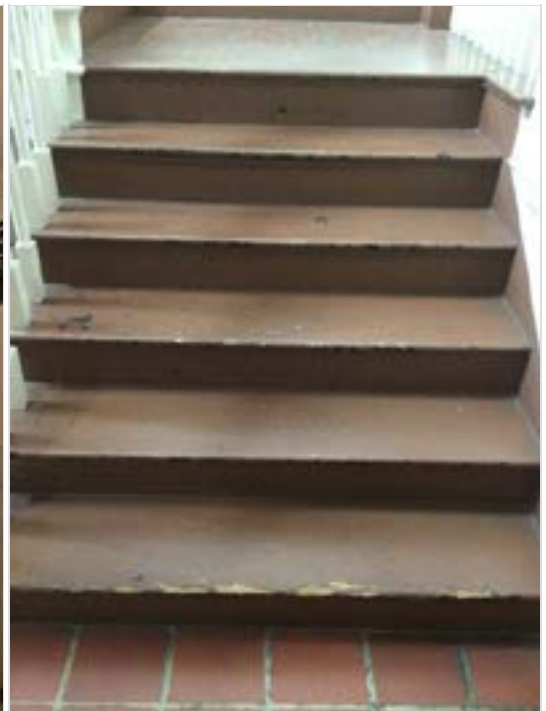
Stair nosings splintering and damaged. Stair requires painting. Rubber surfacing can be applied to tread nosings to help prevent damage of stairs.

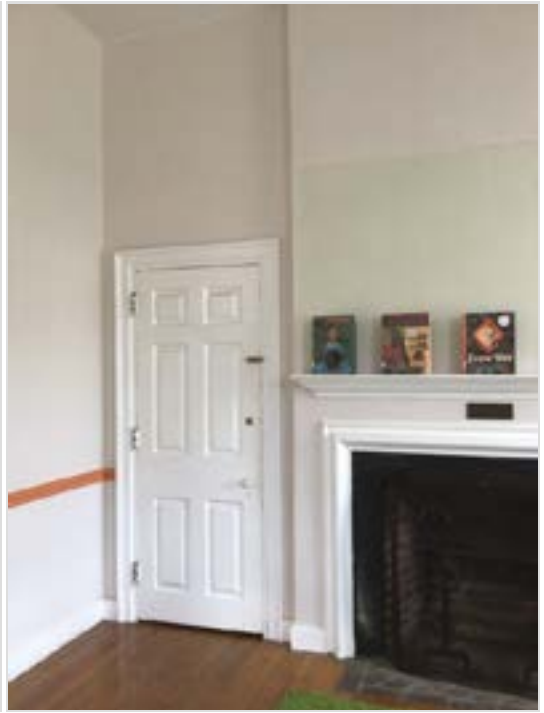
Painting is inconsistent in multiple locations. Repaint room for solid consistent finish.

Closet doors require repair and paint.

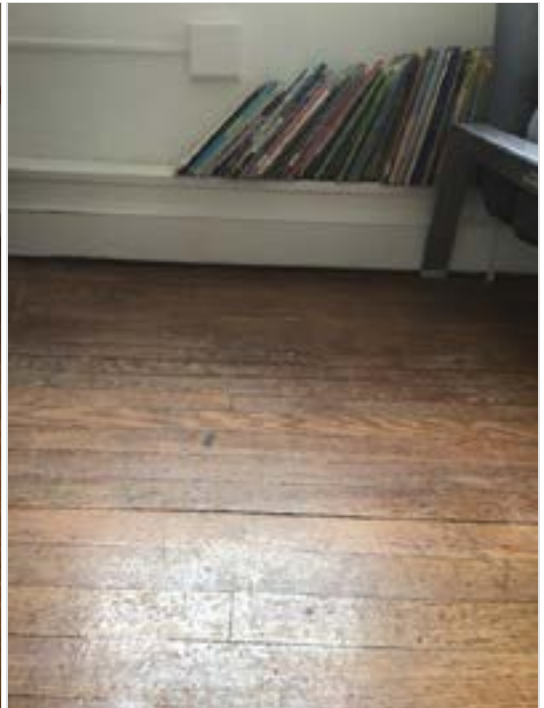
Scuffs on wood floor. Buff and clean.

Gap between floor and wood base. Creates a space to catch a significant amount of dust and debris. Recommend installing a bullnose trim piece.

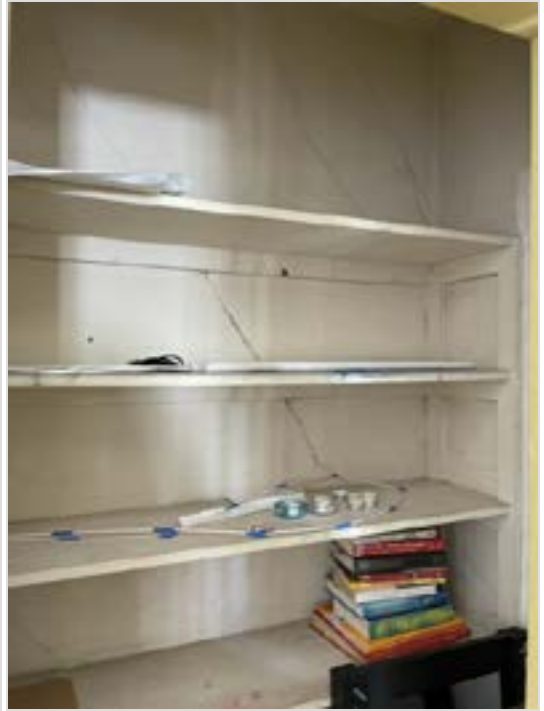
Wall finish in closets are cracking; cause unknown. Further investigation is required.

Cracking in closet wall; cause unknown. Further investigation is required.

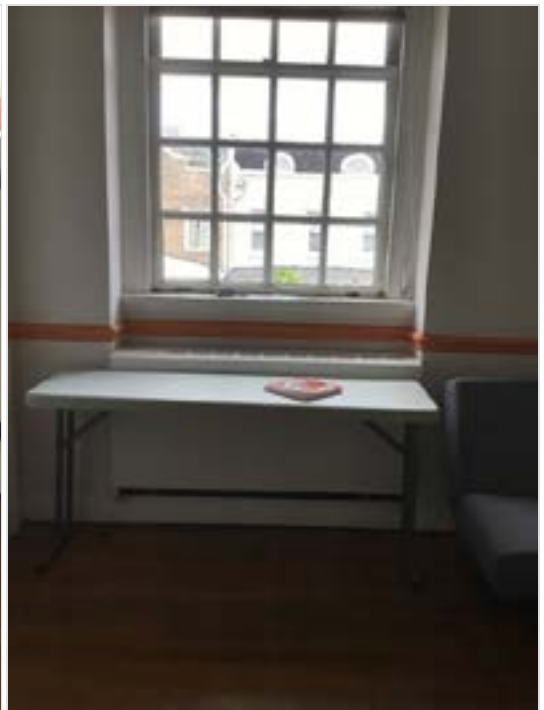
Repaint wood wall base.

Repair/paint window.

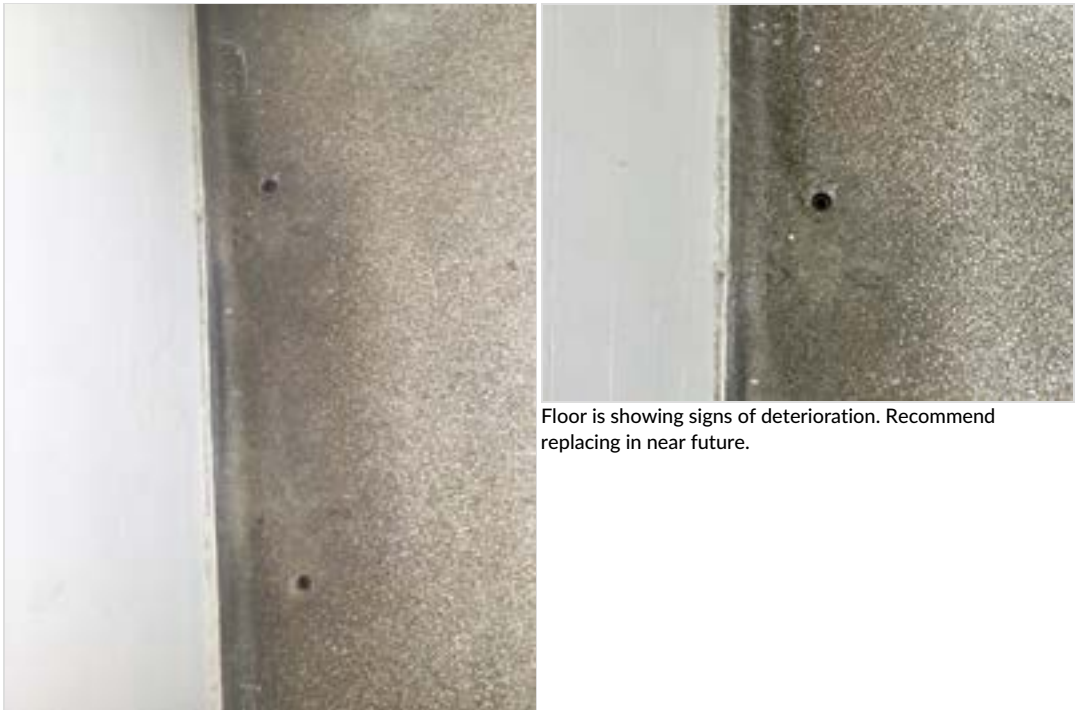
Floor is showing signs of deterioration. Recommend replacing in near future.

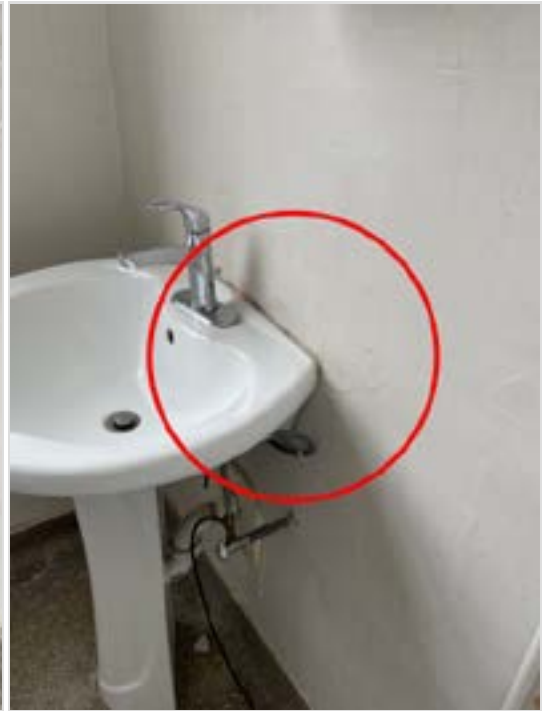
Provide heat shield to keep PVC pipes protected. Seal wall penetration.

Lavatory pulling away from wall. Re-secure and repair/paint wall.

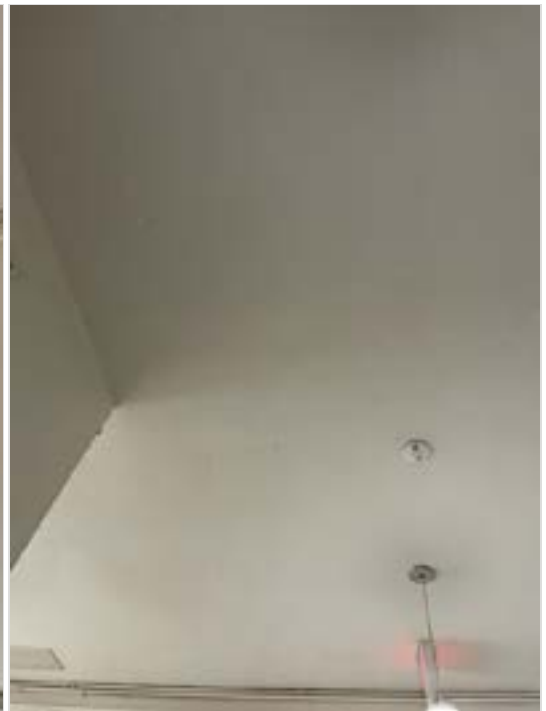
- Paint is peeling, chipping & blistering in multiple locations of walls and ceilings. This is typically caused by paint being applied to a dirty surface or fluid pockets. There appears to be no signs of water infiltration. Walls should be repaired/painted. Surfaces should be clean of debris, oils, etc. prior to painting to prevent reoccurrence.

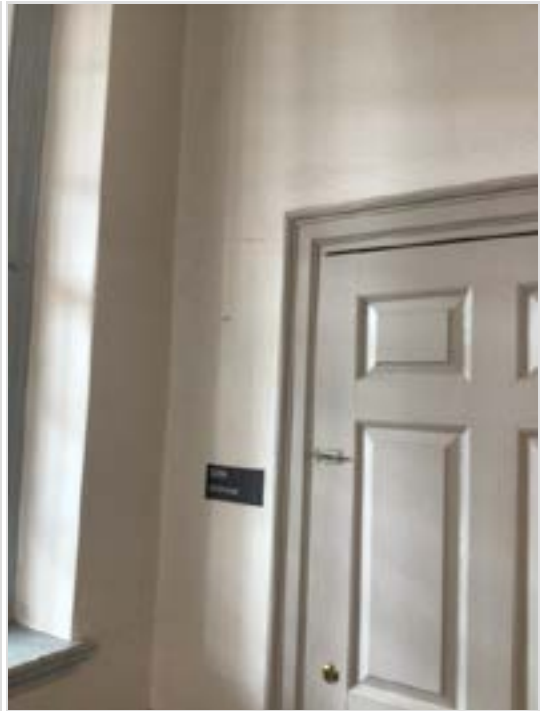
Crack in wall above door. Repair and paint.

Crack to side of door. Repair and paint.

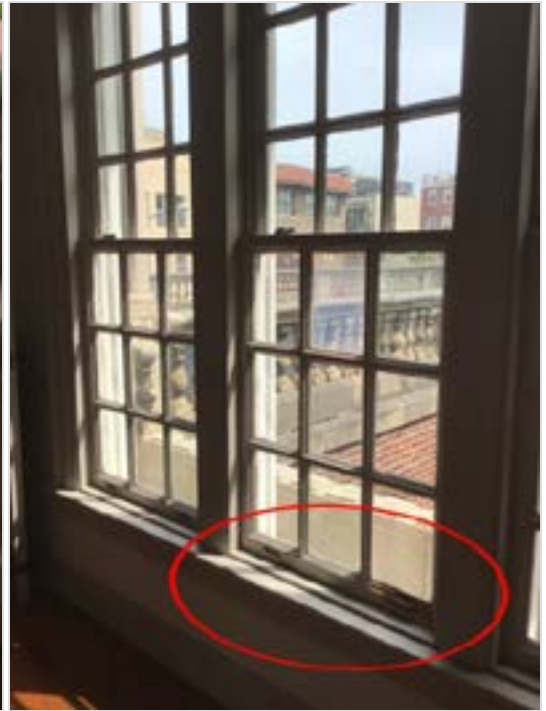
- Wood chipped on windows. Repair and repaint.
- Balusters were removed and not replaced. Keep an eye on demo'd area for potential deterioration.

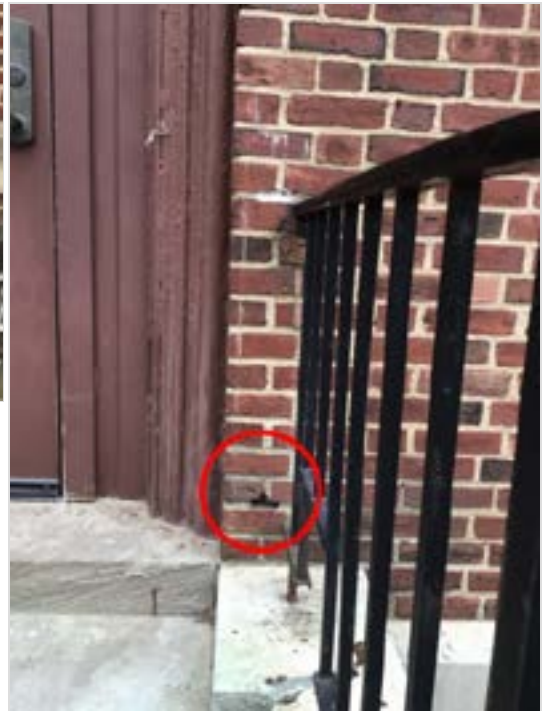
Mortar patches or unfilled holes in masonry are common along exterior on Harvard St. and 15th St.

Railing replaced, holes in the masonry left un-filled.

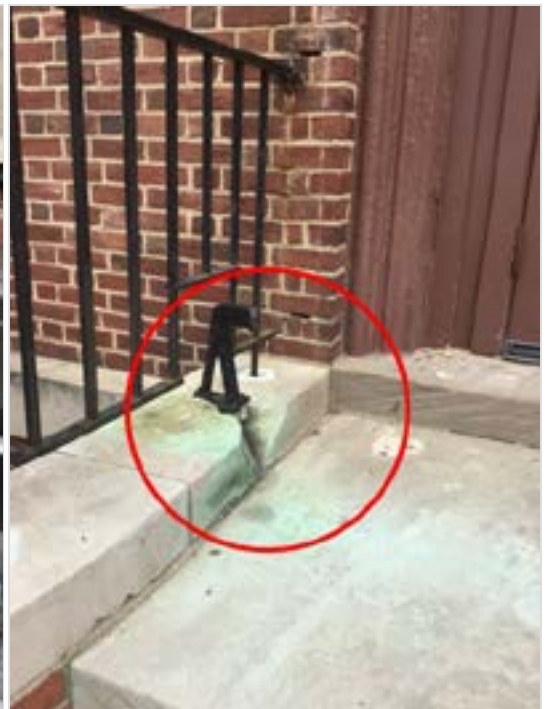
Mortar joint missing near window.

Cast stone cracked

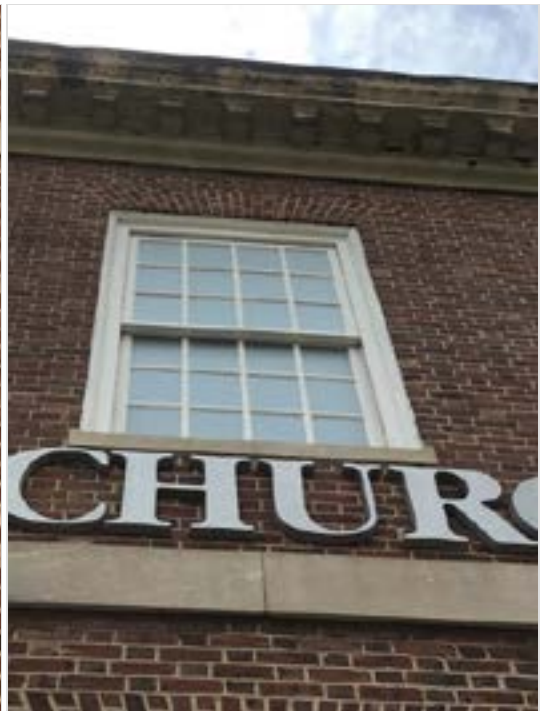
Good window (restored 2015) Frame needs monitoring

Upper level window restored in 2015 and still in good condition.

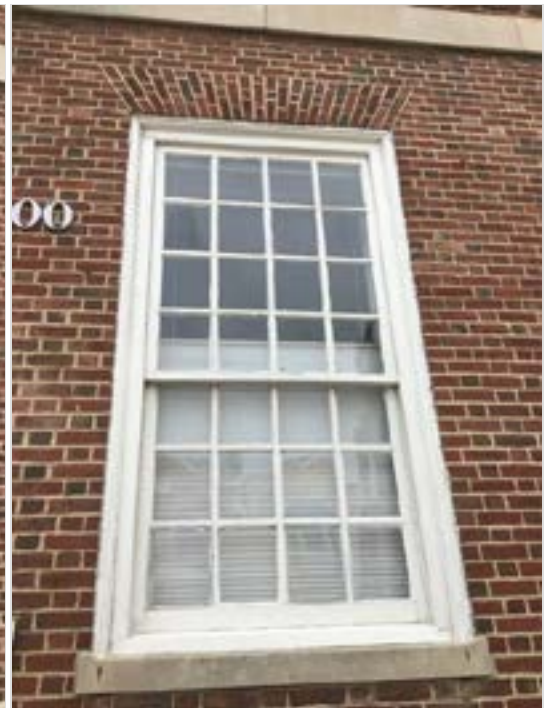
Window restored in 2015; paint still intact but monitor.

Main level window: paint and weatherstripping may need attention. Window panes and frames will need to be monitored for replacement.

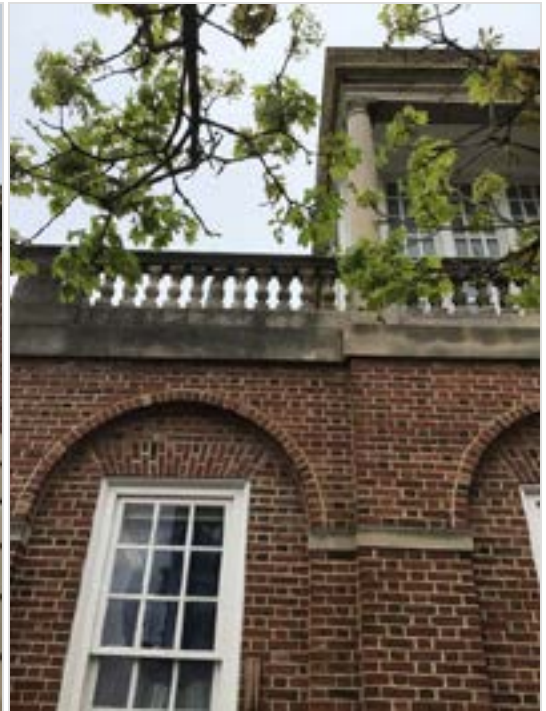
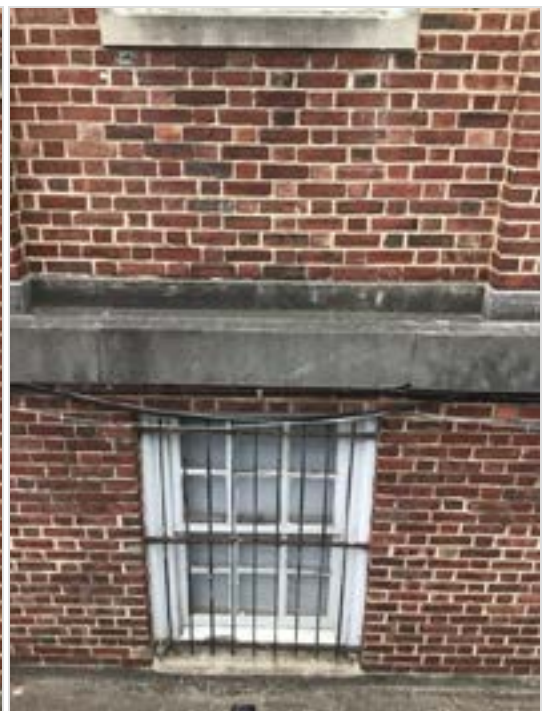
Façade elements directly below the Jenny Lynn Terrace on 16th street show have significant water damage when compared to other parts of the façade. The assumption is that water is not draining properly from the terrace and, as a result, damaging the masonry and stone below.
