All Souls Church
1500 Harvard Street NW (US)
Report number: 2206.03-1
Date: April 21, 2022 10:00

Feasibility Assessment Walk Through

ALL SOULS CHURCH
BUILDING ASSESSMENT
2022

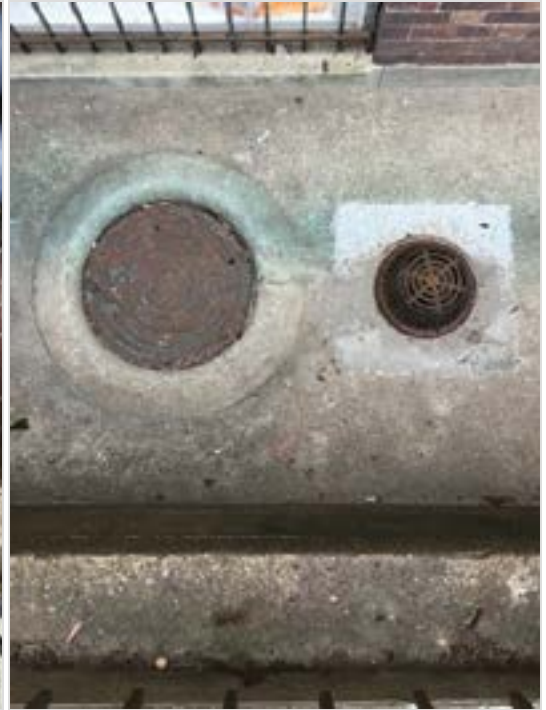
Structural issues appearing in the boiler room below this drain.

The area below this drain is showing signs of water damage. The efflorescence leads us to believe water has collected here and leaked into the space below.

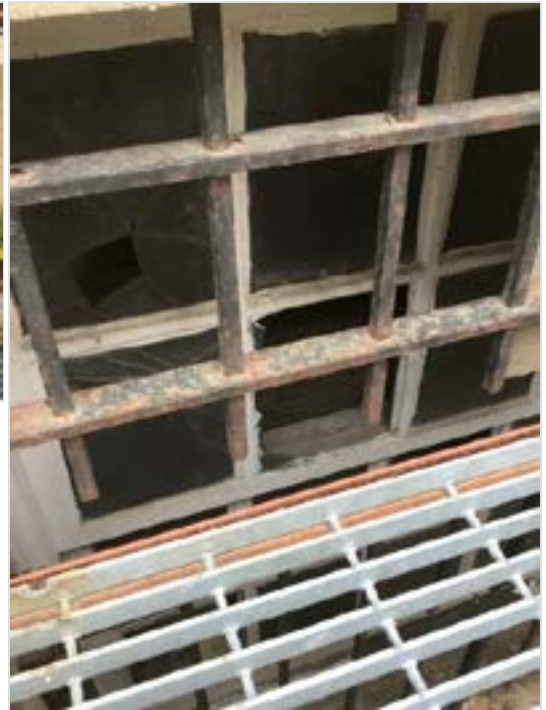
Lower level window wells across the board:
-Louvers require cleaning
-Debris below metal grates requires removal
-Metal window bars require replacement due to rusting

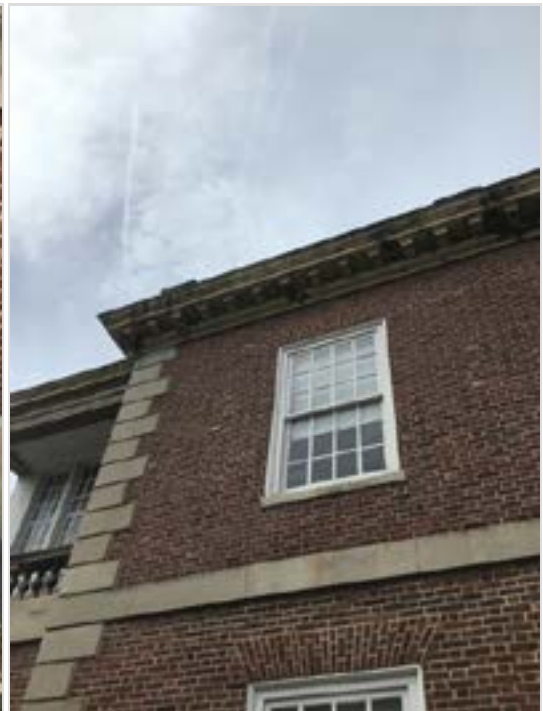
Efflorescence on cast stone directly below the roof line.

Cornicing has water damage; needs cleaning and gutters may need replacement.
