All Souls Church
1500 Harvard Street NW (US)
Report number: 2206.03-1
Date: April 21, 2022 10:00

Feasibility Assessment Walk Through

ALL SOULS CHURCH
BUILDING ASSESSMENT
2022

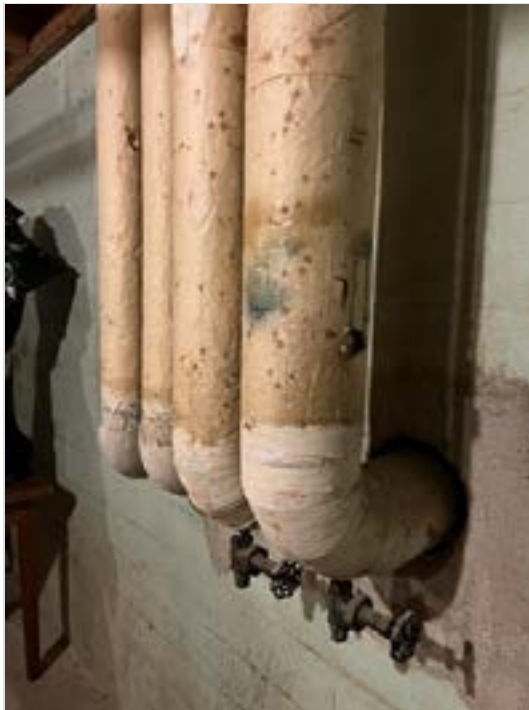
● Archive - 117 [1.19]

Evidence of water infiltration on masonry wall.

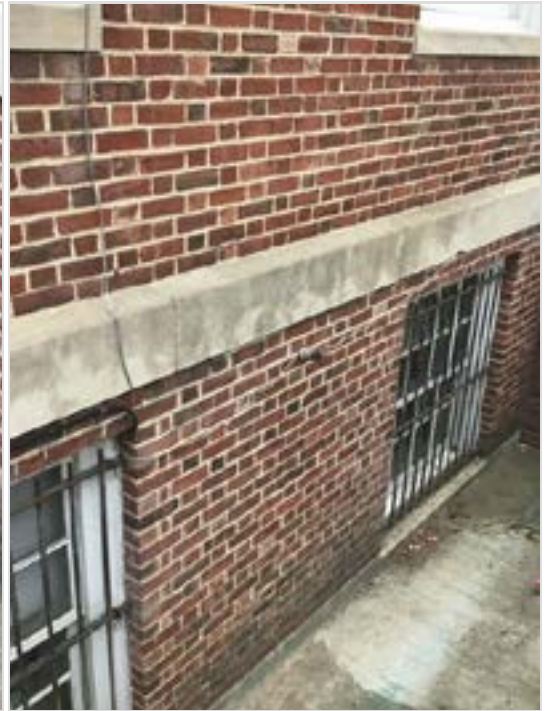
Drain raised above slab + dirt collecting
