All Souls Church
1500 Harvard Street NW (US)
Report number: 2206.03-1
Date: April 21, 2022 10:00

Feasibility Assessment Walk Through

ALL SOULS CHURCH
BUILDING ASSESSMENT
2022

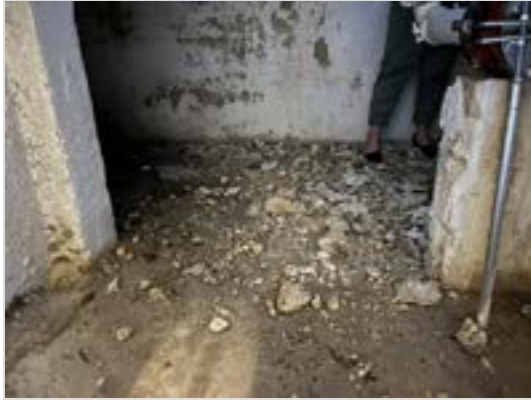
● **Boiler Room - B-001**
[1.1]

- Reinforced concrete has begun to deteriorate around the the drain pipe exposing the pipe and rebar reinforcement which has compromised the integrity of the concrete. This is located near the perimeter wall adjacent to the weather service room.
- Exposed pipe reveals unconventional support of pipe with PVC pipes and pipe surrounded with what appears to be a heavy duty black garbage bag.
- Cause of deterioration appears to be from water infiltration and/or stress concentration, but further investigation is required to confirm.
- Cause of deterioration should be investigated and cause resolved. Concrete should be repaired as required.
- Refer to images below.

Concrete breaks collected across floor.

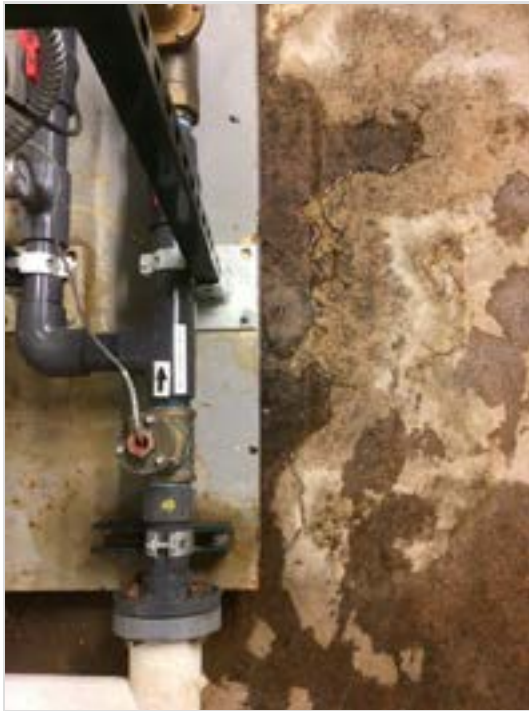
● Weather Service
Room - B-002 [1.2]

Pump line appears to be leaking from an interior point. Location of leak could not be observed.

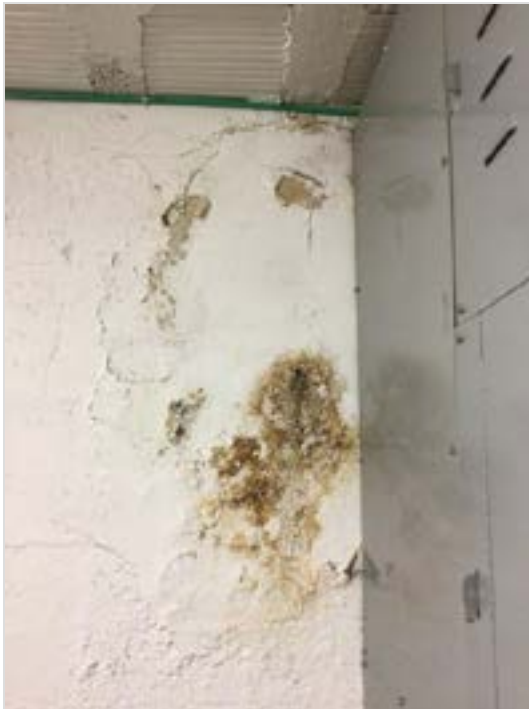
- Signs of water infiltration in the space. Area of infiltration should be located and repaired as required. Repair/paint wall as required after infiltration has been resolved. See image below.

Signs of water infiltration at back corner of the room.

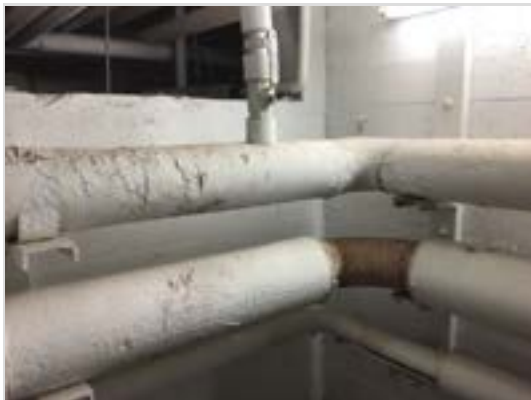
● Mechanical Rooms -
B-004, B-005 [1.4]

Multiple rips and gaps in pipe insulation. Insulation should be repaired/replaced as required.

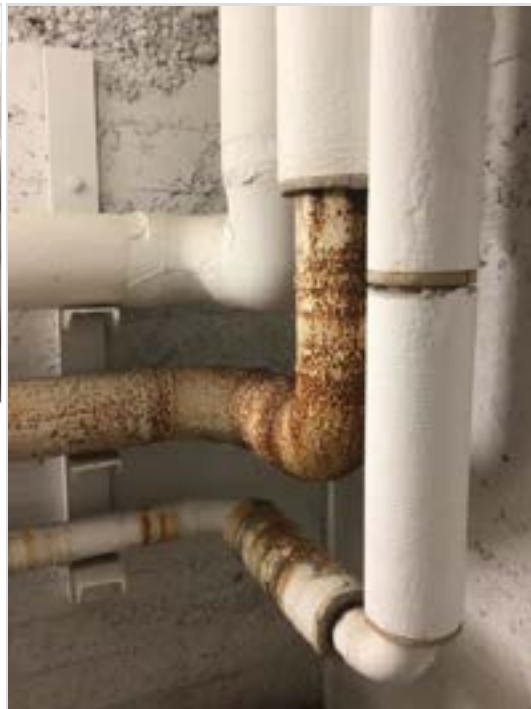
Evidence of pipe corrosion due to water leak. Water leak appears to be from a hot water pipe above.

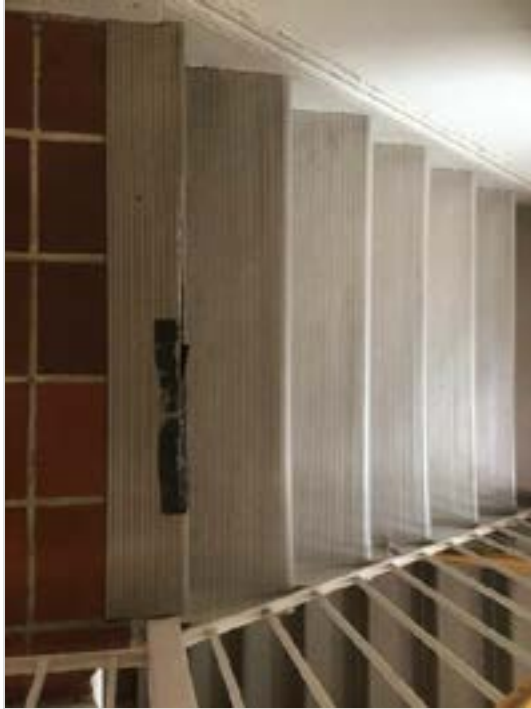
● Stair 2 [1.11]

Treads are damaged. Repair/replace as required.

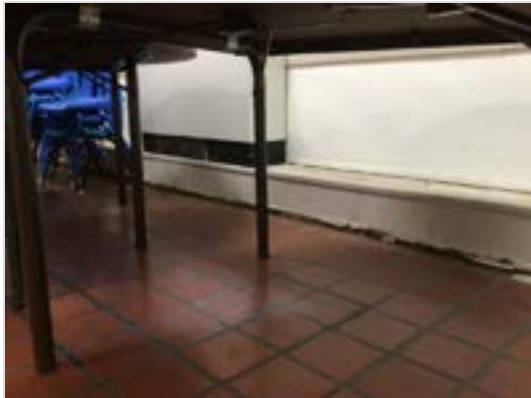
● Dining Room - 114
[1.12]

Cold water pipes within the heating units appear to be causing condensation and leaking. This appears to be causing the wood bases that are supporting the units to rot.

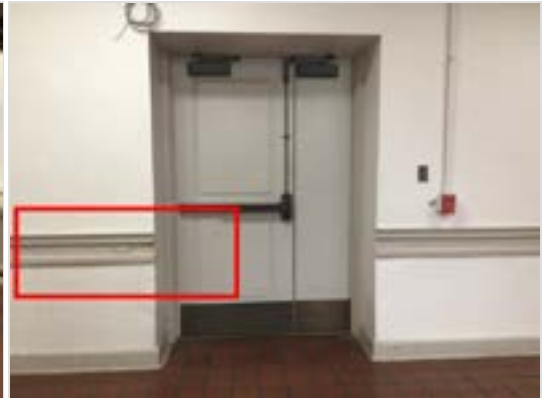
Cracked wall. Patch/repair as required.

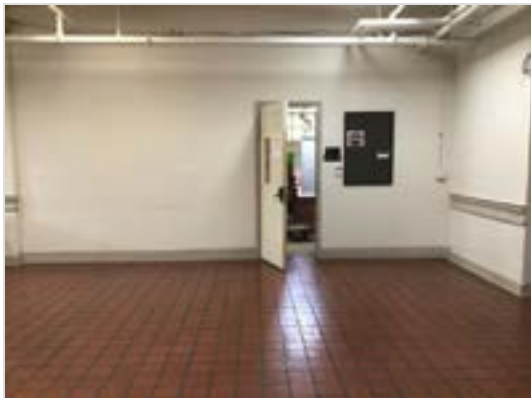
Interior wood doors require repair.

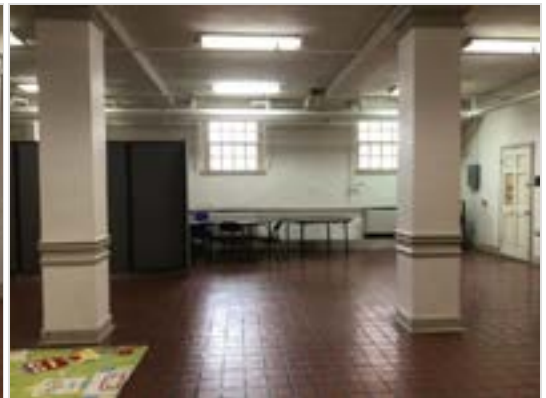
Scuffs on walls and columns in multiple locations. Repair/paint as required.

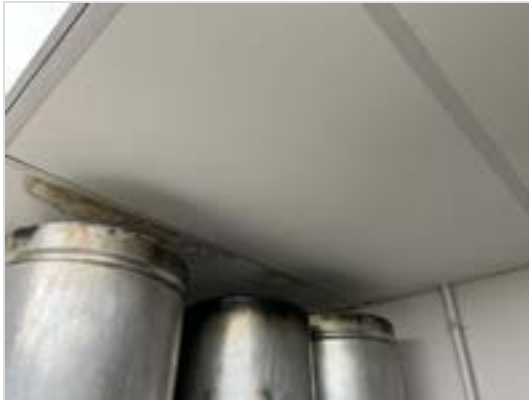
● Kitchen Storage -
114-B [1.13]

Evidence of water infiltration at multiple locations on the ceilings and walls.

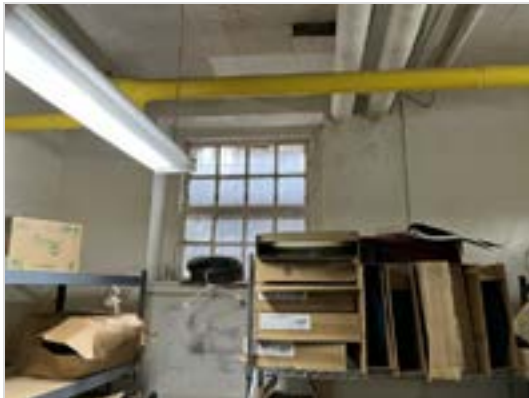
● Storage - 114-C
[1.14]

Window frame deteriorating - needs replacement. Window sill needs paint. Walls need patch, repair, and paint.

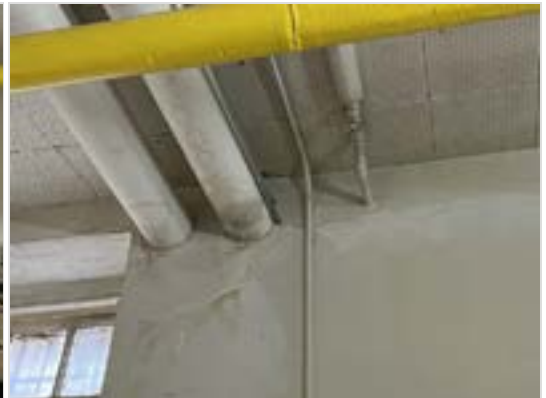
Evidence of water infiltration on pipe insulation and wall.

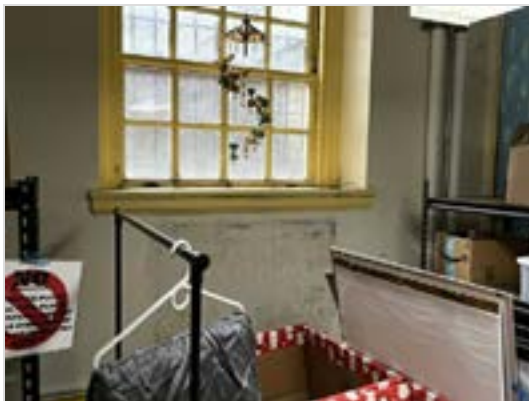
Window sill needs paint, window frame showing signs of deterioration - may need replacement.

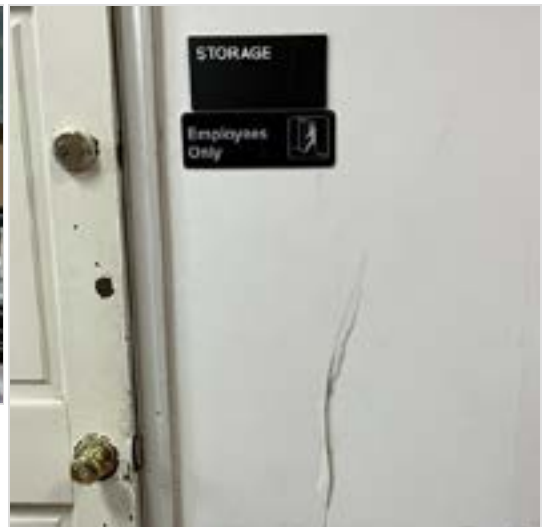
Wood door needs paint; walls chipped and need to be repaired and repainted.

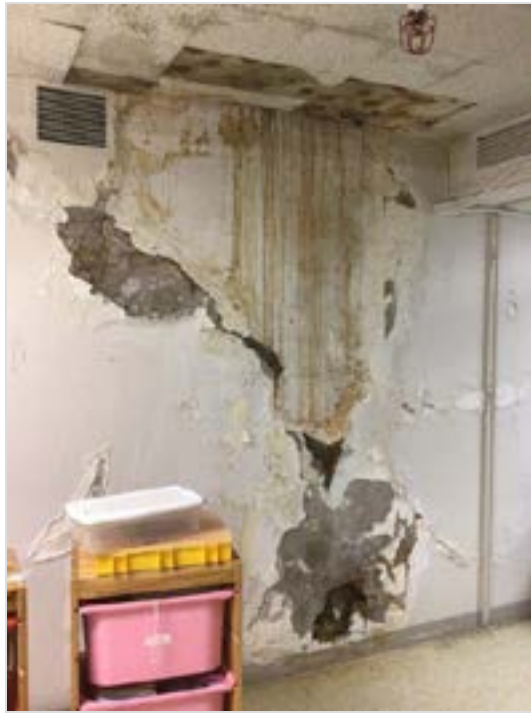
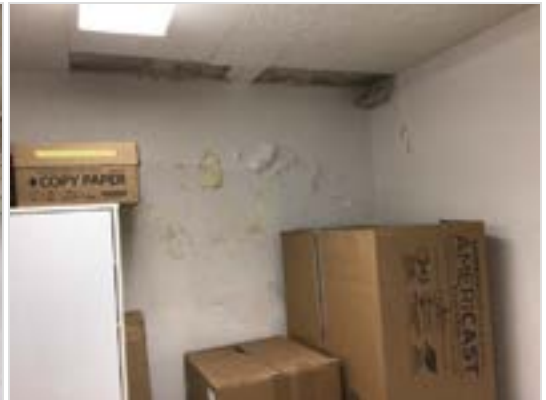
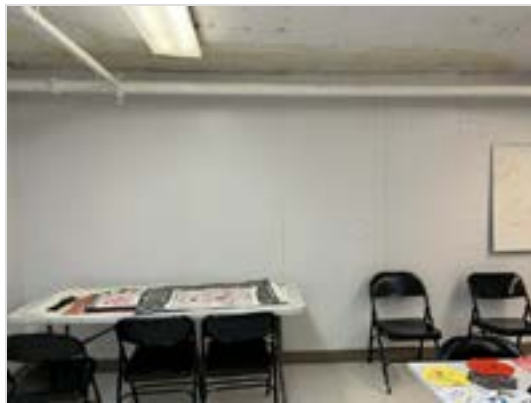
• Classrooms 104/106
& 108 [1.5]

- Evidence of water infiltration at multiple locations. Courtyard is located above this space. Concrete and rebar above may also be affected. Further investigation is required to locate the cause and to understand the full extent of damage. Waterproofing documents should also be reviewed including detailing, warranty coverage and reports for testing completed to confirm performance. Refer to images below.

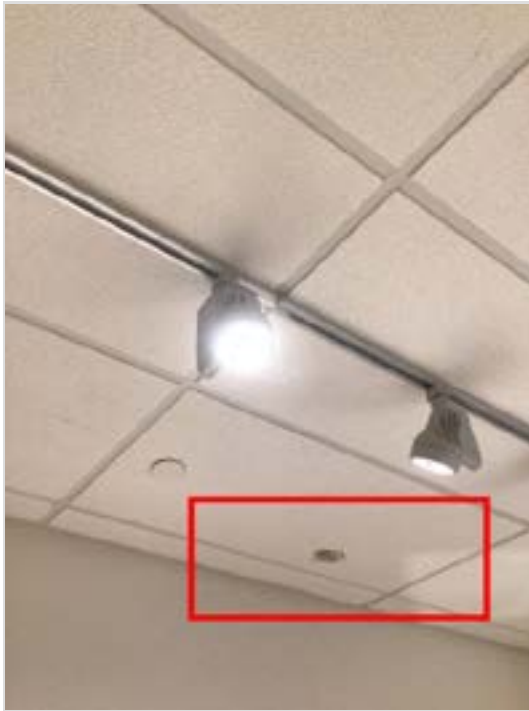
• Stair 4 [1.6]

Evidence of water damage/mold on ceiling tile. Inspect above ceiling to locate source and repair. Replace ceiling tile.

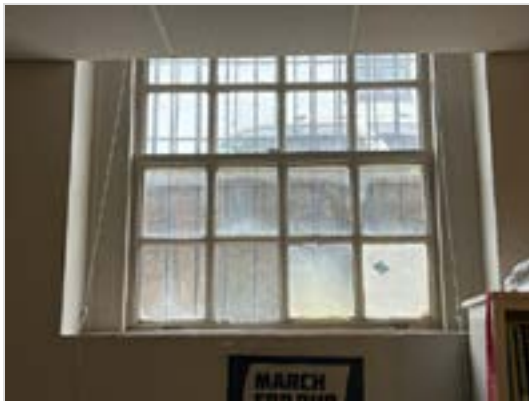
• Office 101 [1.7]

Repair/paint window and frame as required.

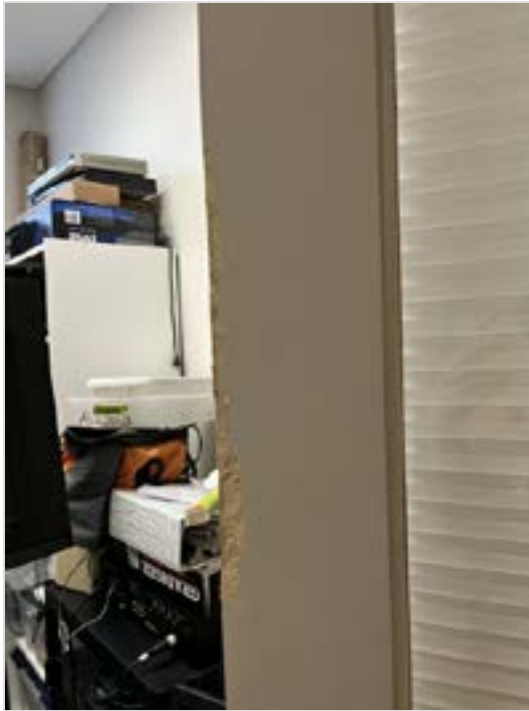
● Network Room 103
[1.8]

Door has significant damage on latch side. Repair/replace door as required.

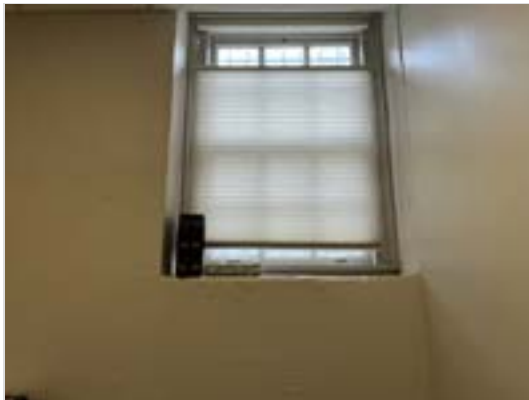
● Office 109 [1.9]

Repair/paint sill and frame as required.

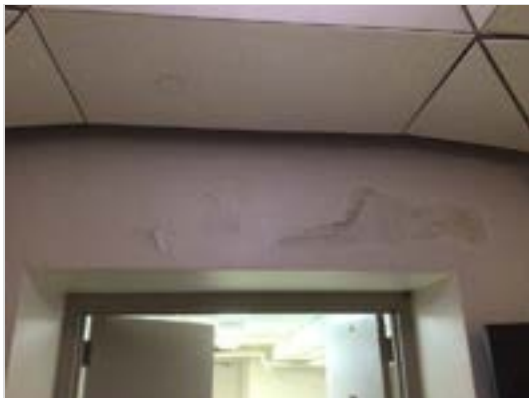
● Corridor 110 [1.10]

- Evidence of water infiltration on ceiling and wall that is shared with Classrooms 104/106 and 108. Refer to image below.

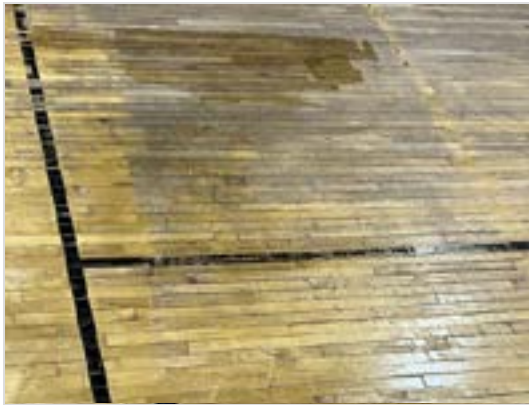
● Multipurpose Room -
115 [1.15]

Wood floor is scratched and scuffed. Floor requires refinishing/cleaning.

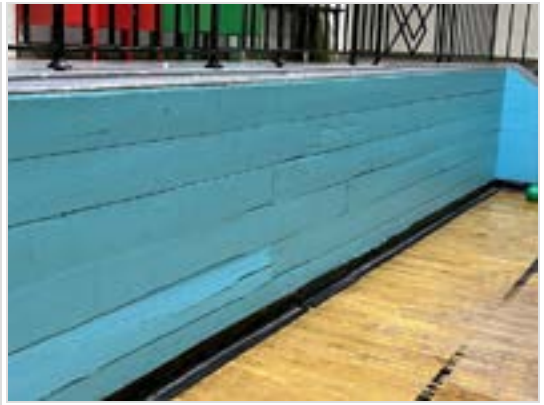
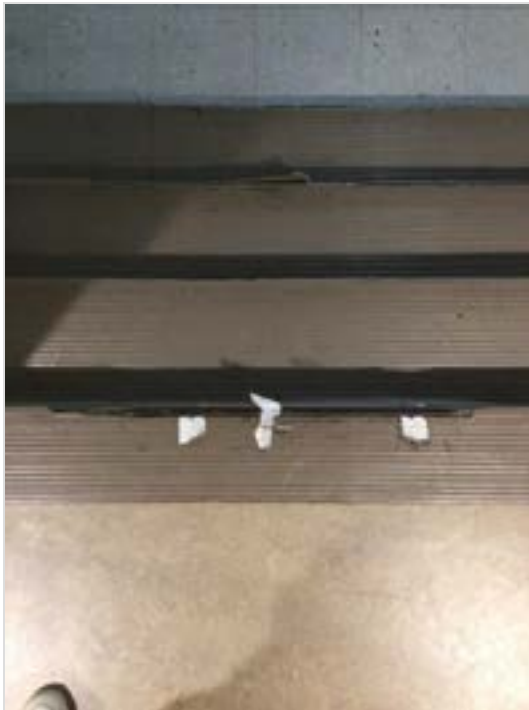
Stair treads in Corridor 115-B are damaged. Repair as required.

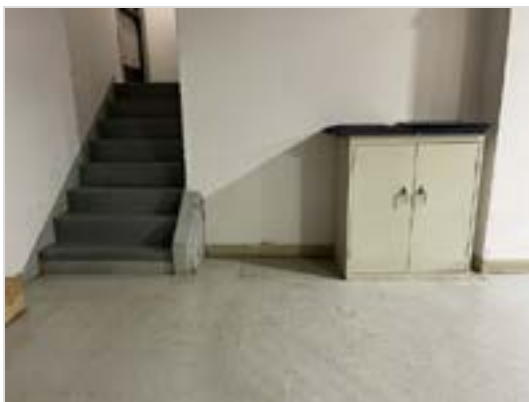
Stair, walls and wall base require repairs and painting.

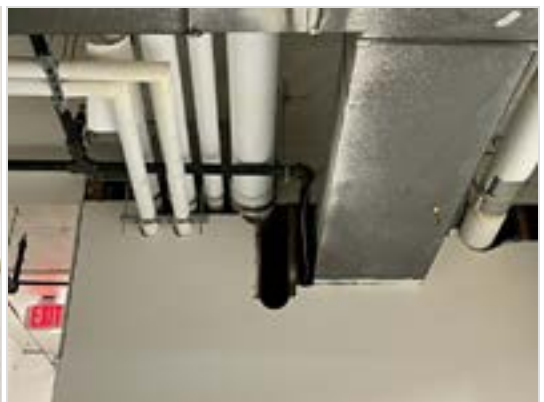
Repair walls around penetrations and paint.

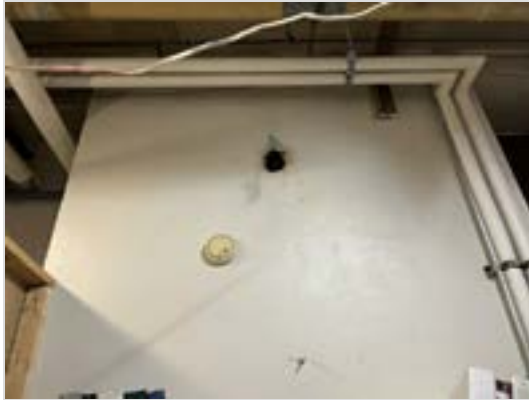
● Storage - 115-A
[1.16]

Hole in drywall requires patching.

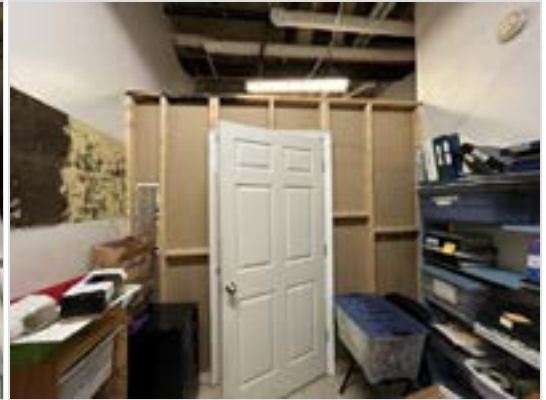
Unfinished construction in multiple locations.

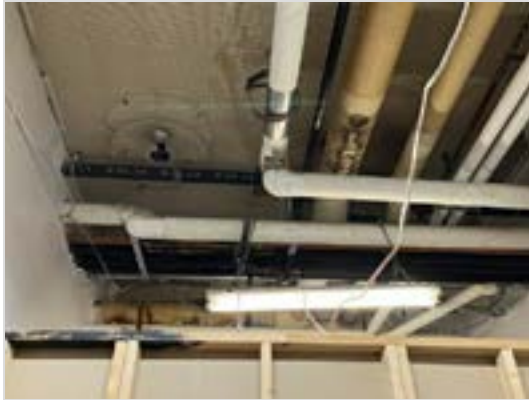
Evidence of water infiltration on pipes and pipe insulation. Investigate for source of leak. Repair leak and replace pipe insulation.

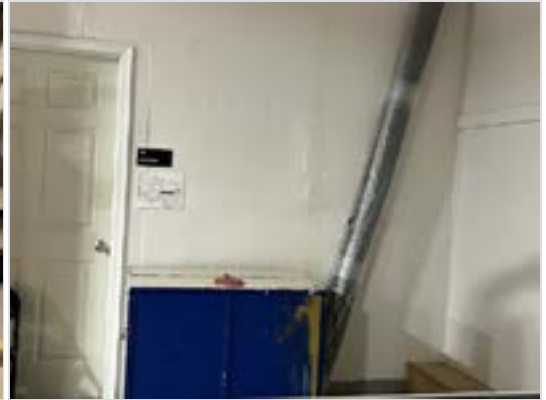
Evidence of water infiltration on walls.

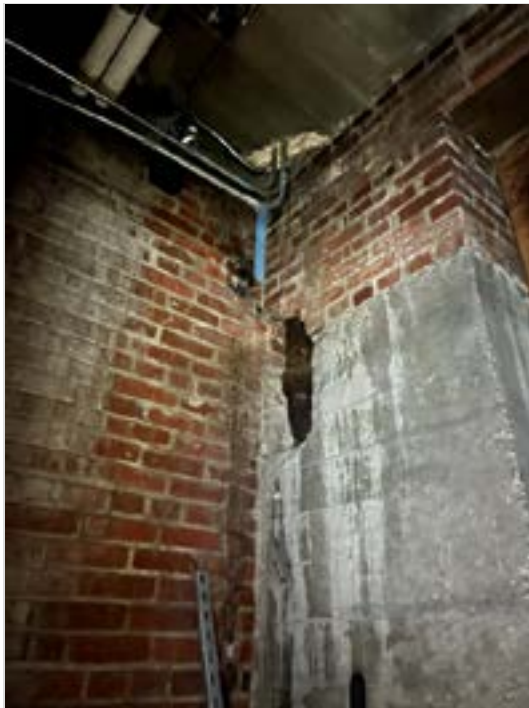
● Storage - 115-F [1.17]

Evidence of water infiltration on masonry walls. Pipe appears to have been previously exposed for maintenance.

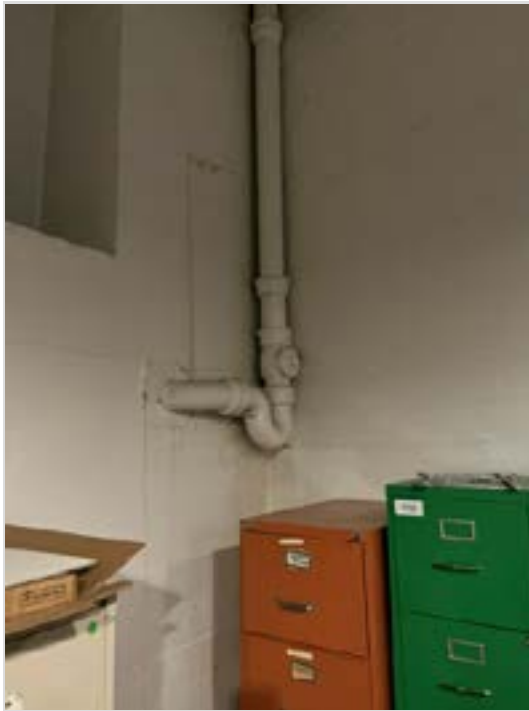
● Archive - 116 [1.18]

Evidence of water infiltration on masonry wall.

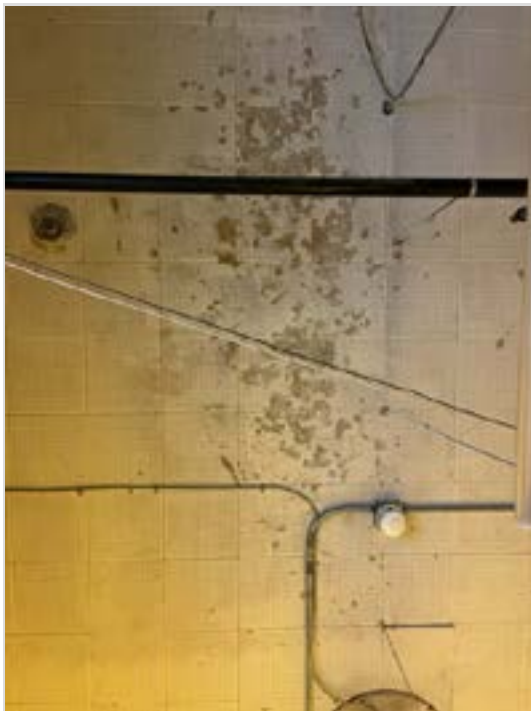
● Archive - 117-A
[1.20]

Wall showing evidence of water infiltration in multiple locations.

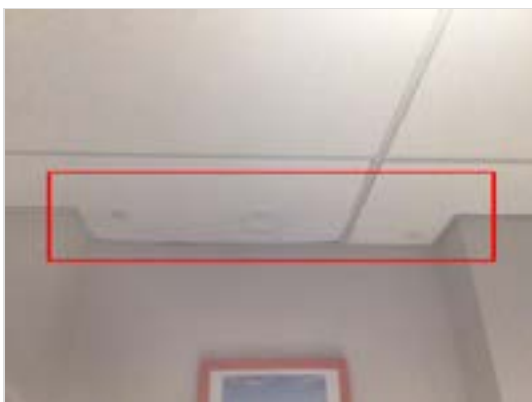
● Corridor 126 [1.23]

- Water damage observed at multiple locations of ceiling tile.
- Source of water should be investigate and repaired. Ceilings tiles to be replaced/repaired as required.

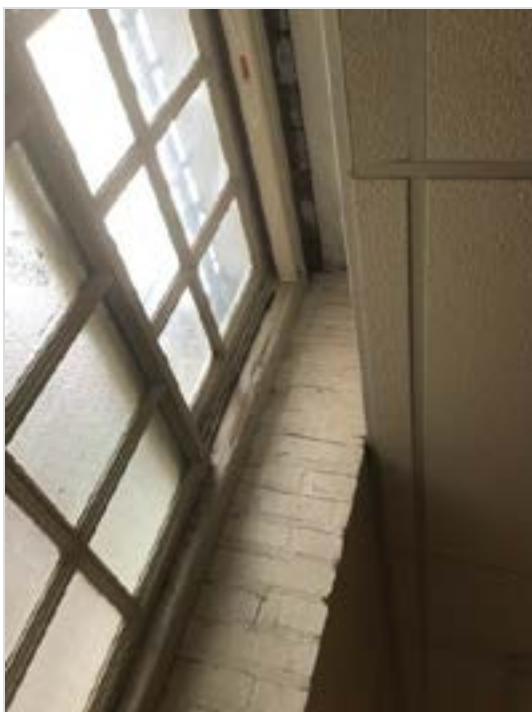
● Office - 131 [1.25]

- Window sill and frame require paint/repair.

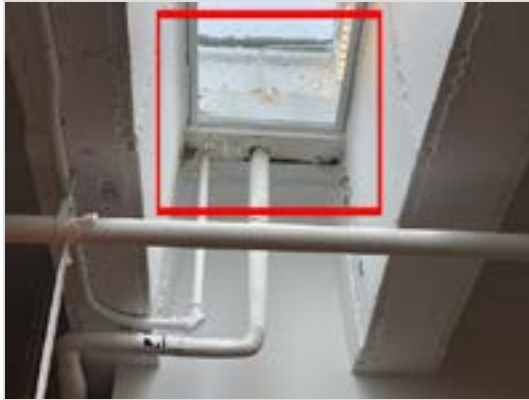
North Skylight

- Evidence of water infiltration at North skylight and corner of storage closet 123A.
 - Source of leak at the closet requires further investigation to determine location/source. There is also evidence of concrete deterioration at beam in closet. Deterioration appears to predate 2015 repairs.
 - Leak at skylight is located below electrical penetrations and appears to be limited at this location.
 - Both locations require water penetration testing and localized excavation to identify sources of water infiltration. Skylight manufacturer and installer should be engaged to assist with investigation and repair at skylight.
 - Refer to images below.
- Ants are also coming into classroom. Could be coming through penetrations/areas of deteriorated concrete.

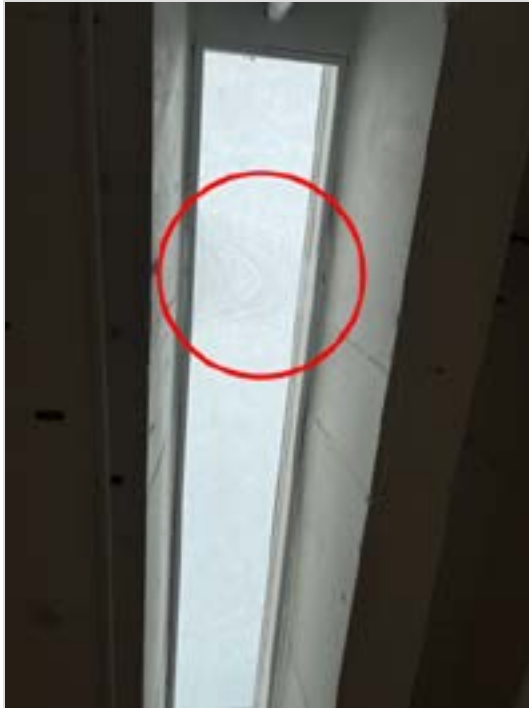
• Classroom - 127
[1.24]

- Uncontrolled water penetration occurs at skylight. Evidence of staining on plexiglass panel below skylight.
- Water penetration testing required to determine source.

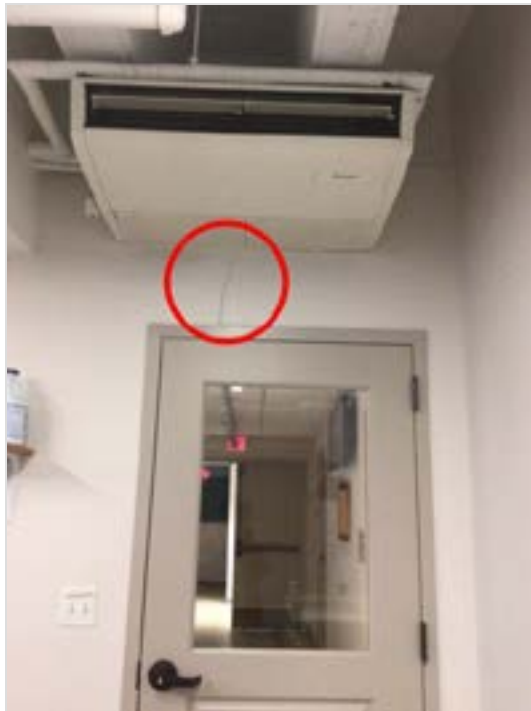
• Classroom -125 [1.22]

- Both classroom entry doors have cracks in drywall below HVAC penetrations. Walls should be repaired as required. Additional bracing may be required between studs.

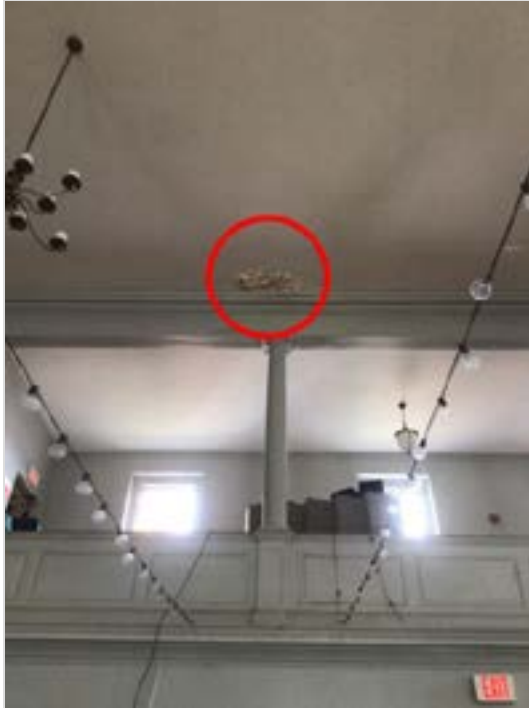
● Pierce Hall - 207
[1.32]

- Signs of water damage and paint peeling/chipping in multiple locations of walls and ceiling. Further investigation required to determine source. Roof assembly and gutter above should be investigated.
- Columns require painting.
- Scuffs and scratches on floor, typical. Buff/refinish as required.
- Paint on decorative wood paneling chipping, typical. Repaint as required.
- Windows have same issues as 2011. Paint is chipping and no weather seals provided at all windows. Repaint windows and provide weather stripping.

Evidence of water damage.

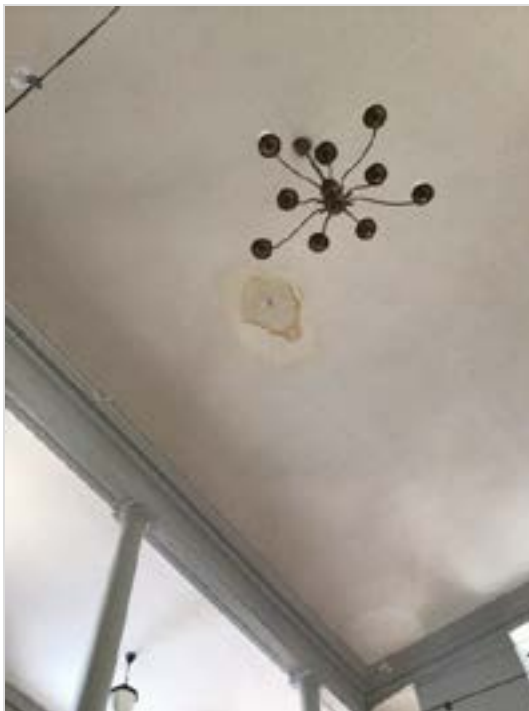
Water damage.

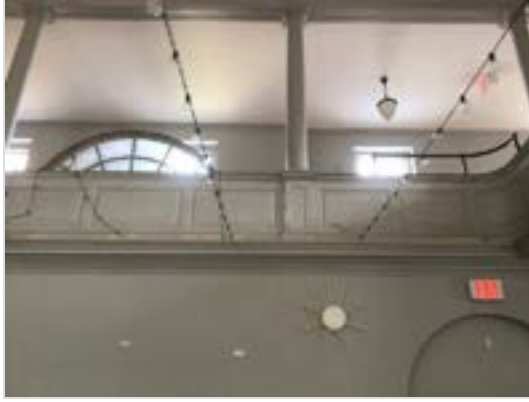
● Pierce Hall - 207
[1.32]

Paint chipping, typical.

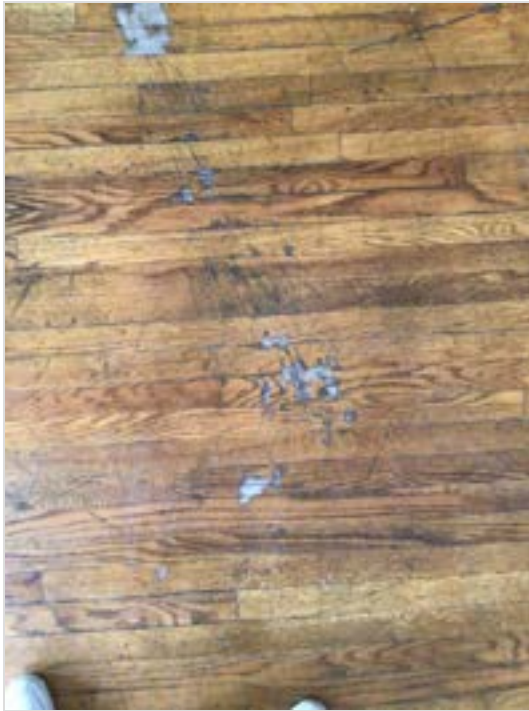
Floor scuffed and scratched.

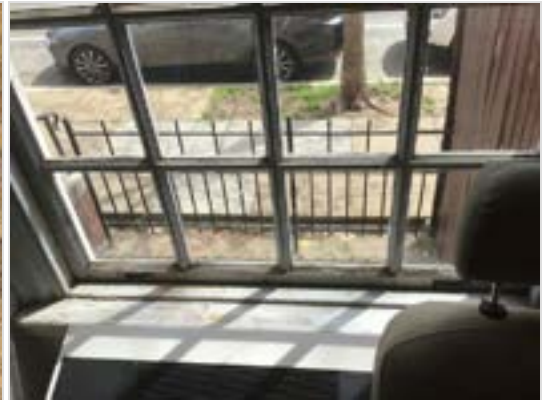
Window requires repainting and weather seals.

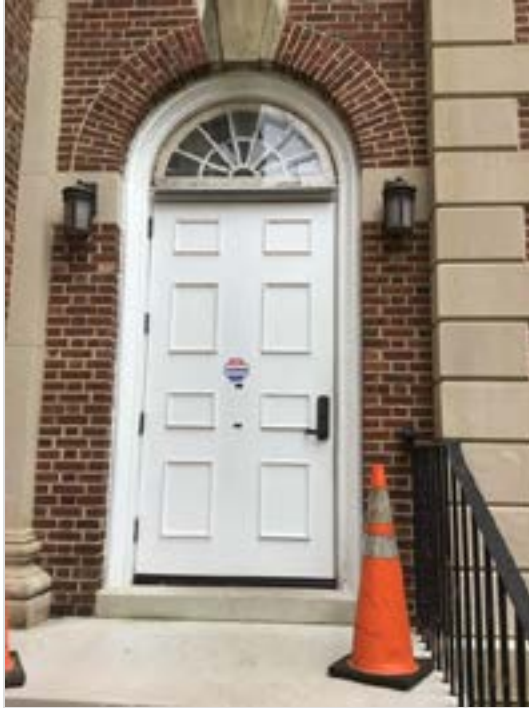
● Exterior (Playground)
[1.62]

- Water damage on exterior trim, cornice, and baluster.
- Transom above door needs replacement.
- railings rusting
- Caulk being used where mortar is missing in the pilaster base.
- Cornice over sanctuary in good condition but has some water damage that should be removed through cleaning.
- Cornice over Pierce Hall (south east portion of the building) has more severe water damage; the metal portion of the cornice is rusting and not fully intact.

Transom needs to be replaced.

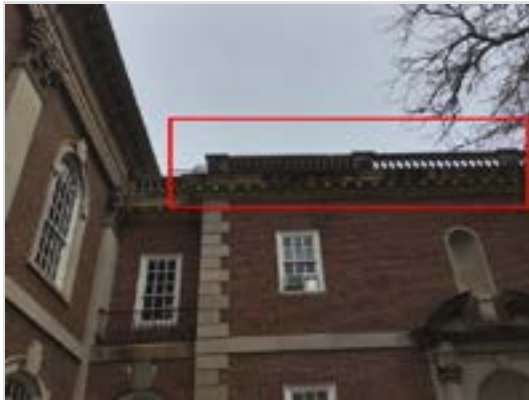
• Exterior (Playground)
[1.62]

Cornice (pierce hall side)

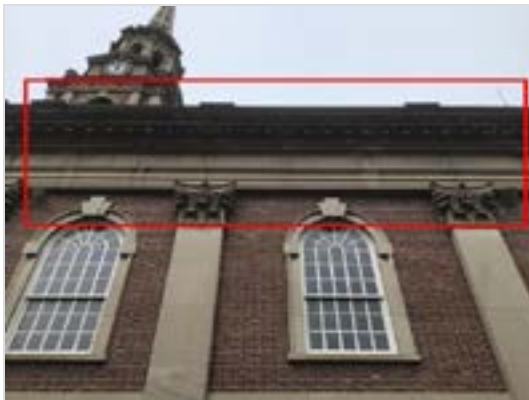
Cornice (sanctuary side)

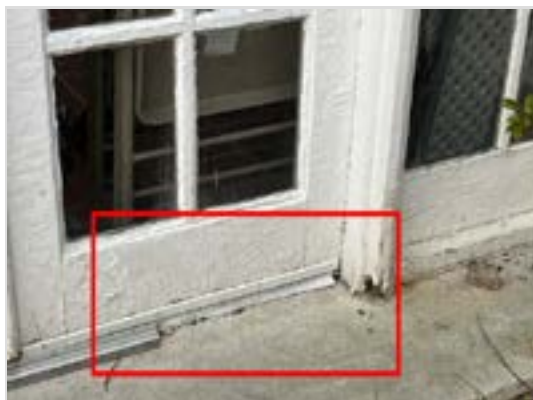
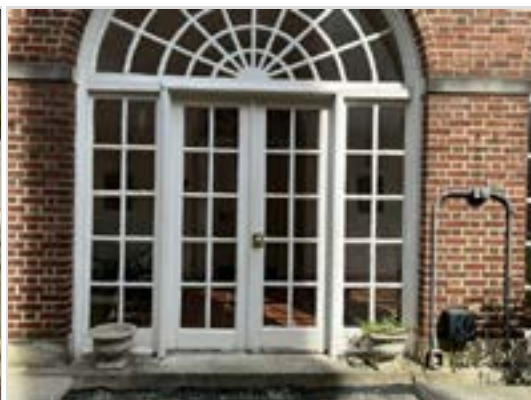
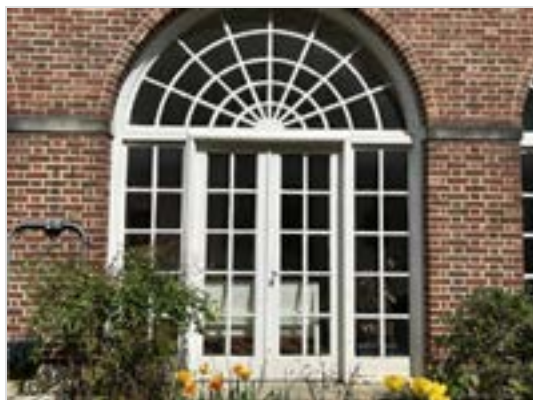
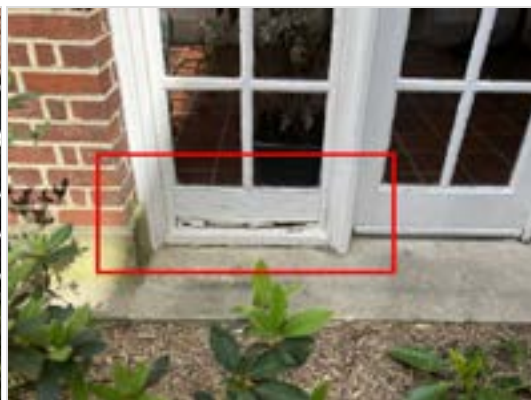
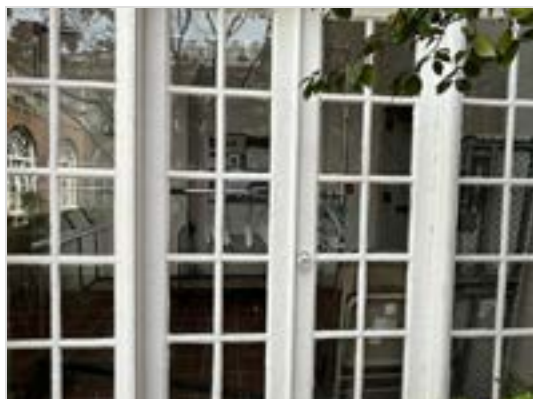
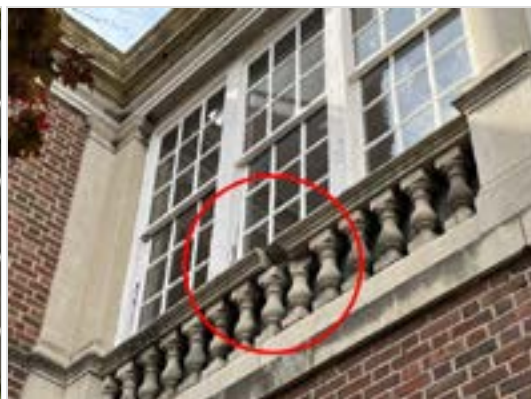
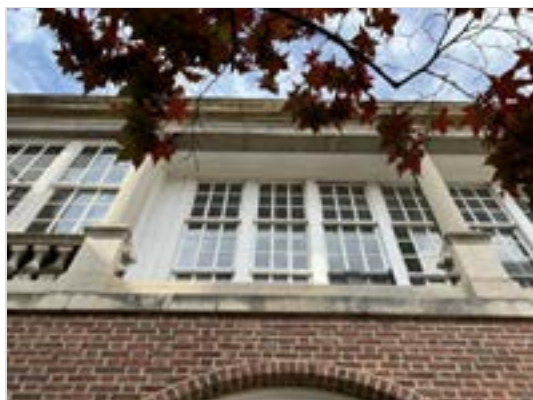
● Courtyard & memorial garden [1.51]

- Painted wood doors and windows are in various states of decay: paint is either cracking or chipping to expose wood. The exposed wood is likely damaged from water exposure.
- Upper terrace baluster was removed for a 2015 addition to the upper floor; broken pieces remain and should be repaired and replaced.

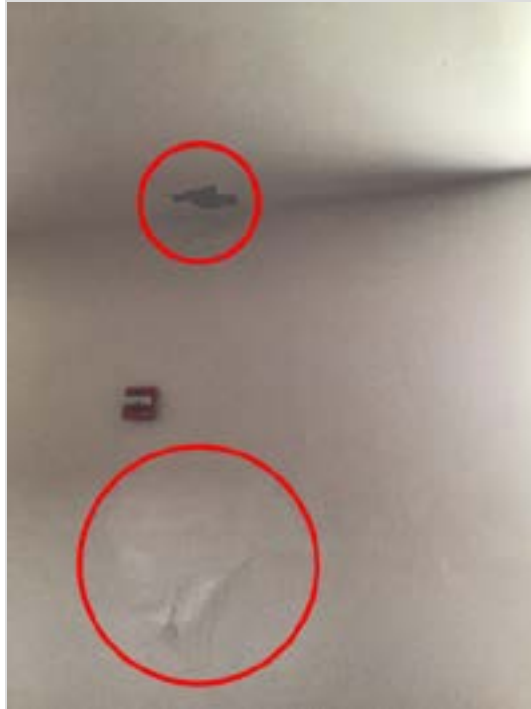
• Sanctuary 209 [1.34]

- Paint is peeling, chipping & blistering in multiple locations of walls and ceilings. This is typically caused by paint being applied to a dirty surface or fluid pockets. There appears to be no signs of water infiltration. Walls should be repaired/painted. Surfaces should be clean of debris, oils, etc. prior to painting to prevent reoccurrence.
- Wall near organ pipes is cracking and paint is chipping in multiple locations. Paint/repair as required.
- Pilasters and cornices require cleaning/repair/painting - typical.
- Vaulted ceiling appears to be cracking in multiple locations. Appears to be evidence of staining/discoloration as well. Closer investigation is required.
- Top of decorative wood columns require cleaning/painting - typical.

Paint cracking and peeling.

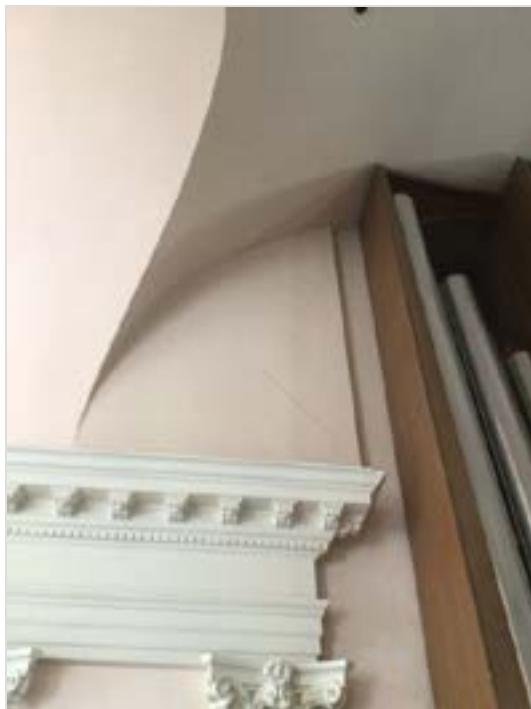
Cracks above decorative wood cornice.

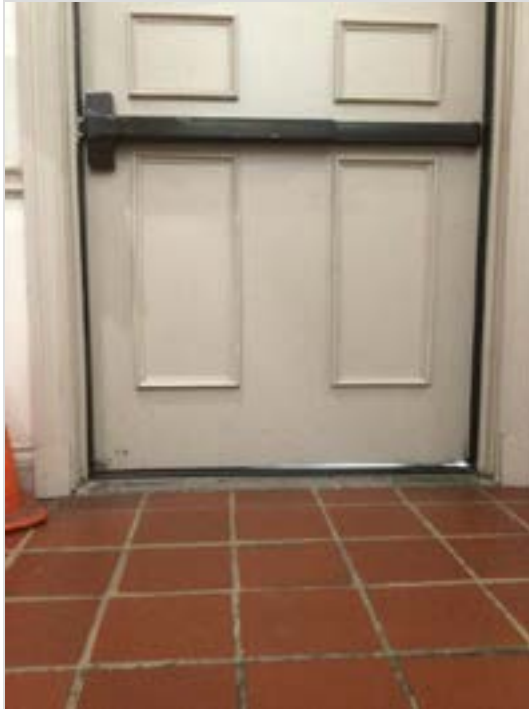
• Narthex 210 [1.36]

- Weather stripping at exterior doors needs replacement.

Air gap at bottom of door. Provide proper weather seals.

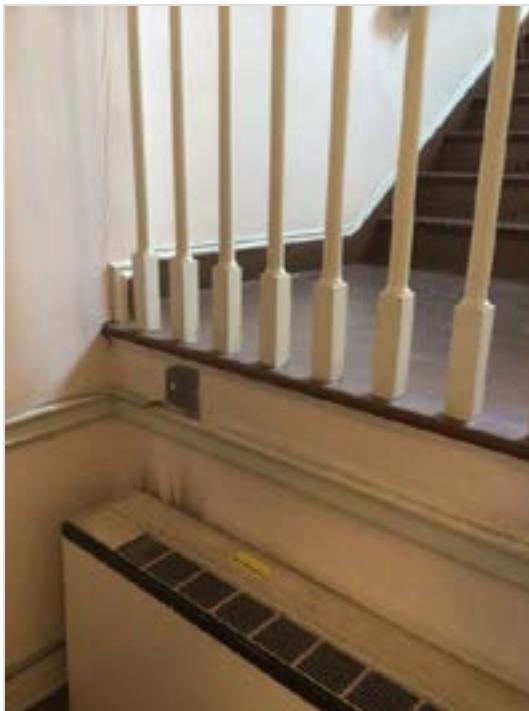
Sand wall smooth. Clean soot from heater. Patch paint and repair wall as required.

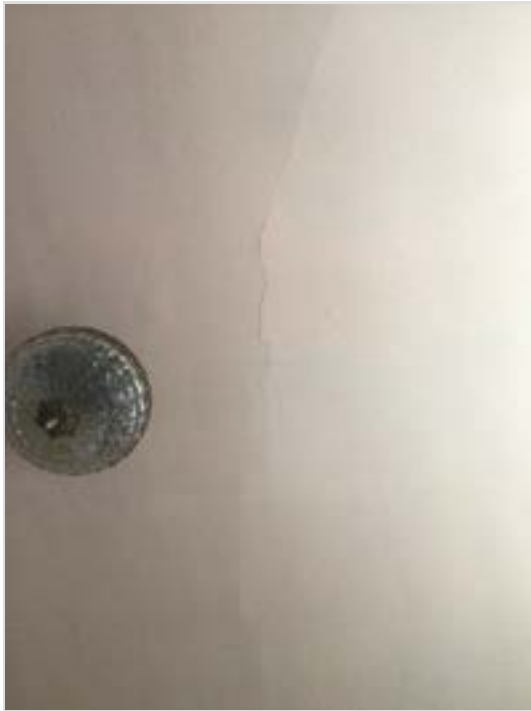
• Sanctuary 209 [1.34]

Cracking in ceiling.

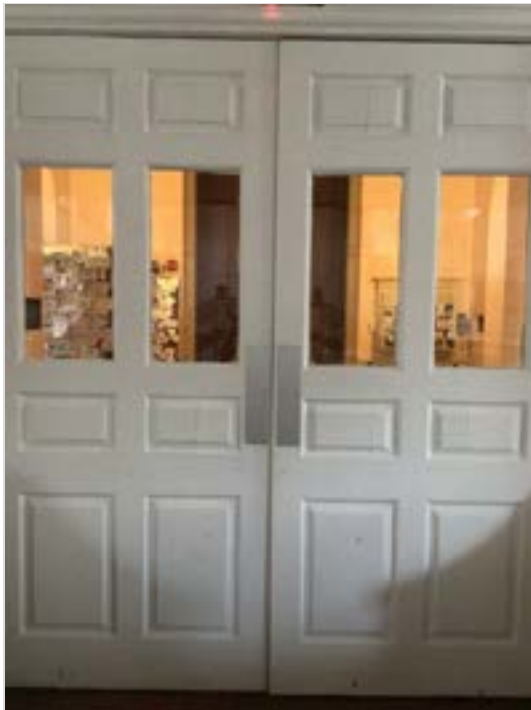
Door panels are damaged and/or cracked.

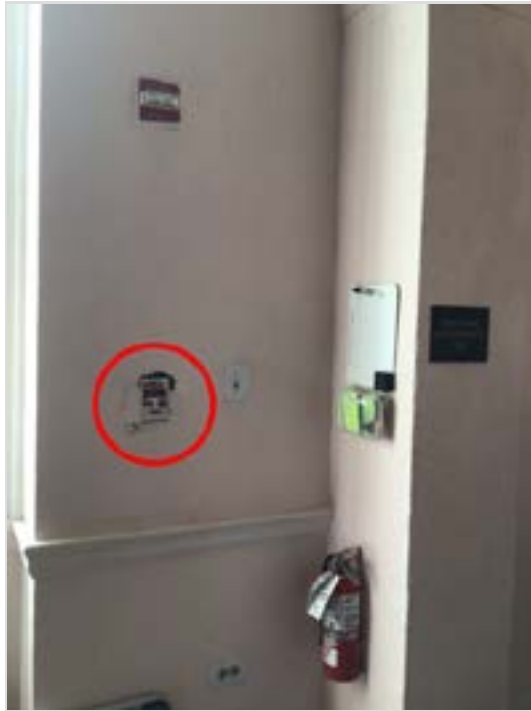
• Sanctuary 209 [1.34]

Damaged drywall at fire alarm pull. Repair and paint as required.

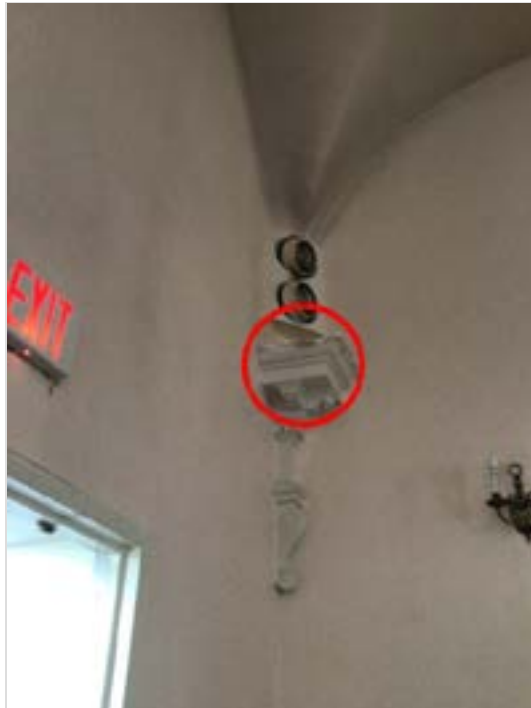
Corbel appears to be deteriorating. Layer of dust visible.

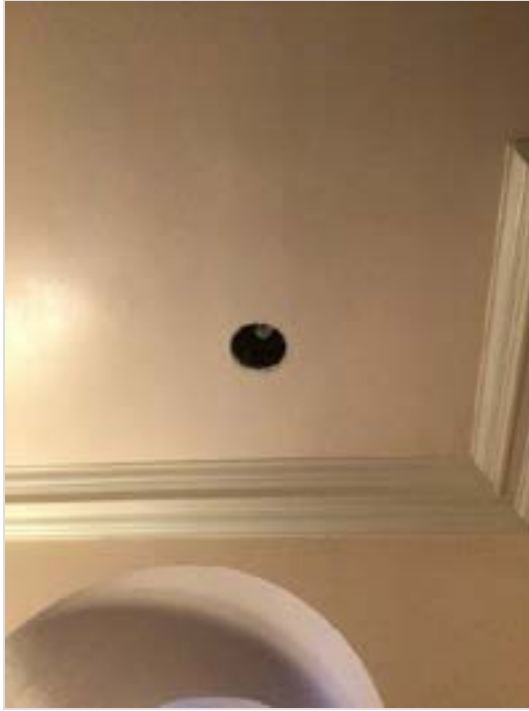
• Vestibule 216 [1.26]

Light can missing

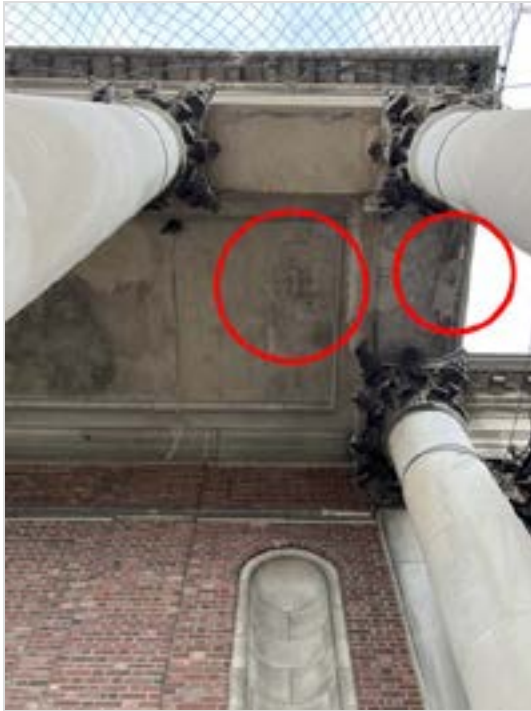
● Exterior - 16th st
[1.52]

- Water damage and efflorescence is typical across the ceiling in the portico.
- Steps are missing mortar joints in multiple locations.
- Steps have sitting water in one location.
- Front door frames and weather stripping needs replacement.
- Front doors do not meet accessibility requirements.
- Pavers may not meet accessibility requirements.

Cast stone ceiling showing signs of water damage / needs cleaning

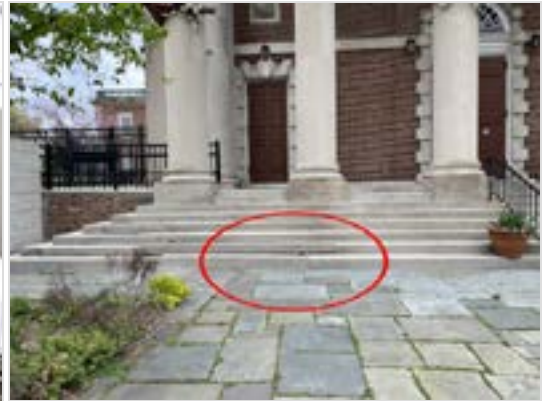
Cast stone stairs not level.

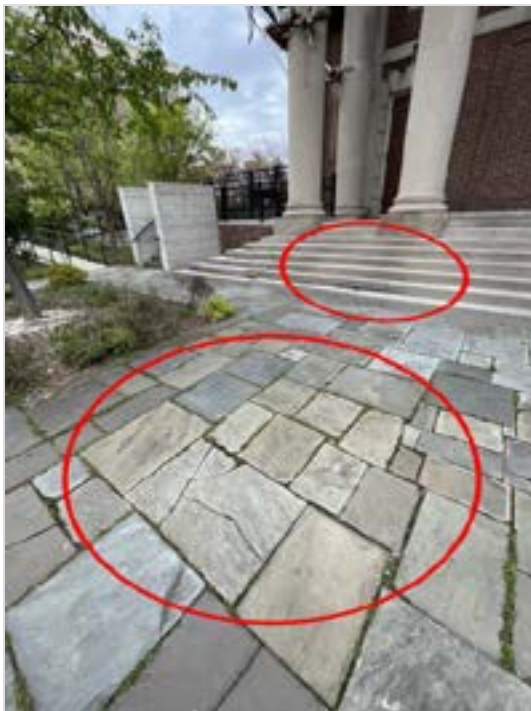
Uneven surface of pavers may not meet accessibility requirement's

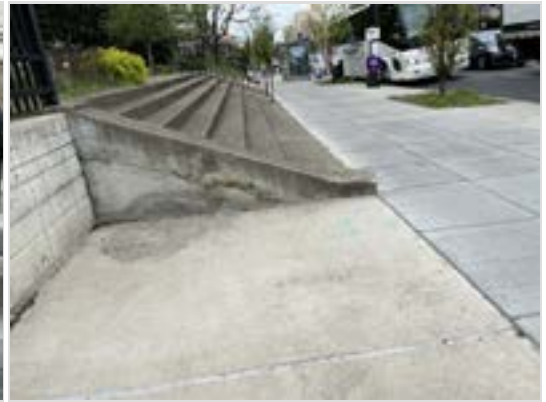
Staircase on 16th street showing signs of corrosion on the concrete.

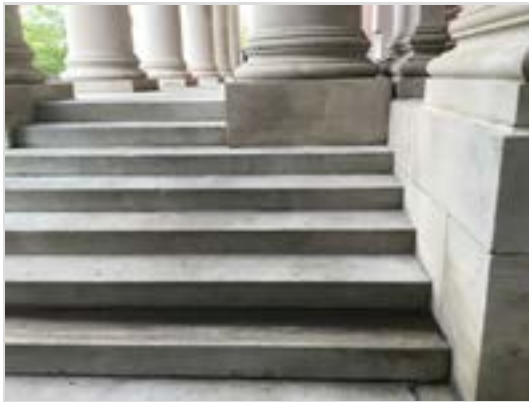
Water collecting on steps to the south west of the front facade.

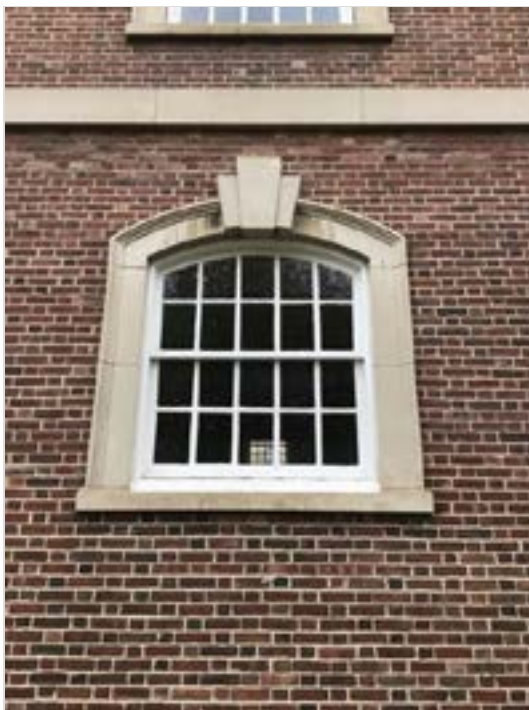
● Exterior - Windows
(Sanctuary South Wall)
[1.60]

Sanctuary windows: window frame and sill in good condition, cast stone window arch has water damage and needs cleaning.

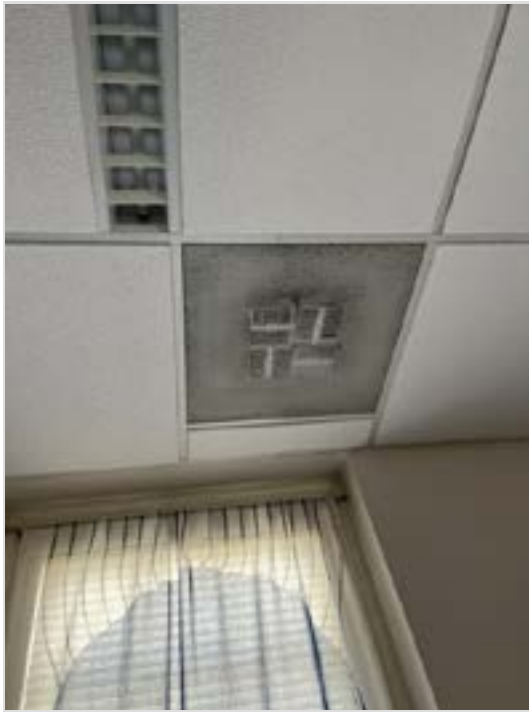
• Office 202 [1.29]

Clean mechanical grilles.
