All Souls Church
1500 Harvard Street NW (US)
Report number: 2206.03-1
Date: April 21, 2022 10:00

Feasibility Assessment Walk Through

ALL SOULS CHURCH
BUILDING ASSESSMENT
2022

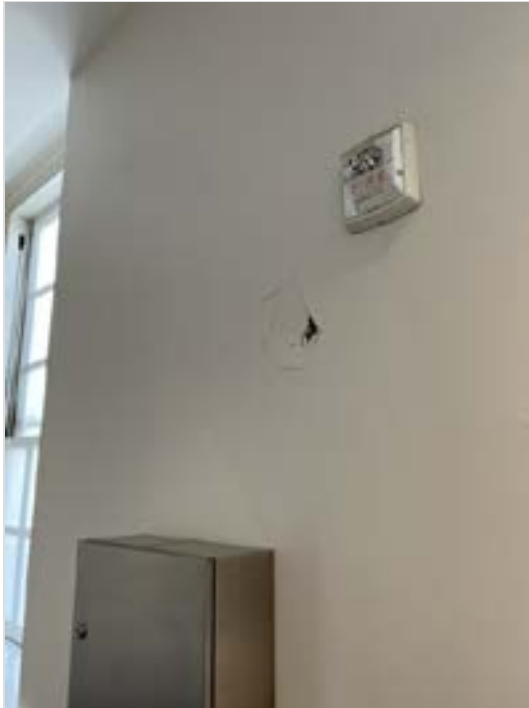
• Restroom 205 [1.30]

Repair hole in wall for clean smooth finish. Paint as required. Patch paint at restroom sign.

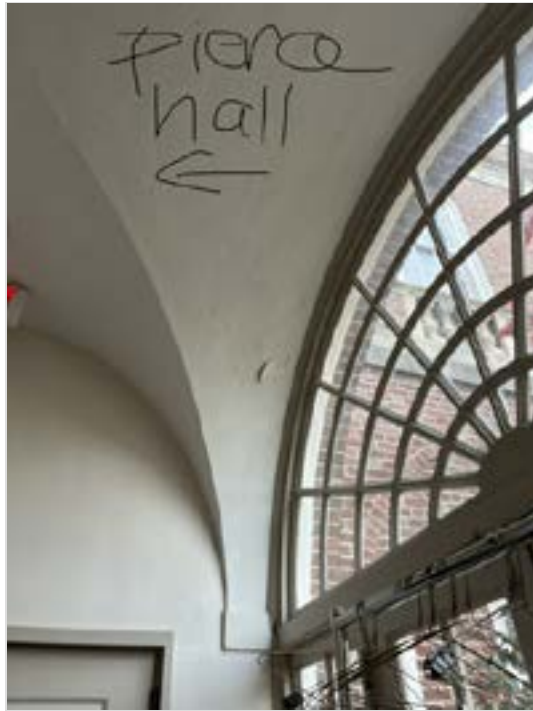
• Corridor 206 [1.31]

- Paint/repair walls as required, typical.

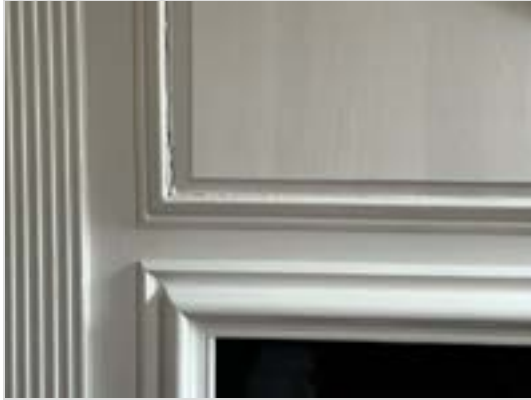
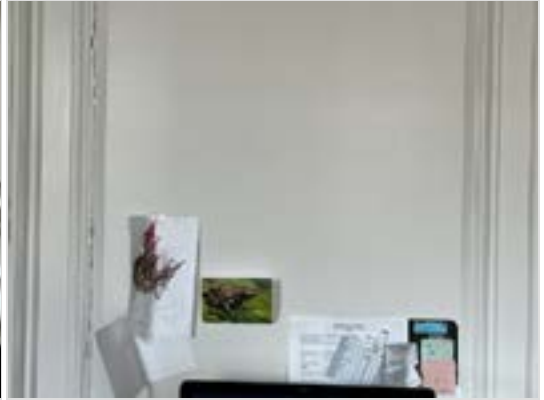
• Office 215 [1.27]

Decorative wood framing is cracking at seams. Fill wood cracks and paint.

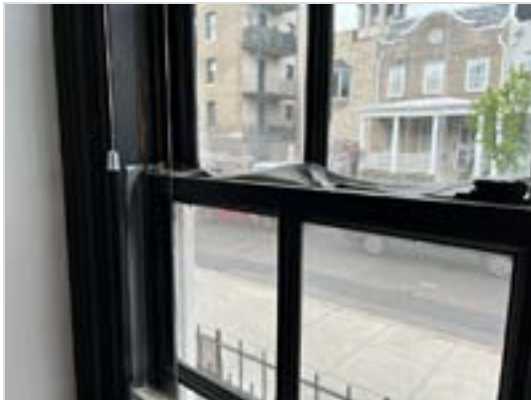
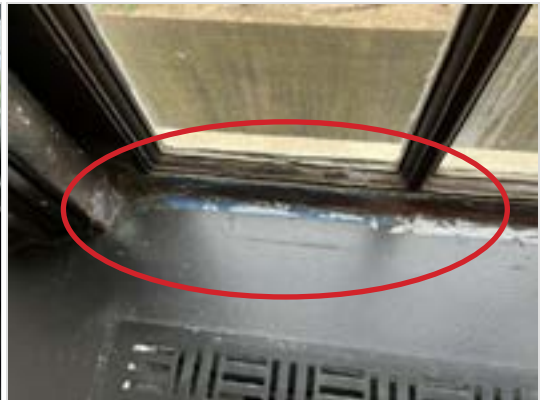
• Library - 217 [1.28]

Window has been duct taped to assist with weather seal. Provide proper weather seals. Remove tape adhesive and repaint windows as required.

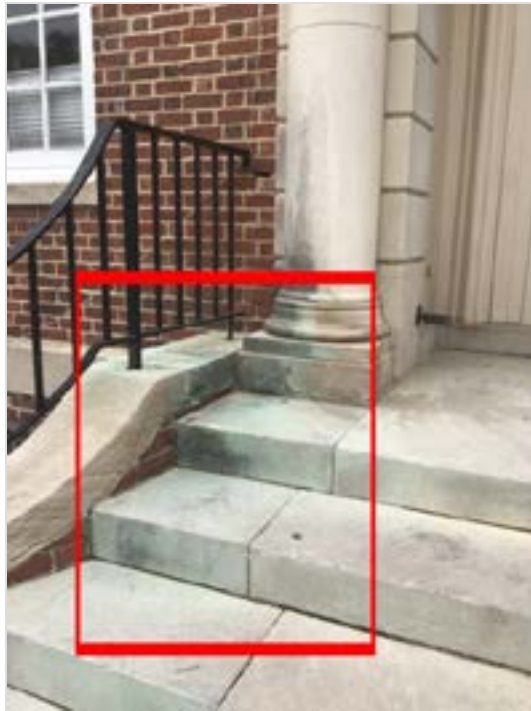
• Exterior (Harvard st entrance) [1.54]

- Significant water damage on the pediment.
- Staining (resulting from excess moisture) on stairs.
- The door and transom are in good condition.

Efflorescence on cast stone steps below pediment.

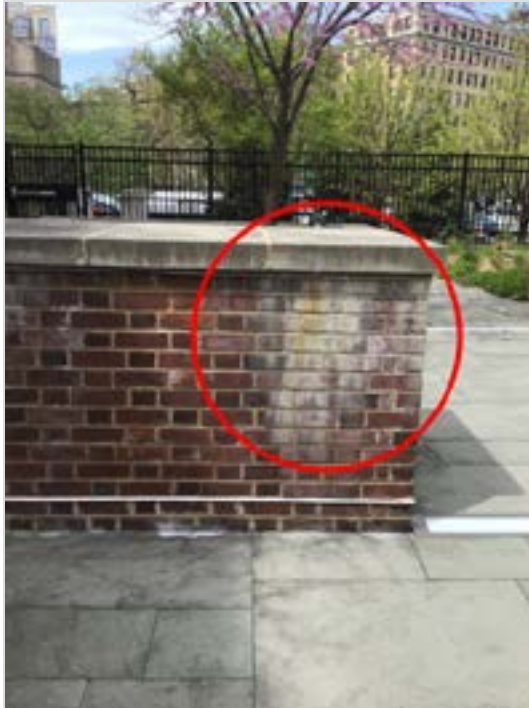
● Northwest terrace
[1.53]

- Skylights over room 127 and 123 need to be repaired; leaks or water marks are present in the interior spaces below each.
- The two pilasters closest to front of the church need to have flashing replaced; other pilaster bases should be monitored.
- Efflorescence on the raised brick walls in the terrace, typ.
- Flashing is deteriorating in sunken plant beds.

Efflorescence typical on raised brick walls.

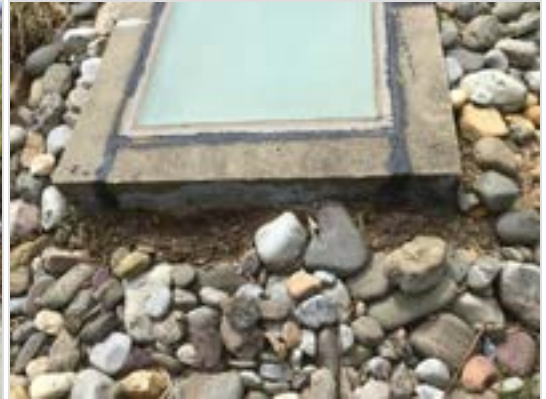
Skylight mortar/ flashing needs immediate attention.

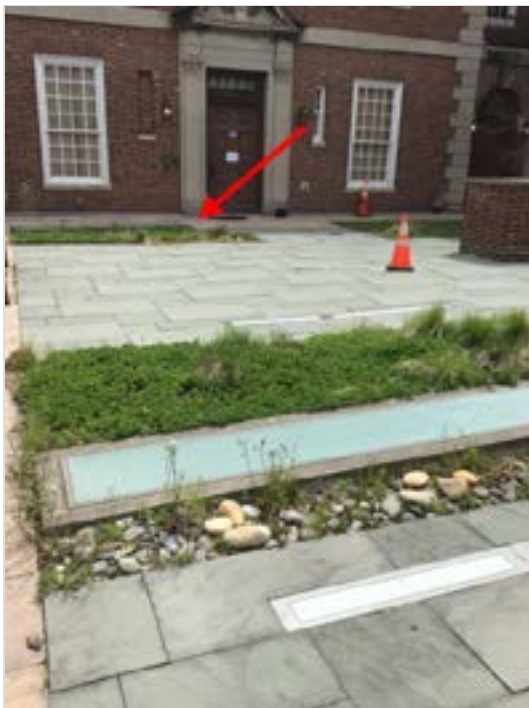
Skylight over room 127 needs repair.

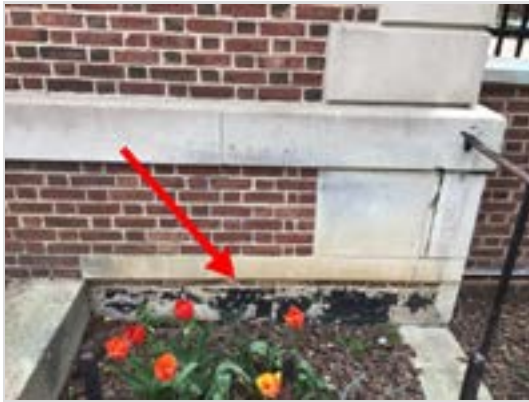
- Northwest terrace [1.53]

Flashing needs to be repaired at planter on harvard st.

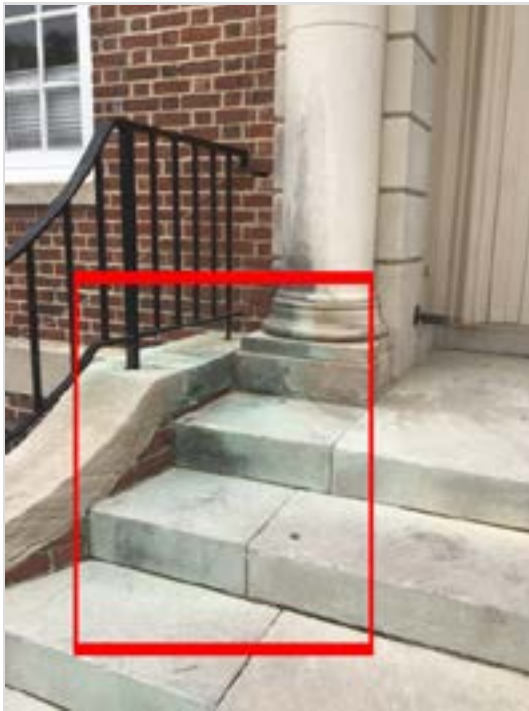
- Exterior (Harvard st entrance) [1.54]

- Significant water damage on the pediment.
- Staining (resulting from excess moisture) on stairs.
- The door and transom are in good condition.

Efflorescence on cast stone steps below pediment.

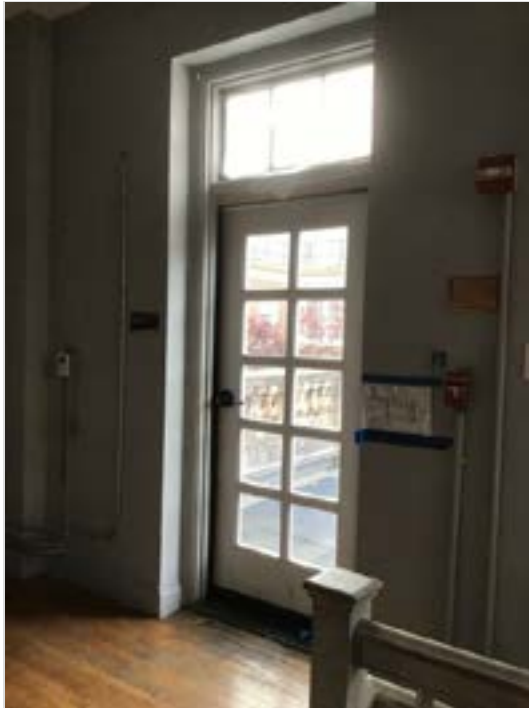
● Pierce Hall Mezzanine
- 312 [1.33]

Door does not have weather seals. Seals should be provided. Paint scuffed - paint/clean as required.

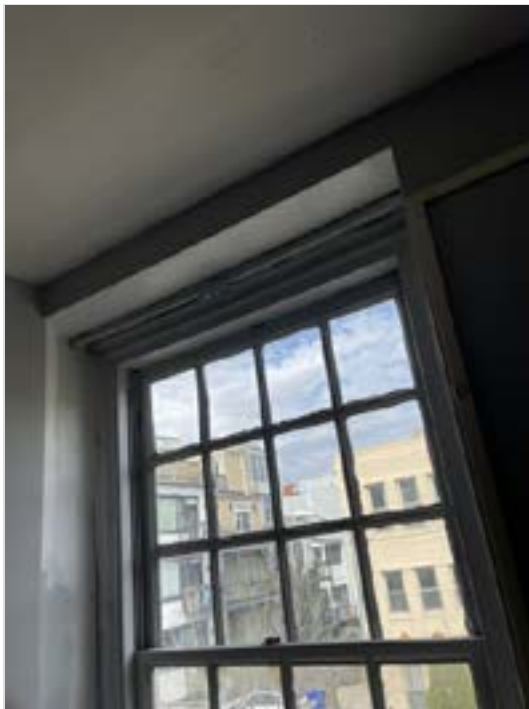
Repaint windows and provide weather seals.

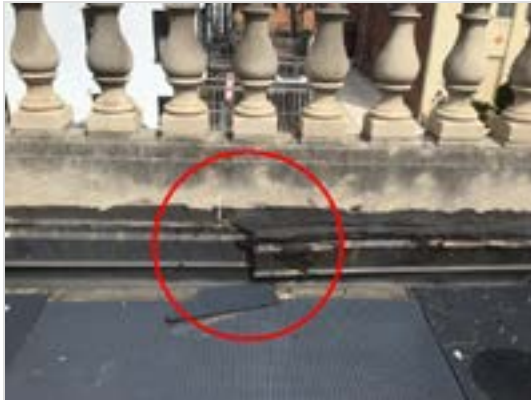
• Jenny Lynn Terrace
[1.55]

- Flexible pavers need to be replaced or re-attached.
- Flashing needs to be replaced.
- Door to the terrace requires repair, refinishing, and/or replacement
- Window wall surrounding the elevator needs repair, refinishing, and/or replacement

Flashing needs replacement

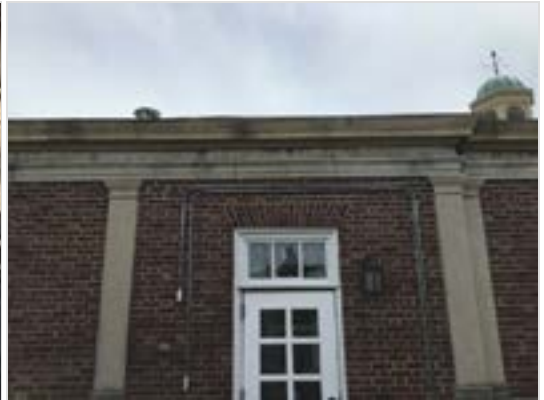
Water damage on cornice

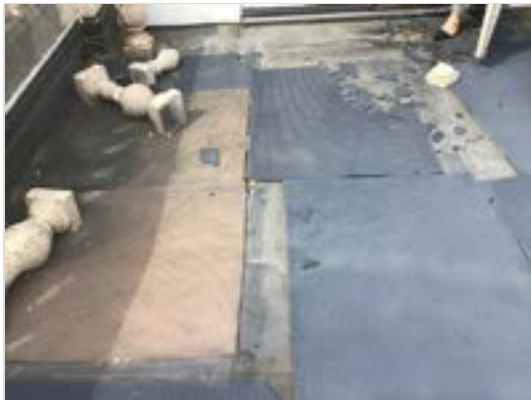
Flexible pavers need replacement

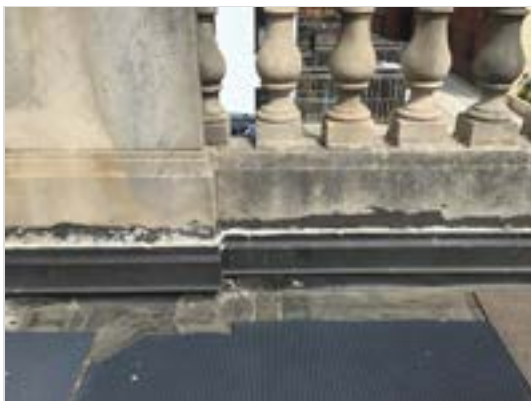
Standing water; slope to drain

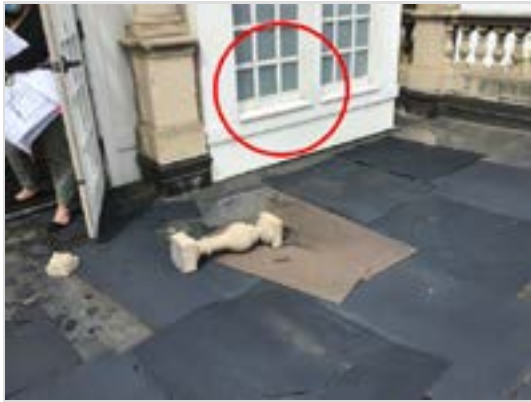
● Jenny Lynn Terrace
[1.55]

Exposed wood; window frames need repair, refinishing, and/or replacement

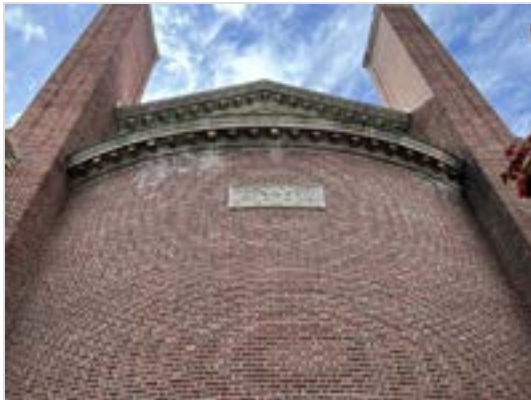
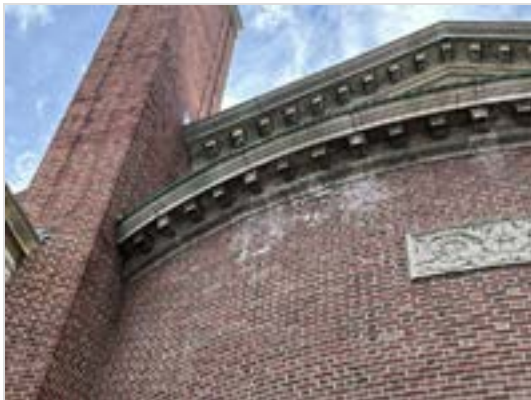
● Exterior - Masonry
(Sanctuary East Wall)
[1.61]

Efflorescence under cornice; gutters above cornice need to be repaired and/or replaced

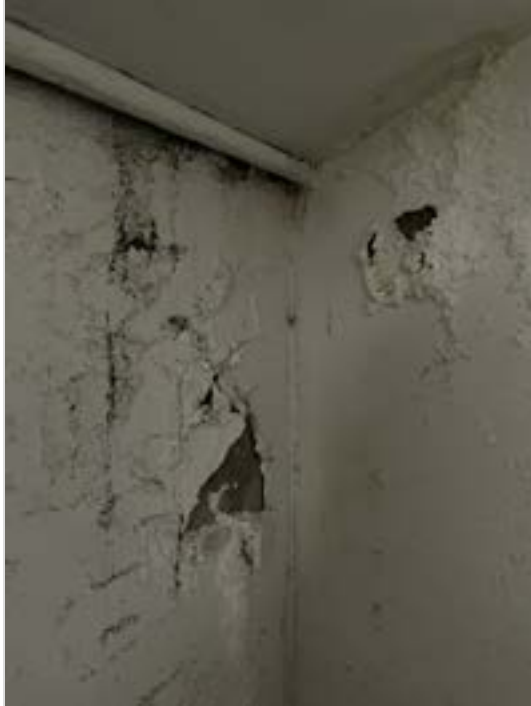
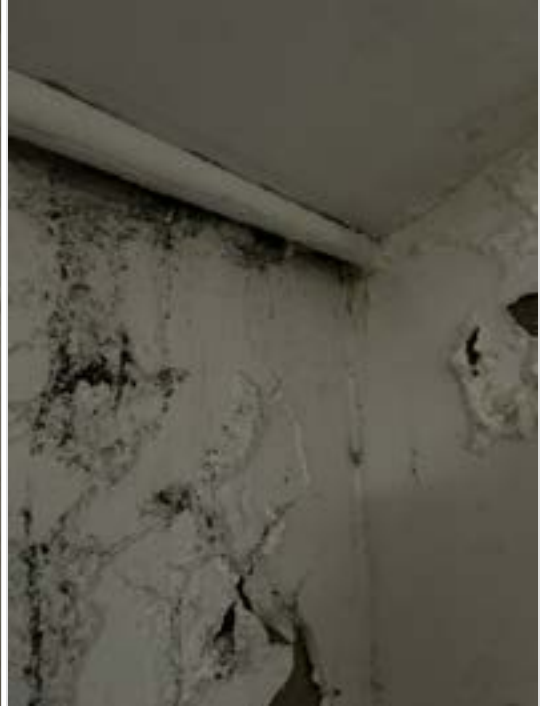
- Room 316 [1.50]

- Paint is peeling, chipping & blistering in multiple locations of walls and ceilings. This is typically caused by paint being applied to a dirty surface or fluid pockets. Base surface appears to be concrete. Moisture could be seeping through concrete. Paint should be removed and room dried out. Prime base with concrete densifier followed by a penetrating water repellent seal to keep out moisture.

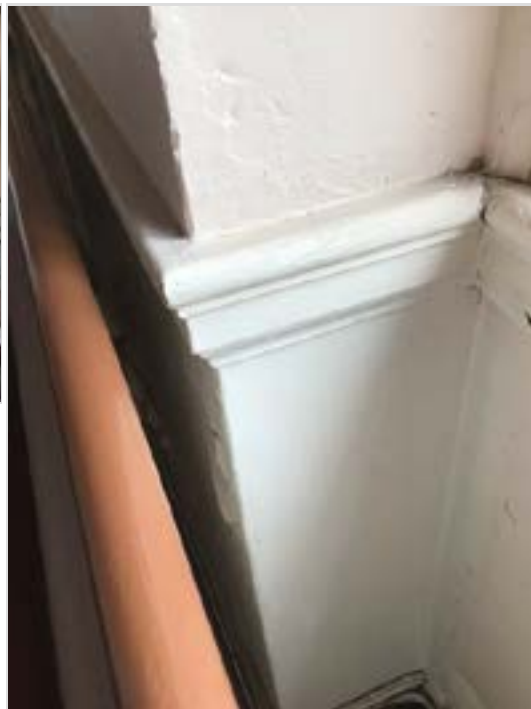
Perimeter wainscoting is chipping. Repair/paint as required.

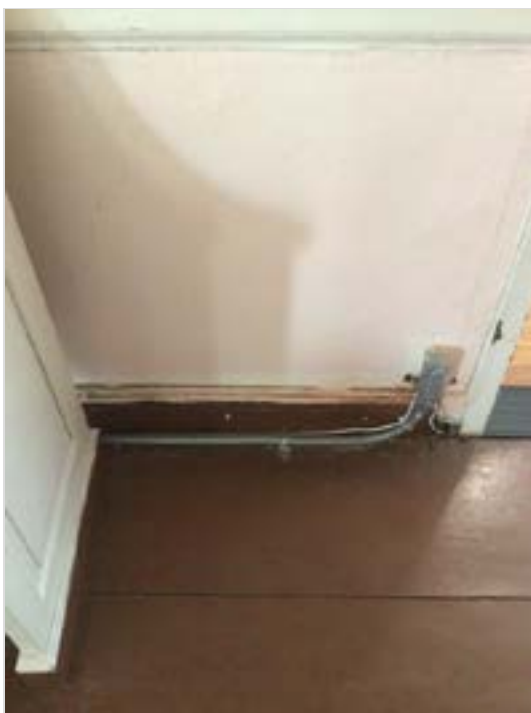
Exposed wiring in multiple locations.

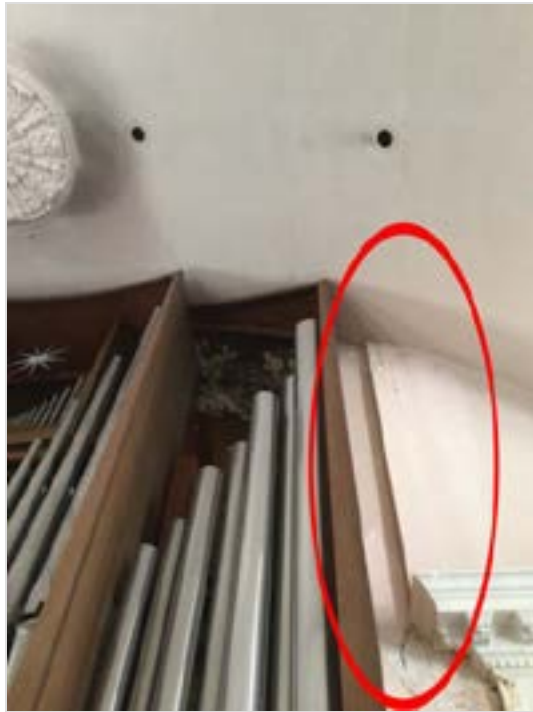
● Organ Room [1.39]

- Paint is deteriorating near vaulted ceiling.
- Cracking can be seen in ceiling radiating from down light.
- Areas should be repaired and repainted.

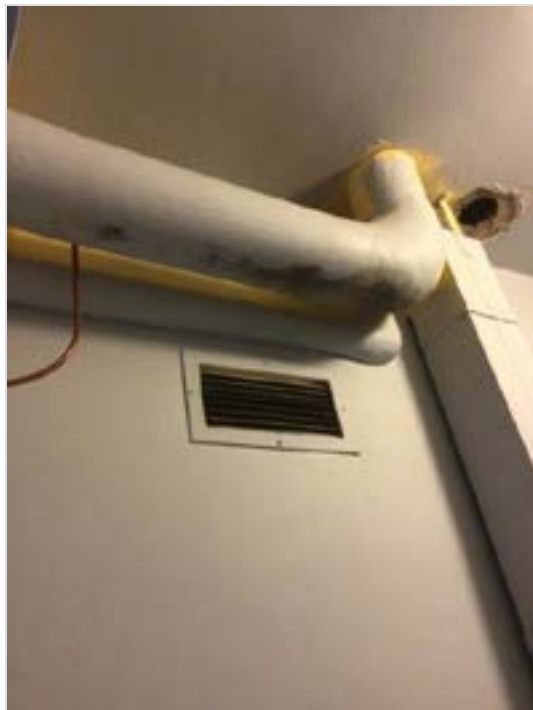
● Youth Room 401 [1.40]

- Evidence of water damage in multiple locations.

Signs of potential pipe leak due to staining.

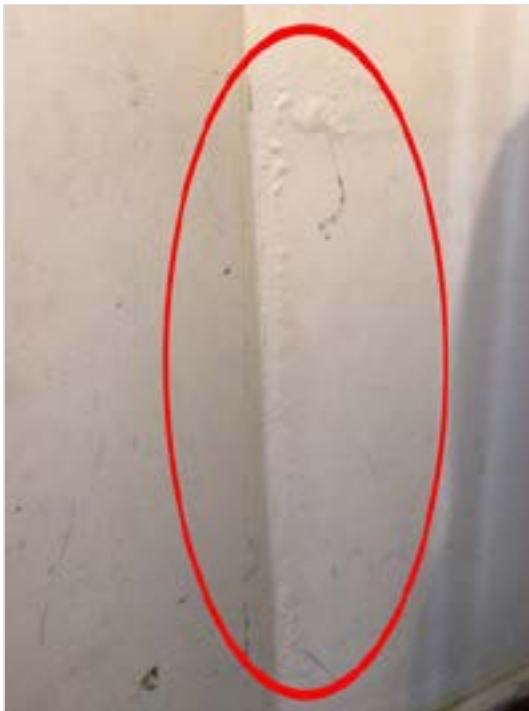
● Bell tower stairs [1.42]

- Paint is peeling, chipping & blistering in multiple locations of walls and ceilings. This is typically caused by paint being applied to a dirty surface or fluid pockets. There appears to be no signs of water infiltration. Walls should be repaired/painted. Surfaces should be clean of debris, oils, etc. prior to painting to prevent reoccurrence.

Paint blistering.

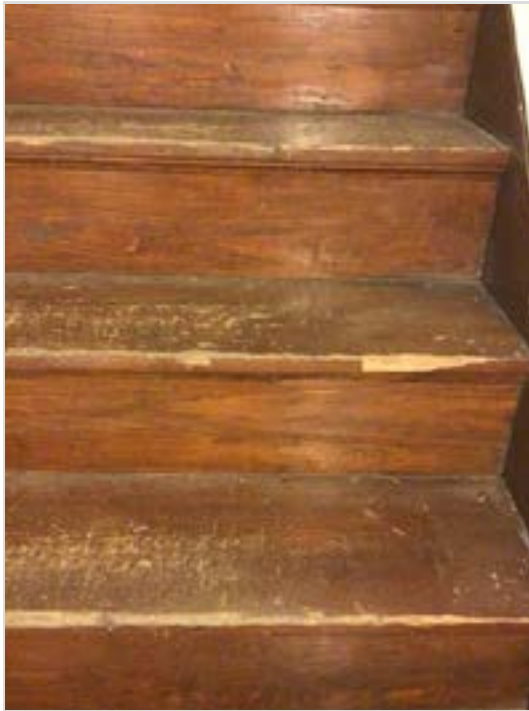
● Bell tower stairs
[1.42]

Stair nosings splintering and damaged. Stair requires refinishing can be applied to tread nosings to help prevent damage of stairs.

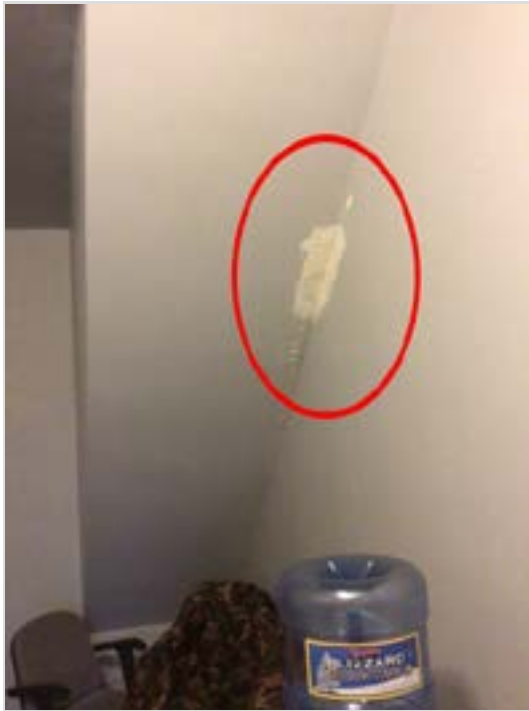
- Youth Room 401
[1.40]

Paint blistering.

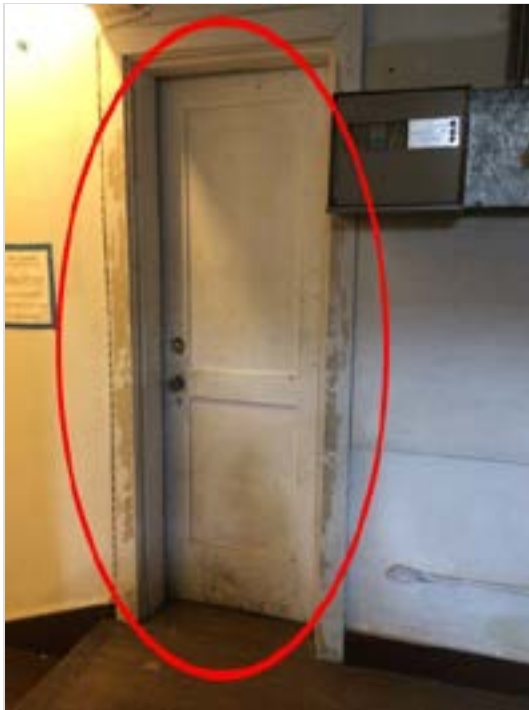
- Storage 403 [1.41]

Door to bell tower requires repair and paint.

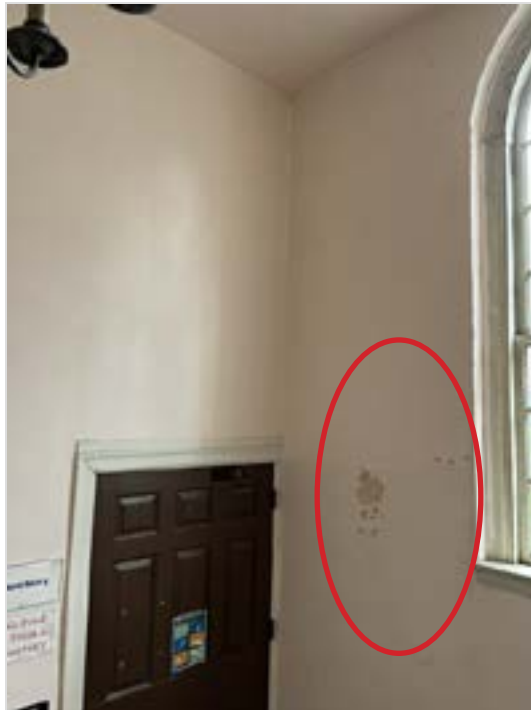
• Stair 5 [1.37]

- Paint is peeling, chipping & blistering in multiple locations of walls and ceilings. This is typically caused by paint being applied to a dirty surface or fluid pockets. There appears to be no signs of water infiltration. Walls should be repaired/painted. Surfaces should be clean of debris, oils, etc. prior to painting to prevent reoccurrence.
- Window frame a mullions require repair and painting.

Blistering and peeling paint.

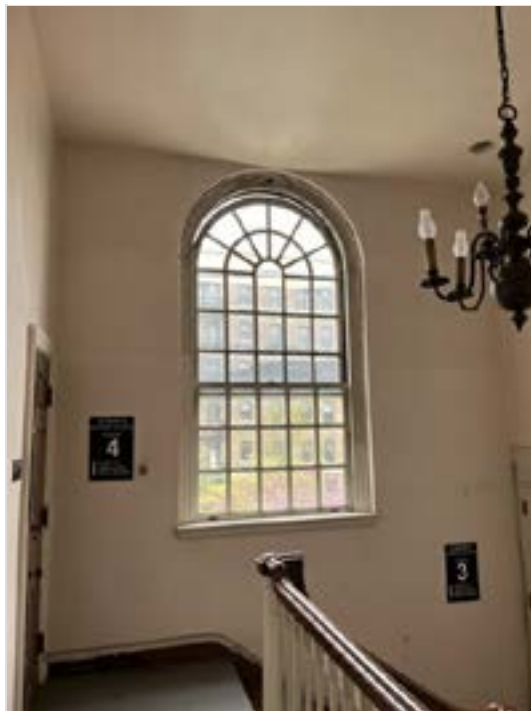
Stair nosings splintering and damaged. Stair requires painting. Rubber surfacing can be applied to tread nosings to help prevent damage of stairs.

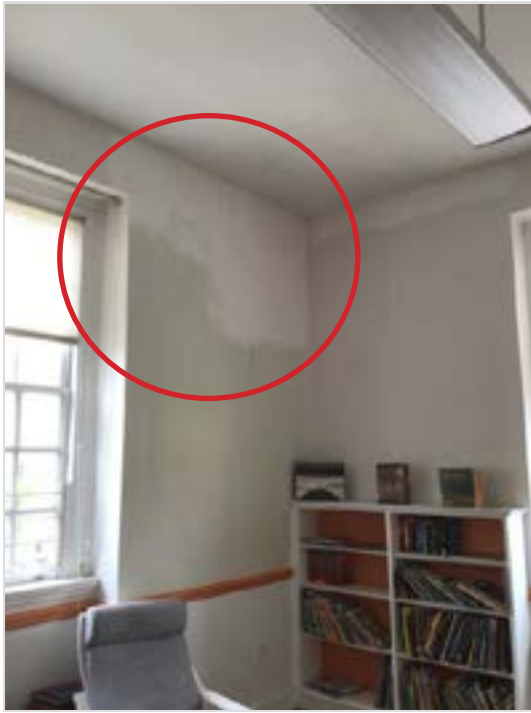
● Classroom - 301
[1.44]

Painting is inconsistent in multiple locations. Repaint room for solid consistent finish.

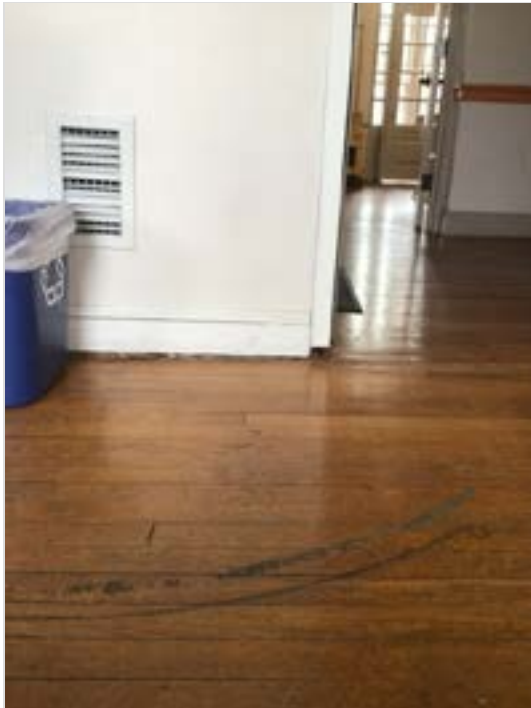
Scuffs on wood floor. Buff and clean.

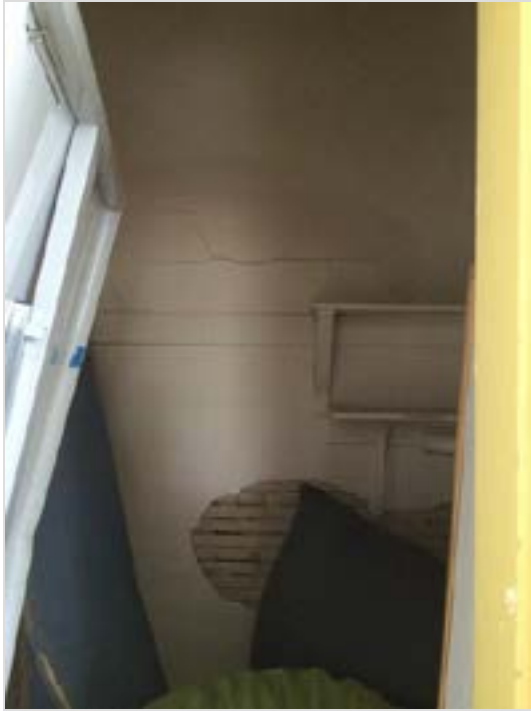
● Classroom - 301
[1.44]

Wall finish in closets are cracking; cause unknown. Further investigation is required.

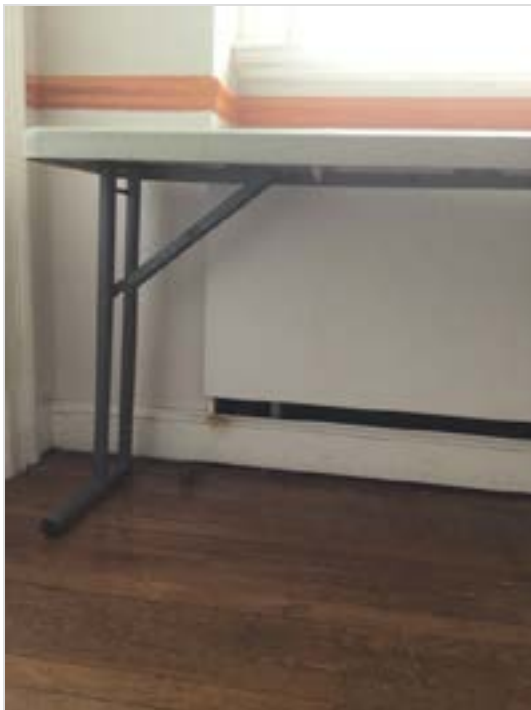
Repaint wood wall base.

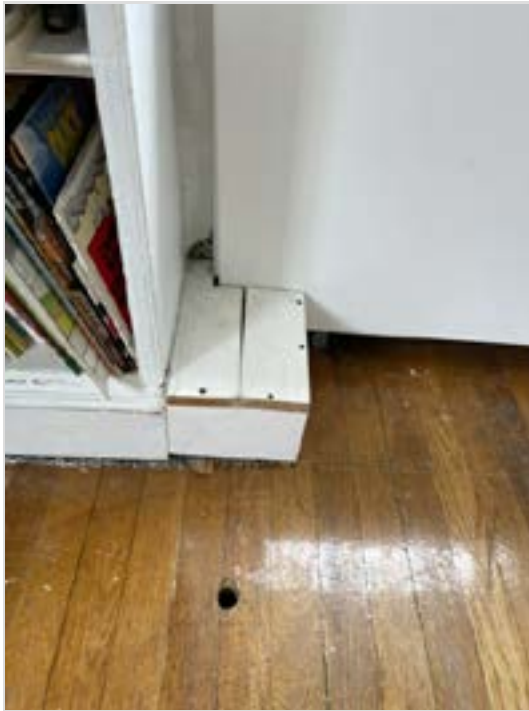
● Classroom - 301
[1.44]

Hole in wood floor.

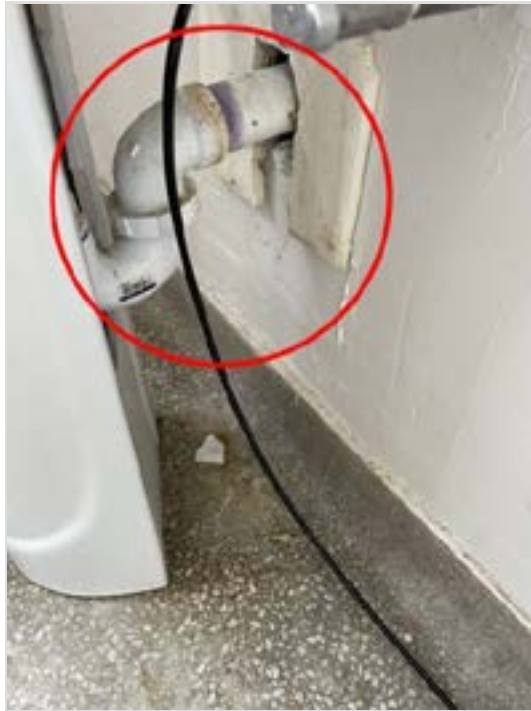
● Restroom 303 [1.45]

Provide heat shield to keep PVC pipes protected. Seal wall penetration.

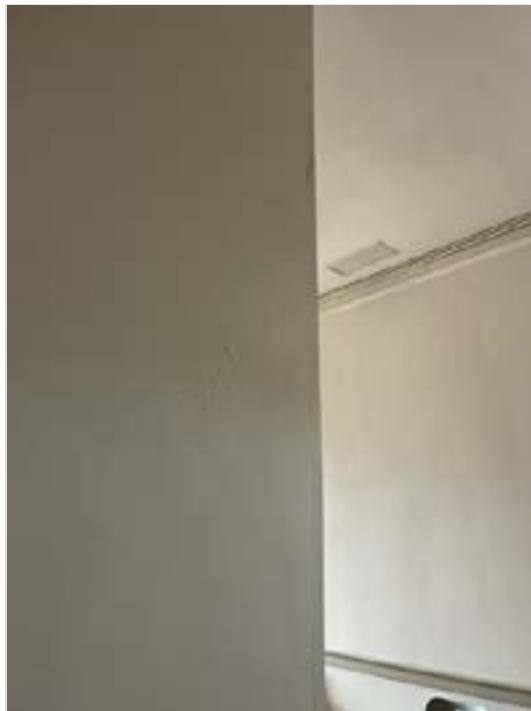
● Corridor 305 [1.46]

- Paint is peeling, chipping & blistering in multiple locations of walls and ceilings. This is typically caused by paint being applied to a dirty surface or fluid pockets. There appears to be no signs of water infiltration. Walls should be repaired/painted. Surfaces should be clean of debris, oils, etc. prior to painting to prevent reoccurrence.

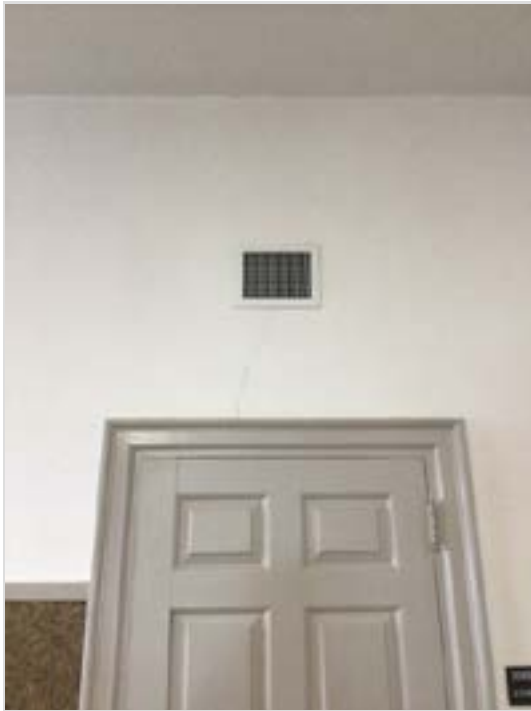
● Classroom - 306
[1.47]

Crack in wall above door. Repair and paint.

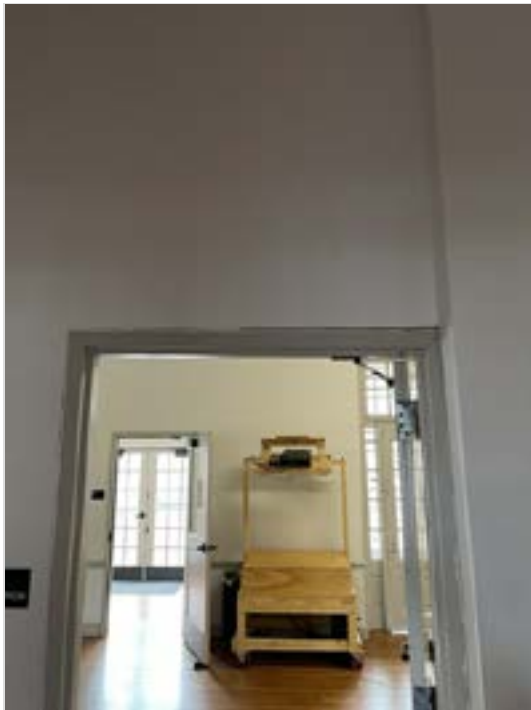
Door frame settling and "detaching" from wall. Remove frame to confirm proper blocking is provided. Reinstall with proper support and paint frame and wall as required.

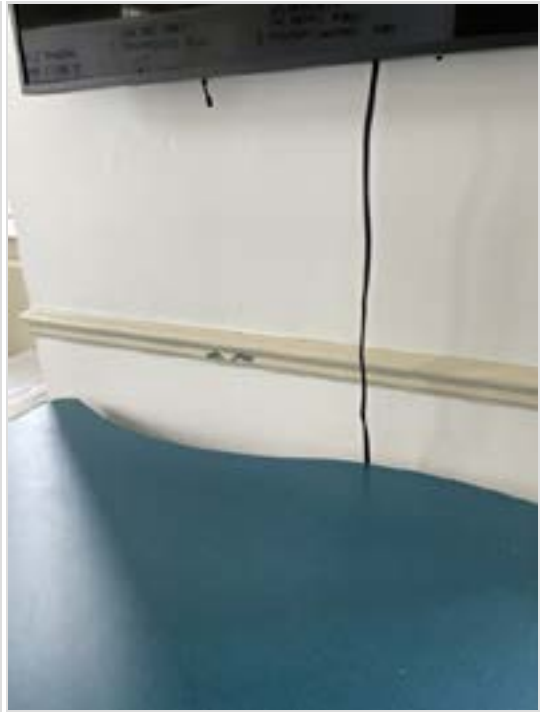
Patch paint room as required.

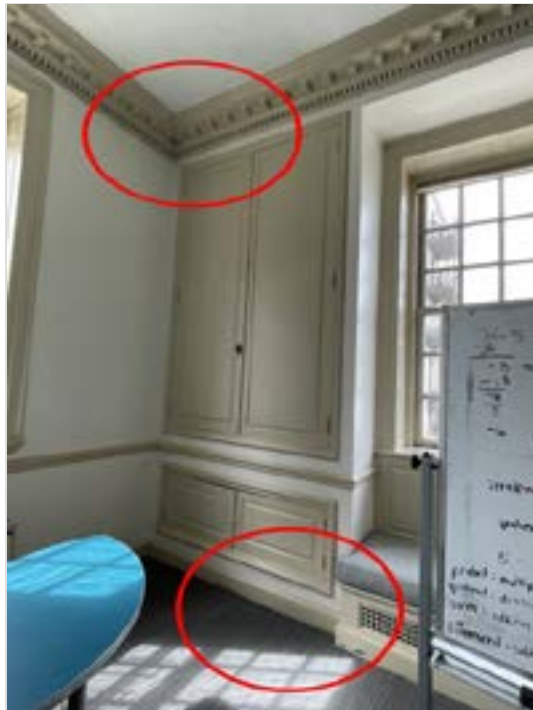
Wood trim requires repainting in multiple locations.

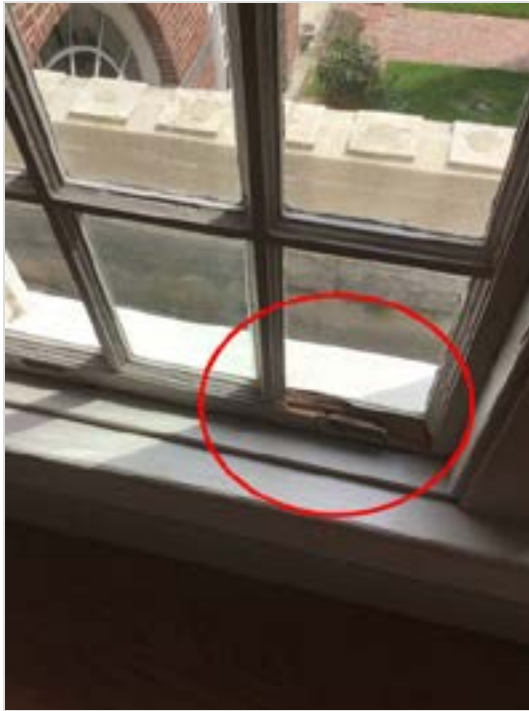
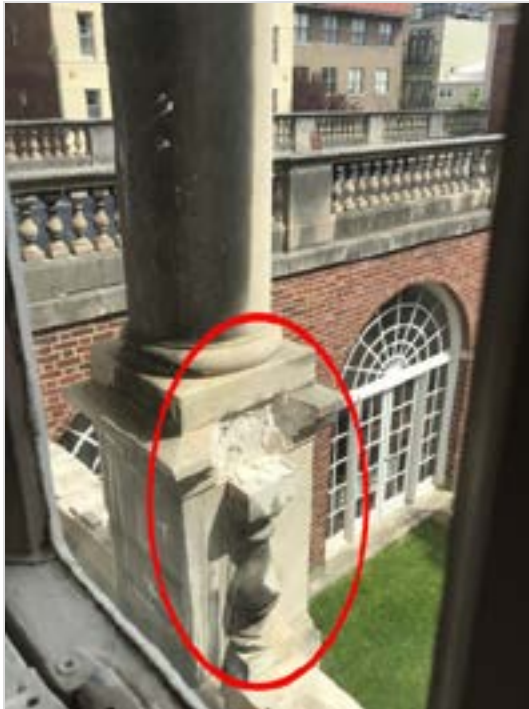
• Gallery 310 [1.49]

- Wood chipped on windows. Repair and repaint.
- Balusters were removed and not replaced. Keep an eye on demo'd area for potential deterioration.

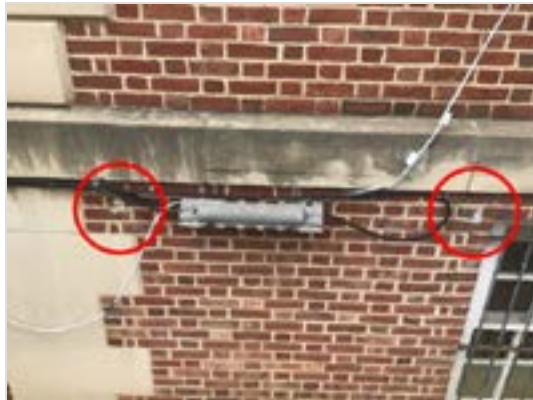
- Exterior - Masonry (15th St. and Harvard St.) [1.56]

Mortar patches or unfilled holes in masonry are common along exterior on Harvard St. and 15th St.

Railing replaced, holes in the masonry left un-filled.

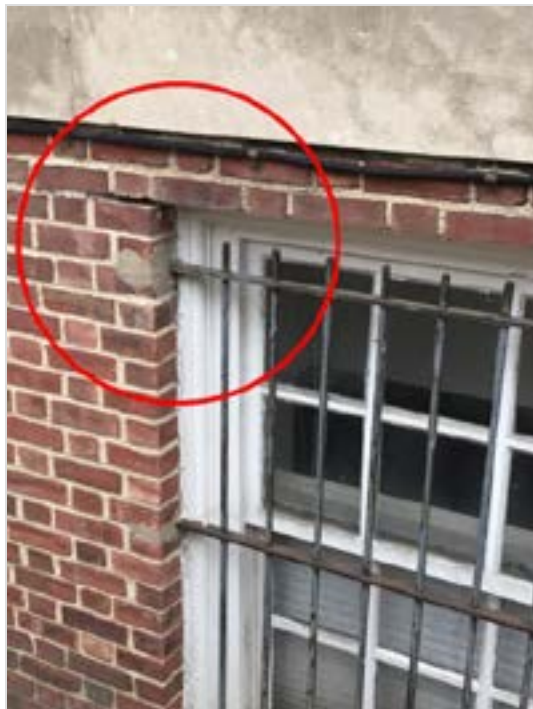
Mortar joint missing near window.

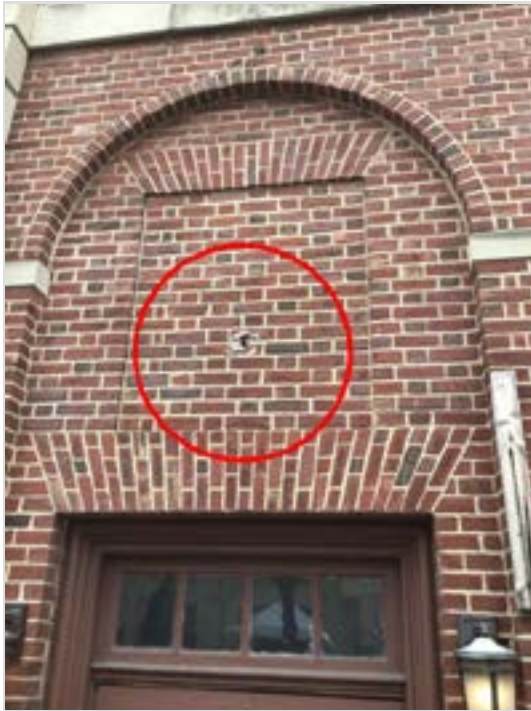
- Exterior - Masonry
(15th St. and Harvard St.) [1.56]

Lighting fixture or flag pole was removed but the hole was not properly filled.

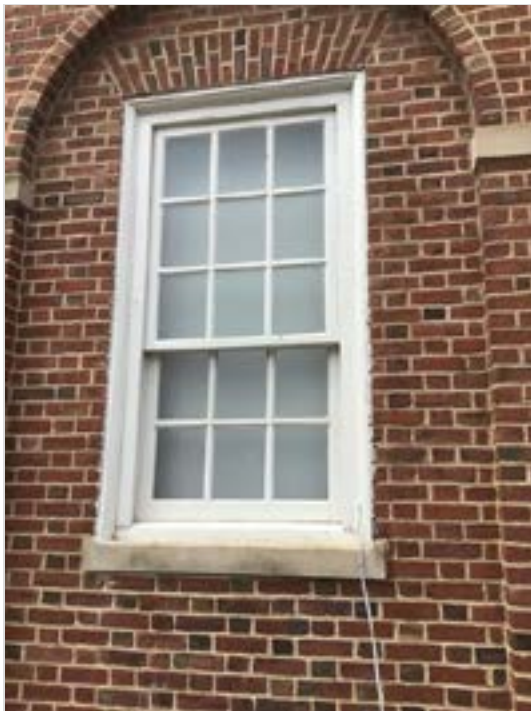
- Exterior - Windows
(15h st and Harvard st)
[1.57]

Good window (restored 2015) Frame needs monitoring

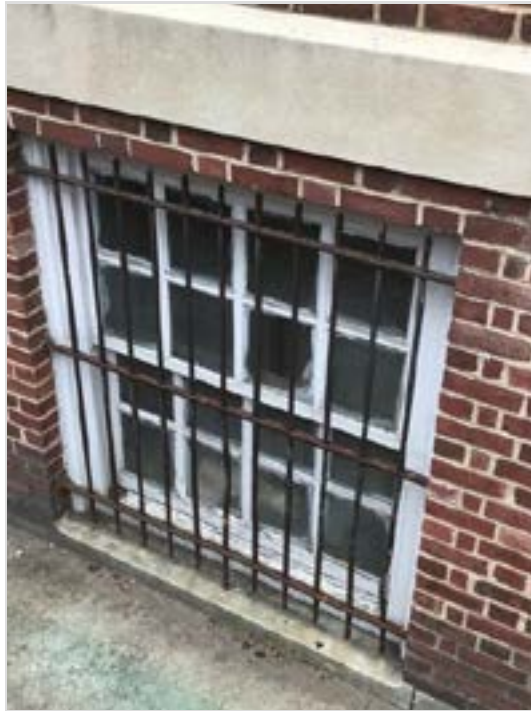
- Exterior - Windows
(15h st and Harvard st)
[1.57]

- Lower level windows are in the worst condition; when the paint is chipped it is likely the wood is also rotting.
- Main level windows are in good condition but the paint is cracking and should be re-painted to avoid damage to the wood frame.
- Upper level windows are in best condition showing minimal damage to paint.

Lower level window

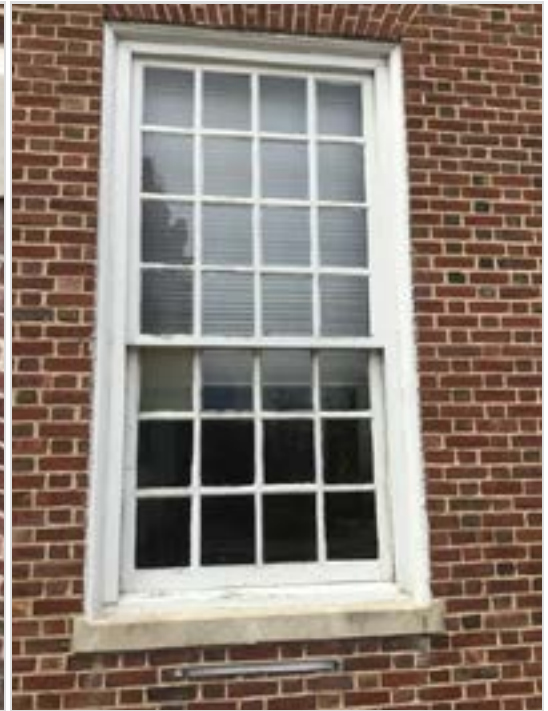
A number of windows on 15th st were not painted in 2015 -
- Wood exposed on most typ

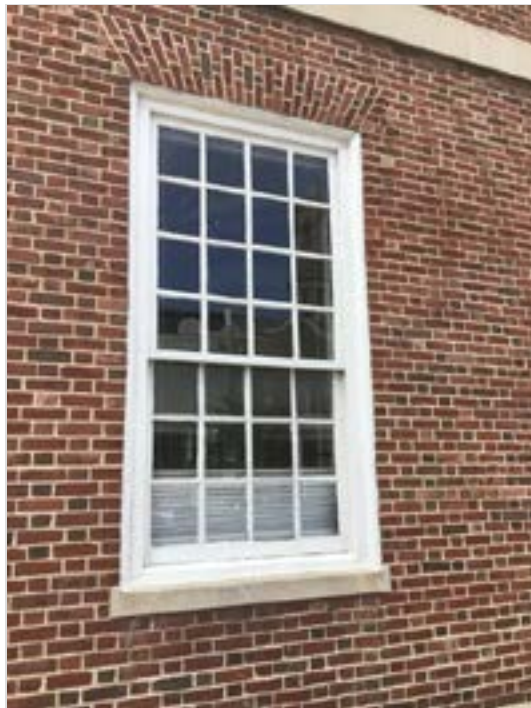
Window restored in 2015; paint still intact but monitor.

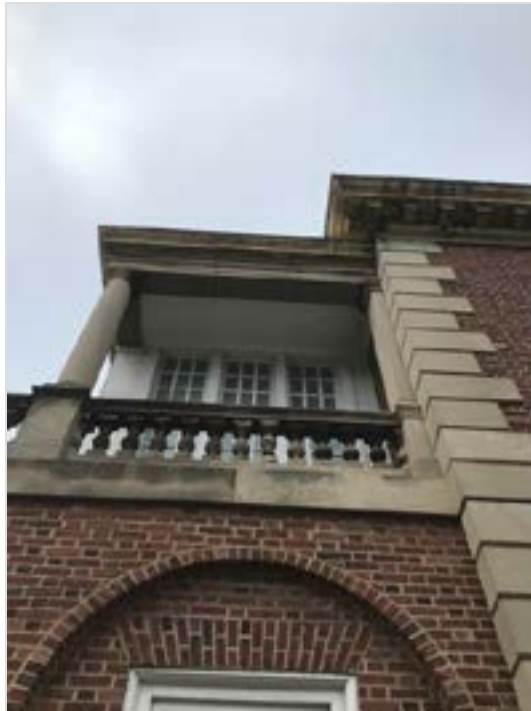
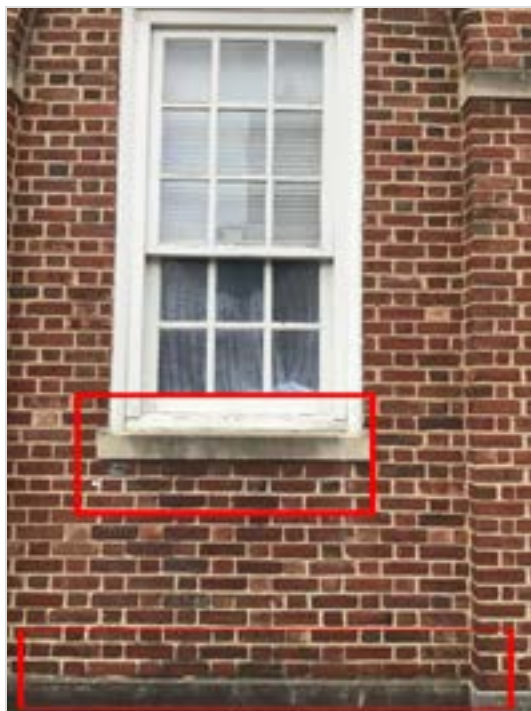
- Exterior (15th St)
[1.58]

Façade elements directly below the Jenny Lynn Terrace on 16th street show have significant water damage when compared to other parts of the façade. The assumption is that water is not draining properly from the terrace and, as a result, damaging the masonry and stone below.

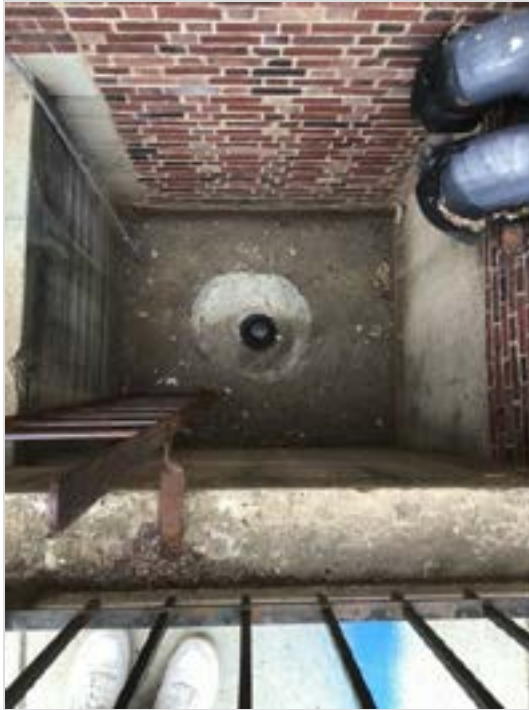
● Exterior (Moat) [1.59]

Structural issues appearing in the boiler room below this drain.

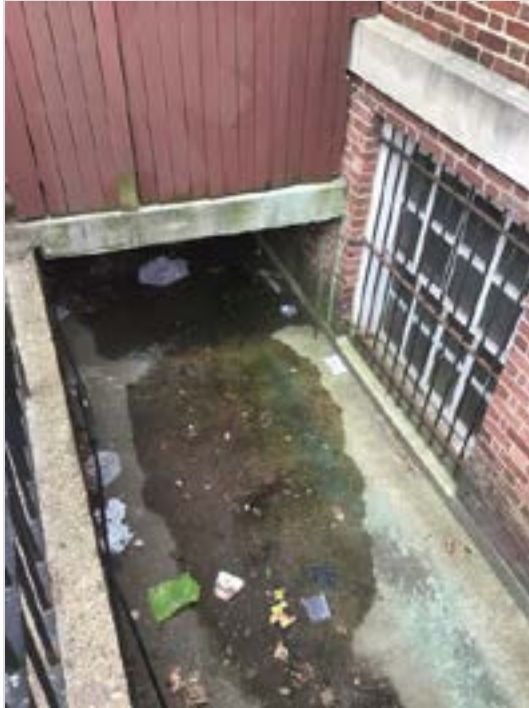
Water collecting under garbage enclosure

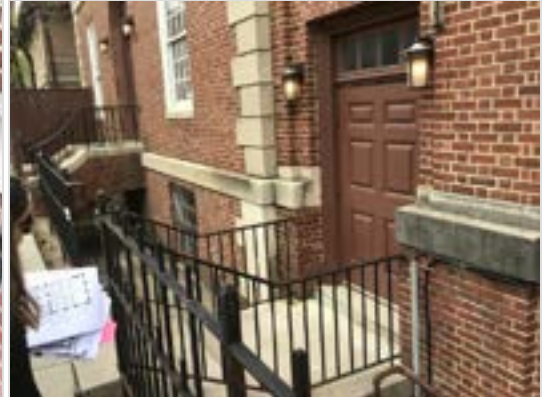
Railing rusting

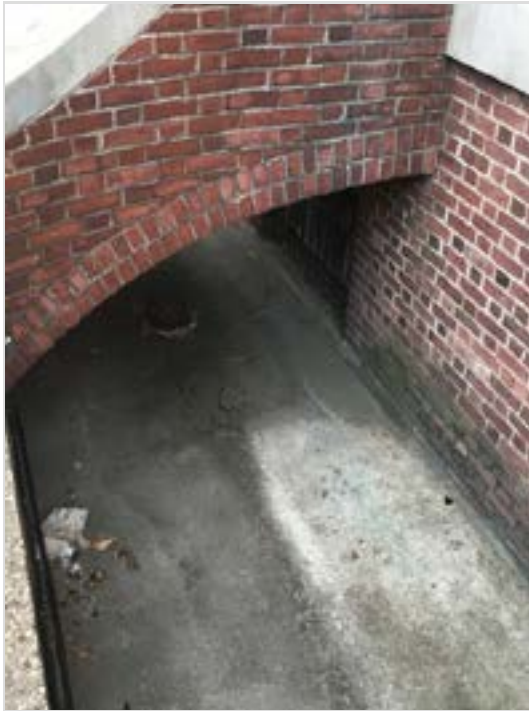
- Exterior (Moat) [1.59]

Drain raised above slab + dirt collecting

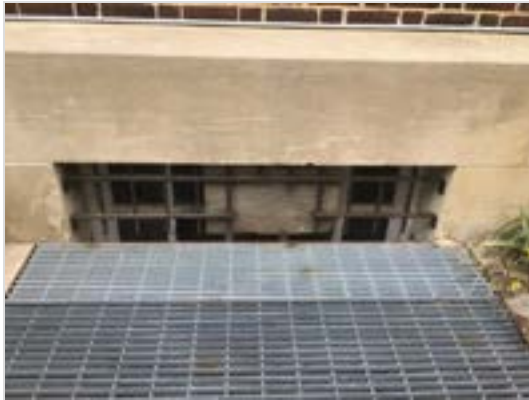
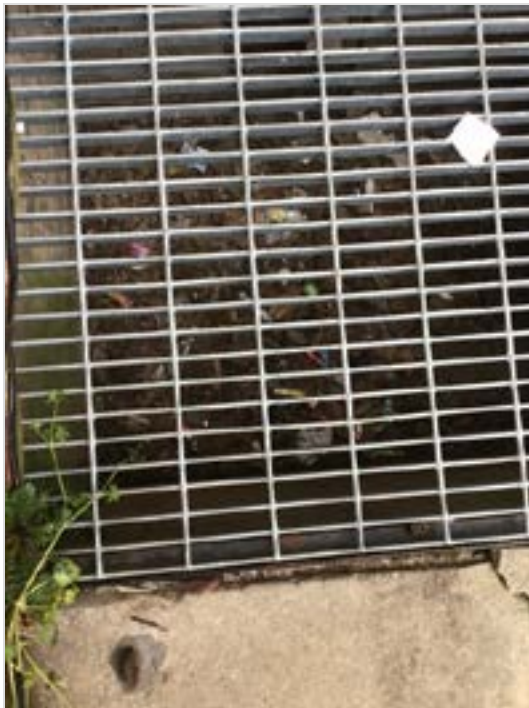
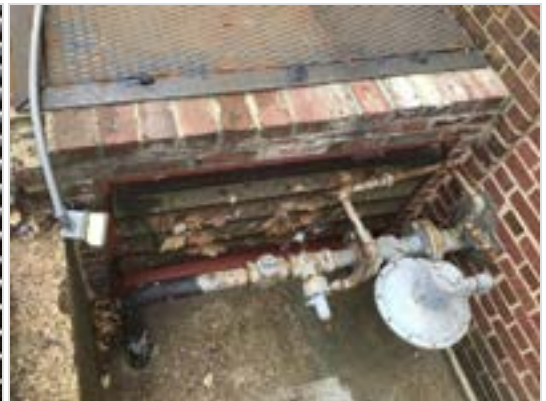
● Exterior - Lower Level
Window Wells (general
issue) [1.63]

Lower level window wells across the board:
-Louvers require cleaning
-Debris below metal grates requires removal
-Metal window bars require replacement due to rusting

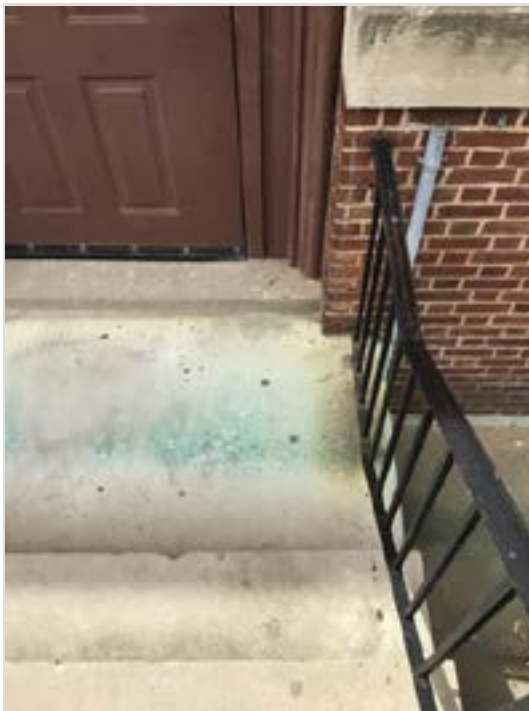
- Exterior - Moat (15th Street) [1.64]

Efflorescence on cast stone directly below the roof line.
